Trub
STR_4272 /M62//63.40//

Structures Principal Inspection Report

02/03/2021
Completed

Structure Name Trub **Maintaining Agent** National Highways Area 10/Area 10
Structure Key STR_4272 **Geographical Area** Manchester
Structure Number /M62//63.40// **Custodian/Region** NH_OWNED / North West
OS Grid 388500 / 409880 **Structure Type** Bridge And Large Culvert

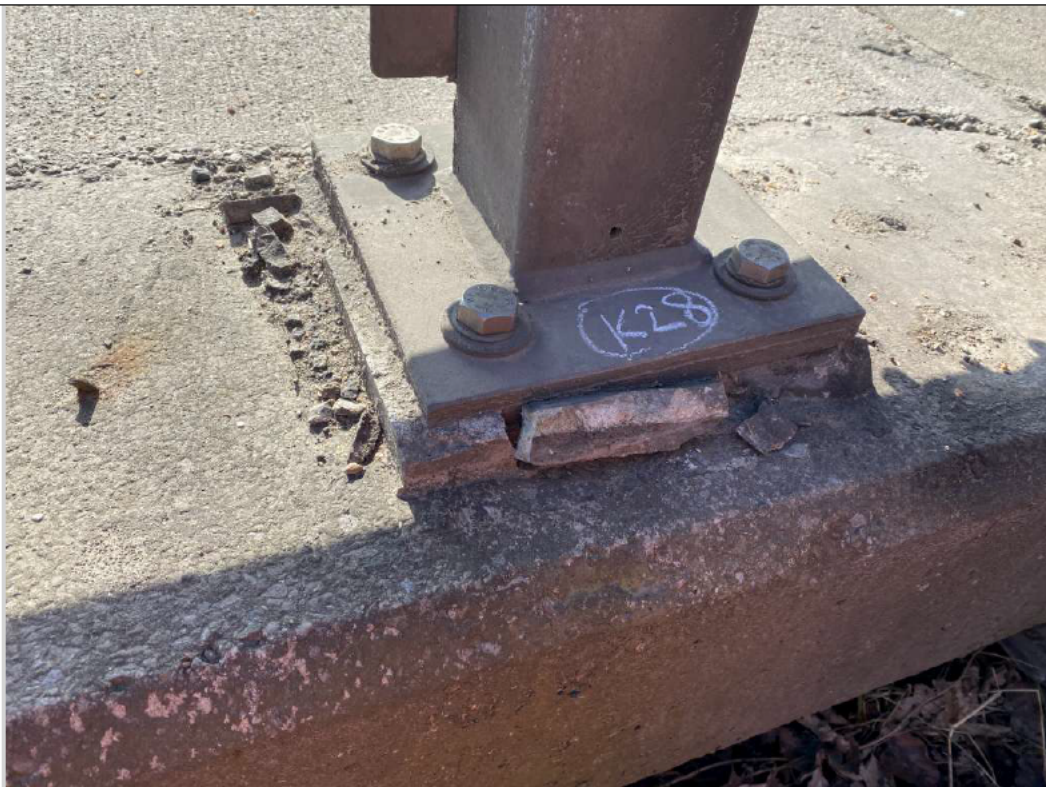
Defect Code	DEF_6621540		
Component	Road Vehicle Restraint System	North Parapet	
Defect Type	Sp - Spalled area Loss of concrete or masonry		
Extent	SC - Defect present in 5% to not more than 20% of area or length of element		
Severity	D2 - Minor: Defect is unlikely to be causing damage to the element or structure now or unlikely to do so in the near future		
Priority	Low		
Comments	The grout beneath the parapet post base plates was found to be cracked and spalled. Monitor at future inspections.		
Cause	Certainty		
Comment on Cause			
Document ID	4005568	Document Title	STR_4272 Defect Photos 02.03.2021
01. View showing spalled grout beneath the North parapet post base plates.jpg

Work Order Number	183956	Priority	Medium
Maintenance Object	Parapet	Maintenance Action	Replace
Estimated Cost	£30,000.00	Recommended Action Date	
Comments	Replace 6m of middle parapet rail. Replace 12m of bottom parapet rail.
