ELR:	AGB	Structure No:	3	Mileage:	Unknown	Examination date:	24/04/20
Route:	Gullane to Longniddry					OS ref:	NT483797
Name:	Luffness Mains					Type:	Overbridge

Examiner Comments on Structure Condition:

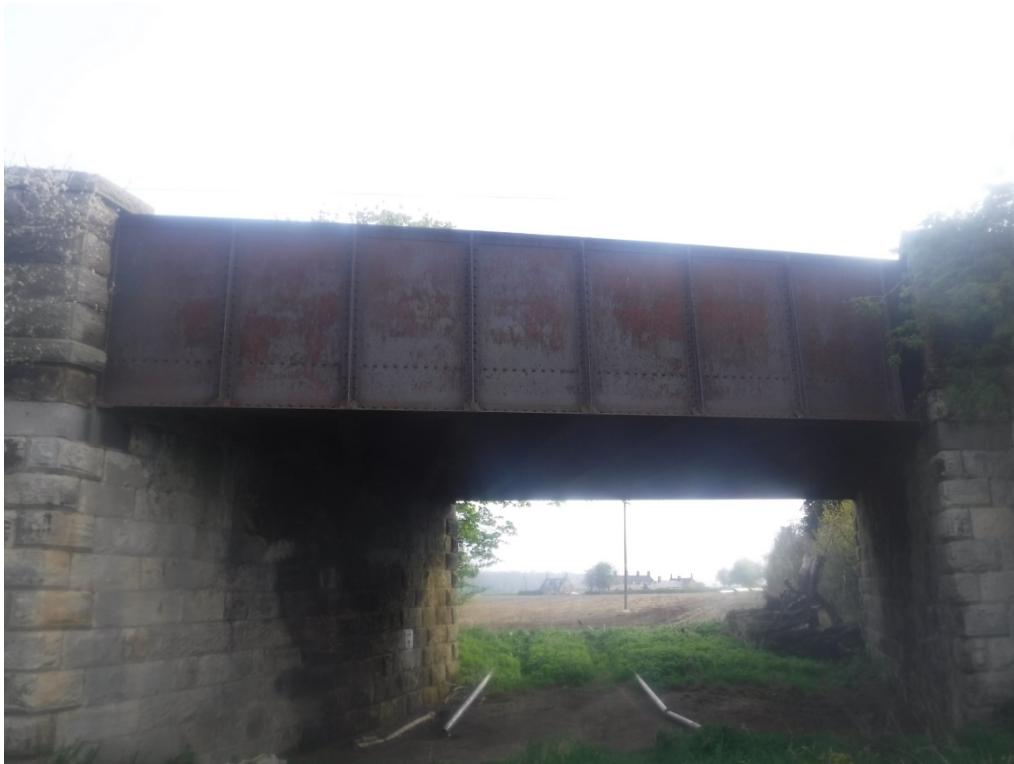
East elevation, moderate to severe corrosion at bearing on both abutments. Slight to moderate surface corrosion over 100% of area. Web plate holed at south elevation Ph No6 - Ph No9

Photo No.6. East elevation parapet girder solum face

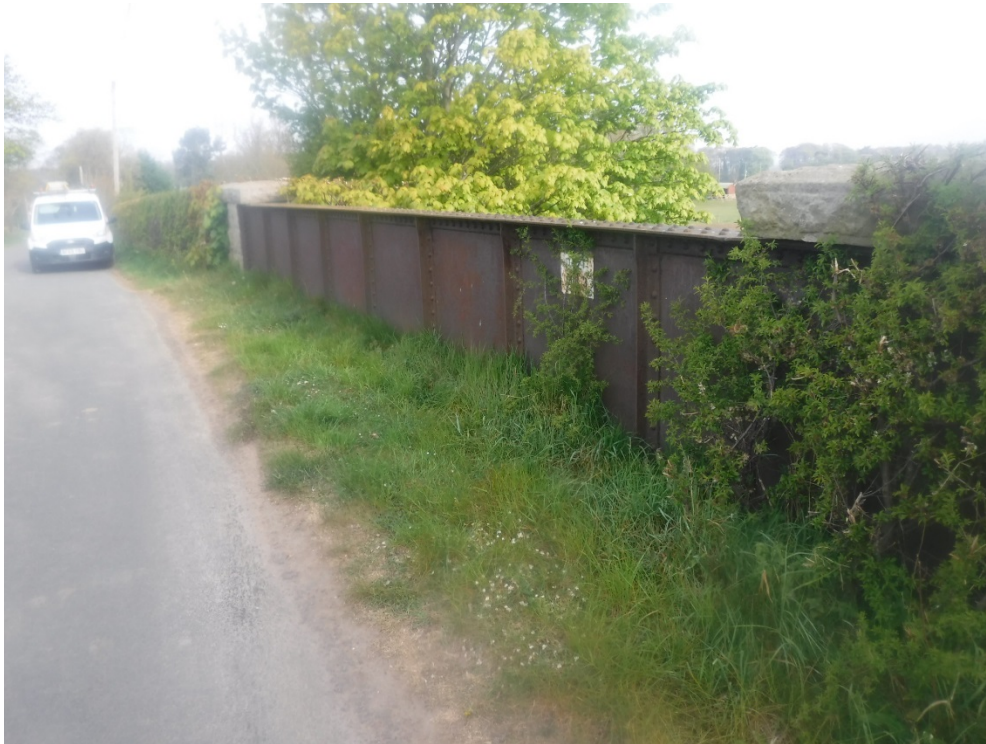
Photo No.7. East elevation parapet girder road face

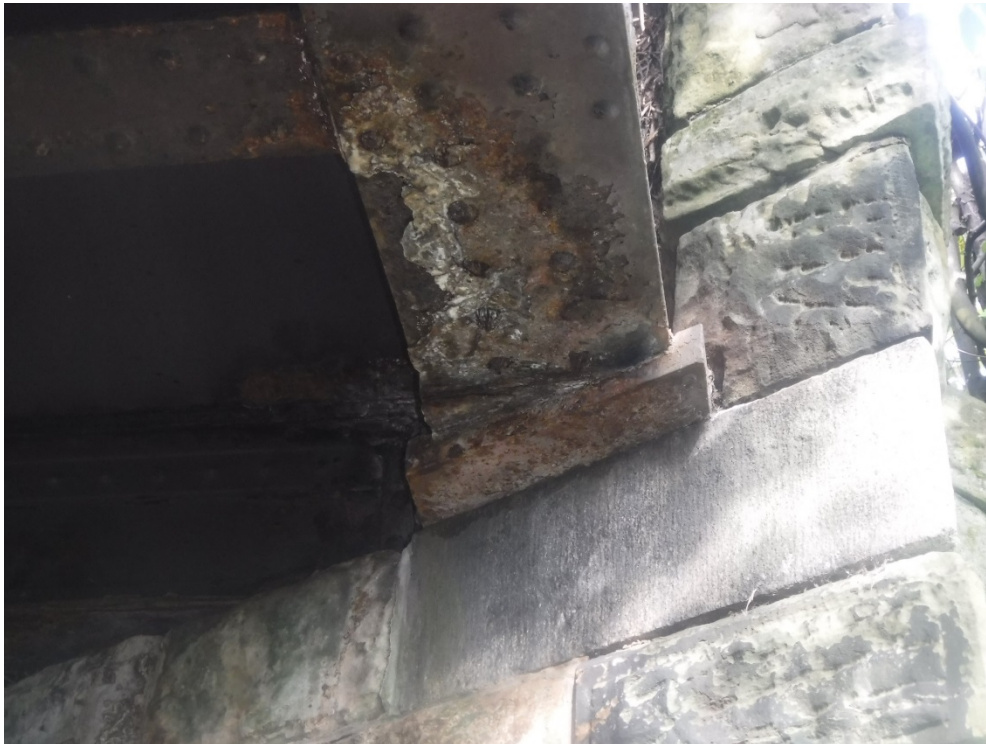
Photo No.8. East elevation parapet girder corrosion

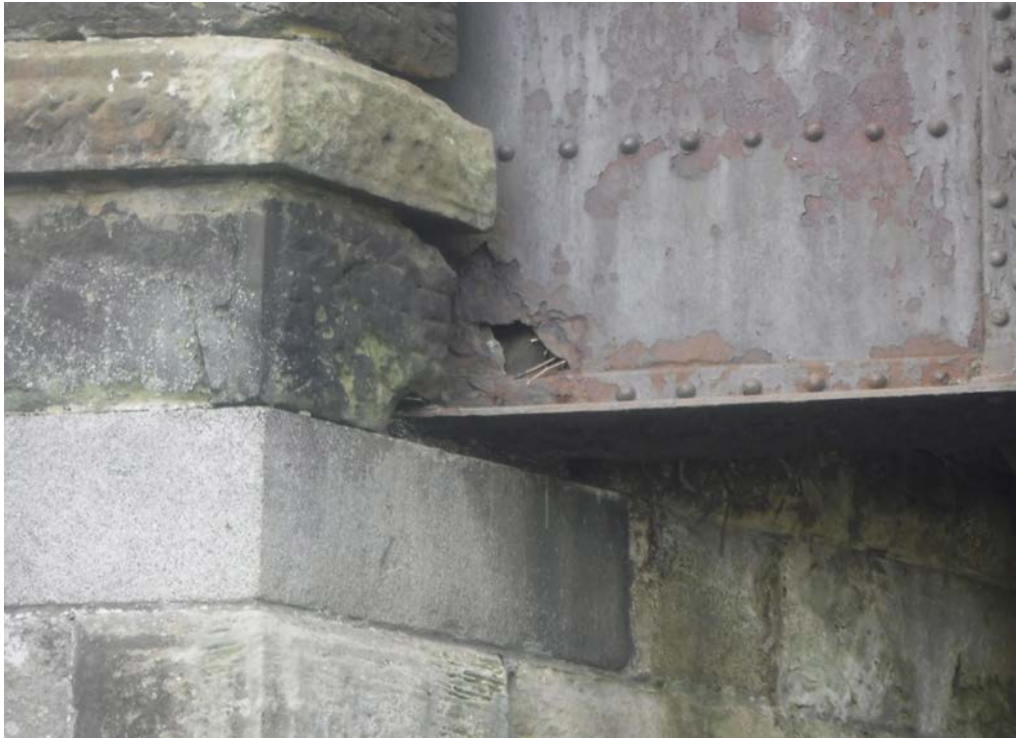
Photo No.9. East elevation parapet girder web plate holed

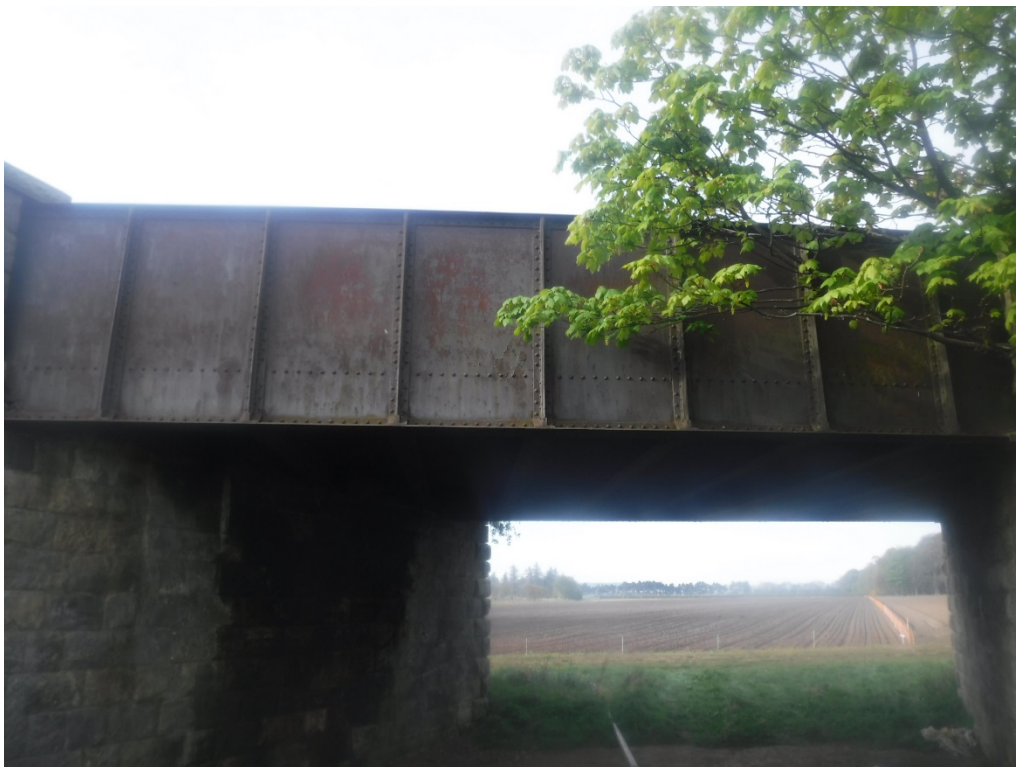
West elevation, moderate to severe corrosion at bearing on both abutments. Slight to moderate surface corrosion over 100% of area. Bottom flange notched at bearing on South elevation bearing plate Ph No10 - Ph No12

Photo No.10. West elevation parapet girder solum face

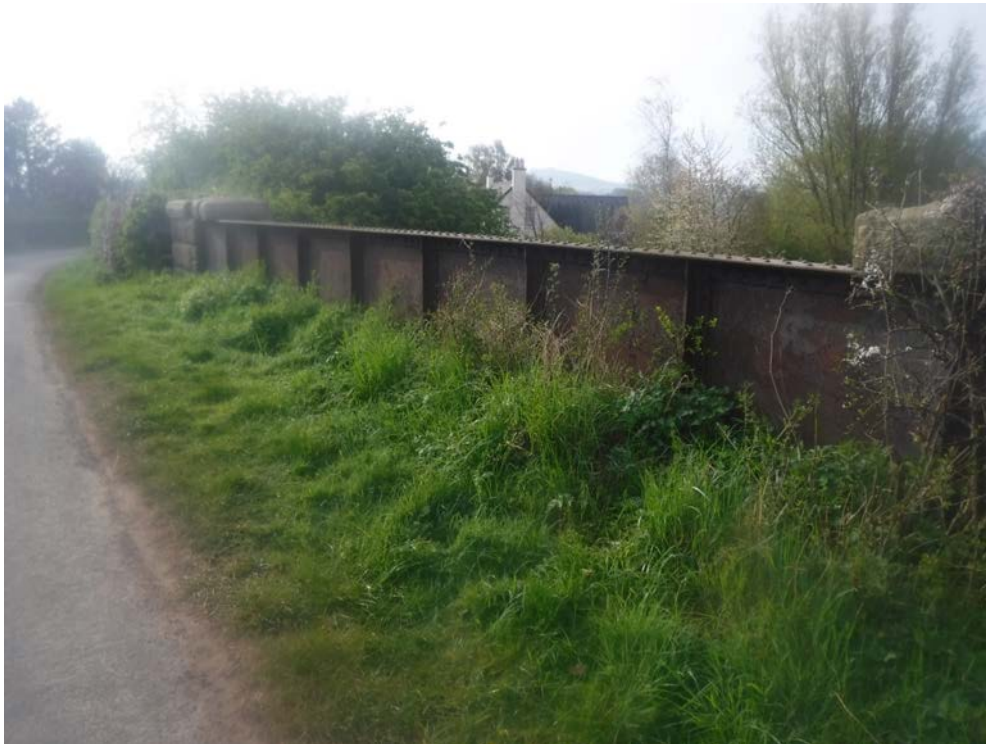
Photo No.11. West elevation parapet girder road face

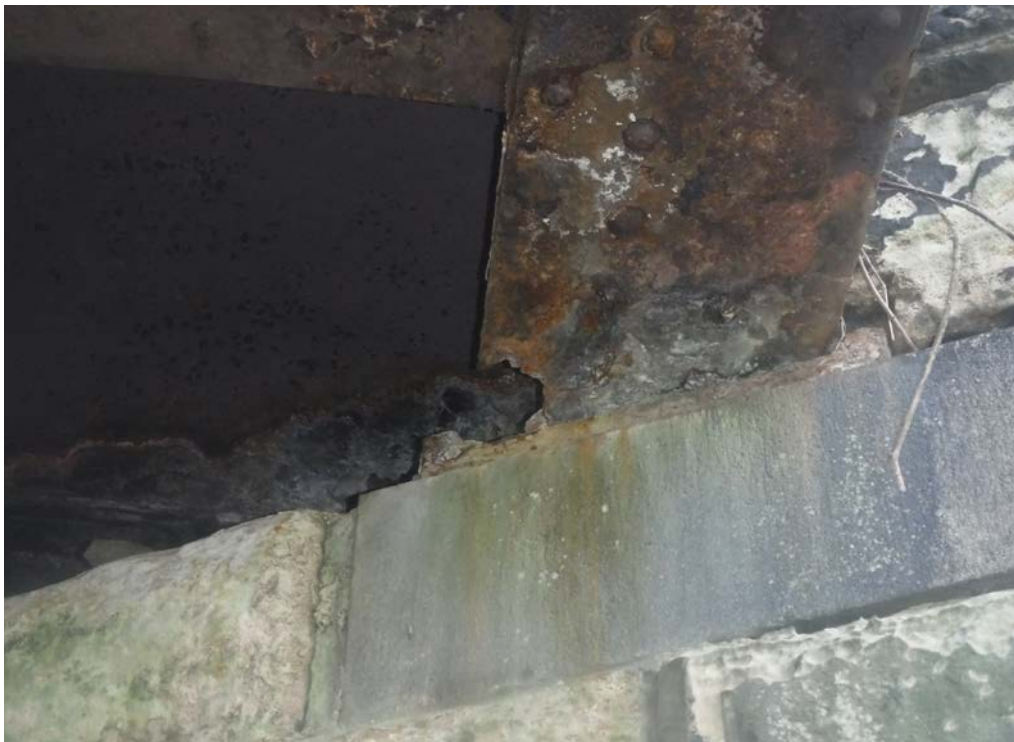
Photo No.12. West elevation parapet girder bottom flange notched

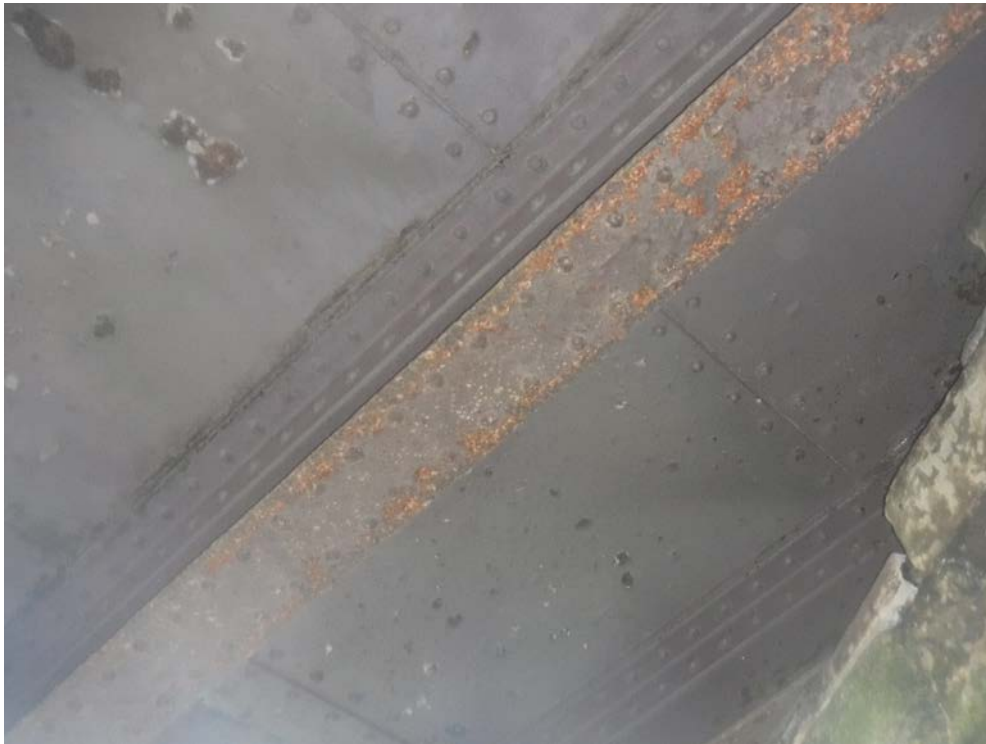
Moderate to severe corrosion to bottom flanges at random intervals throughout area. Ph No13

Photo No.13. Cross girders corrosion

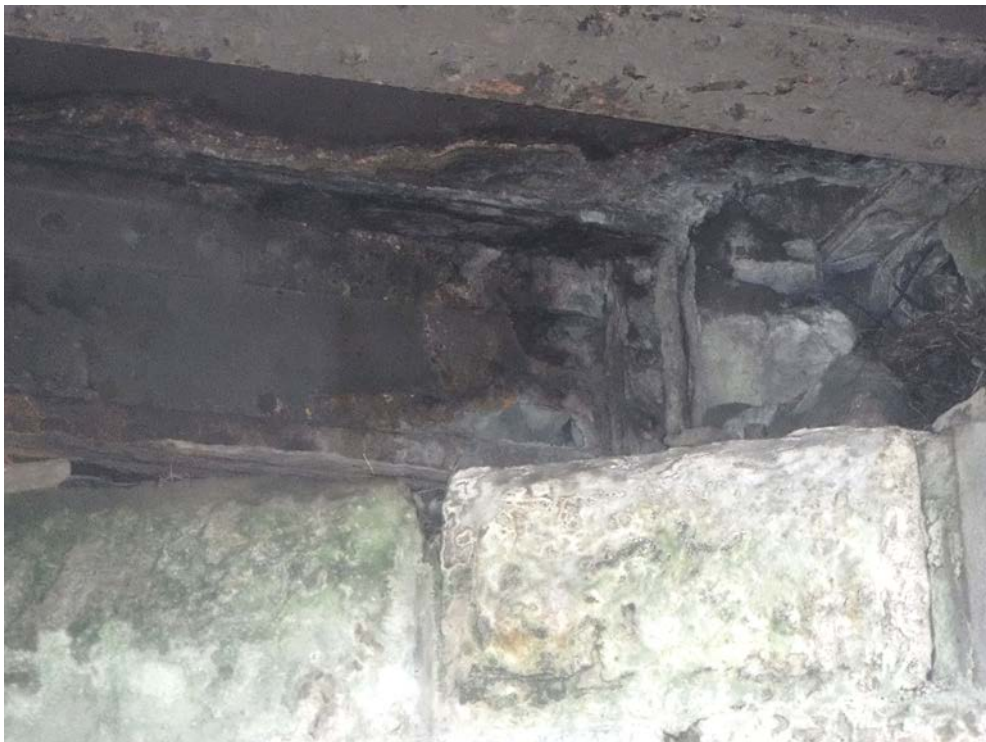
Web plate holed at South west bearing on abutment at West elevation parapet main girder Ph No14

Photo No.14. Cross girders corrosion web plate holed at abutment

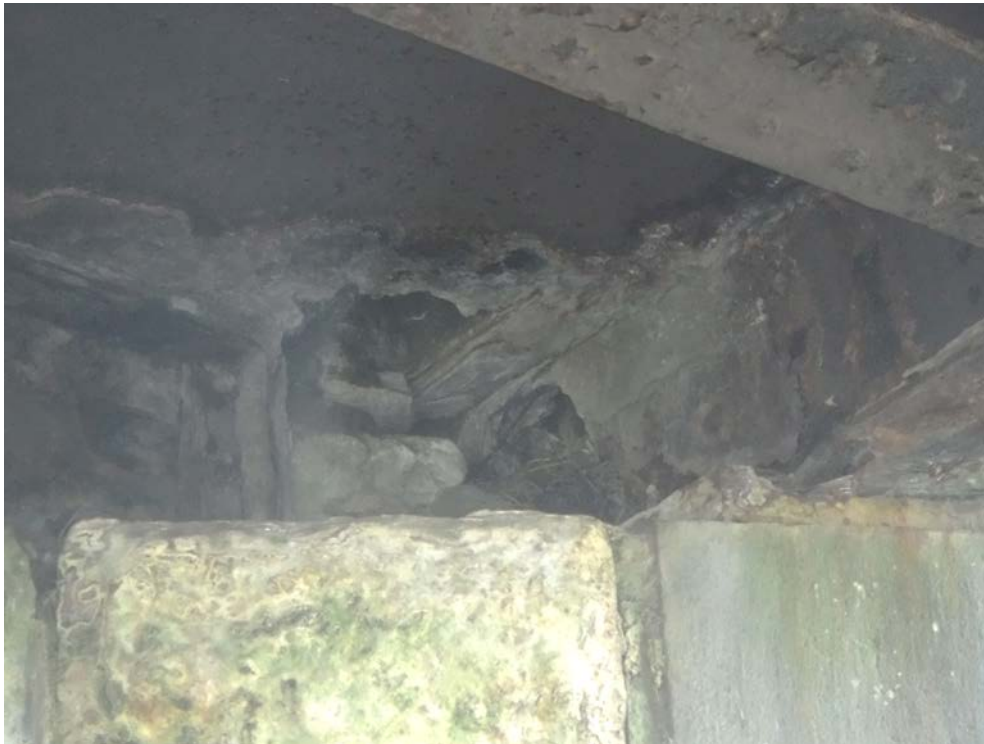
Plate deck holed at West elevation parapet girder Ph No15

Photo No.15. Deck plate holed

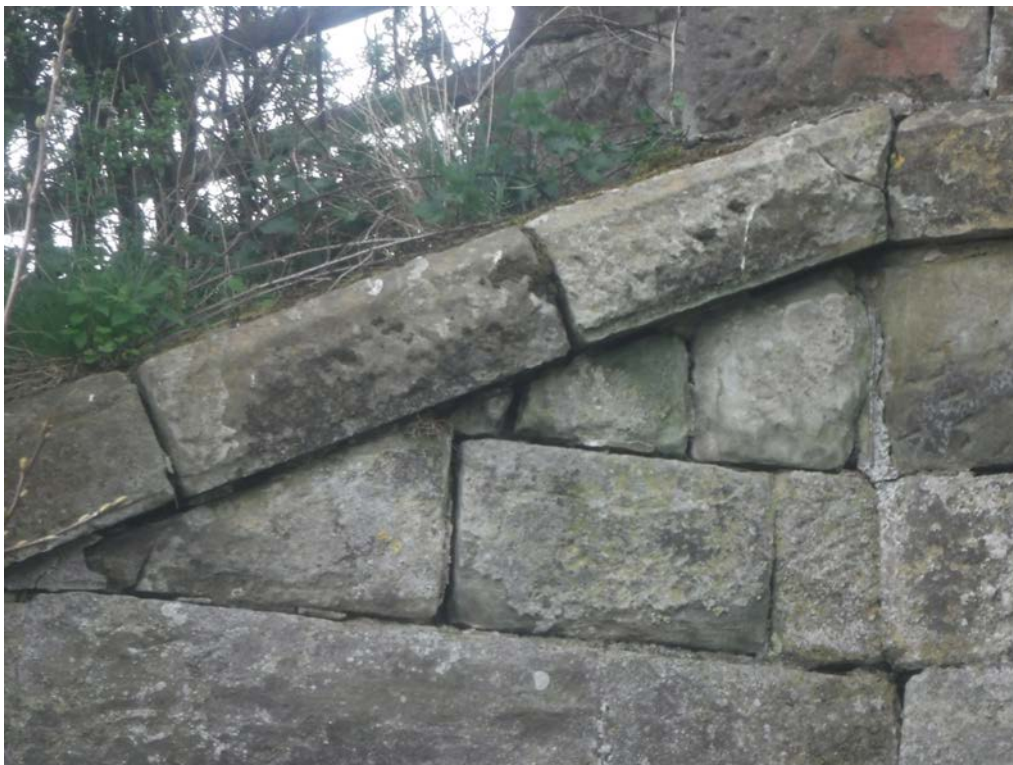
South East elevation, deep open joints under cope stones Ph No16

Photo No.16. South East elevation wing wall open joints

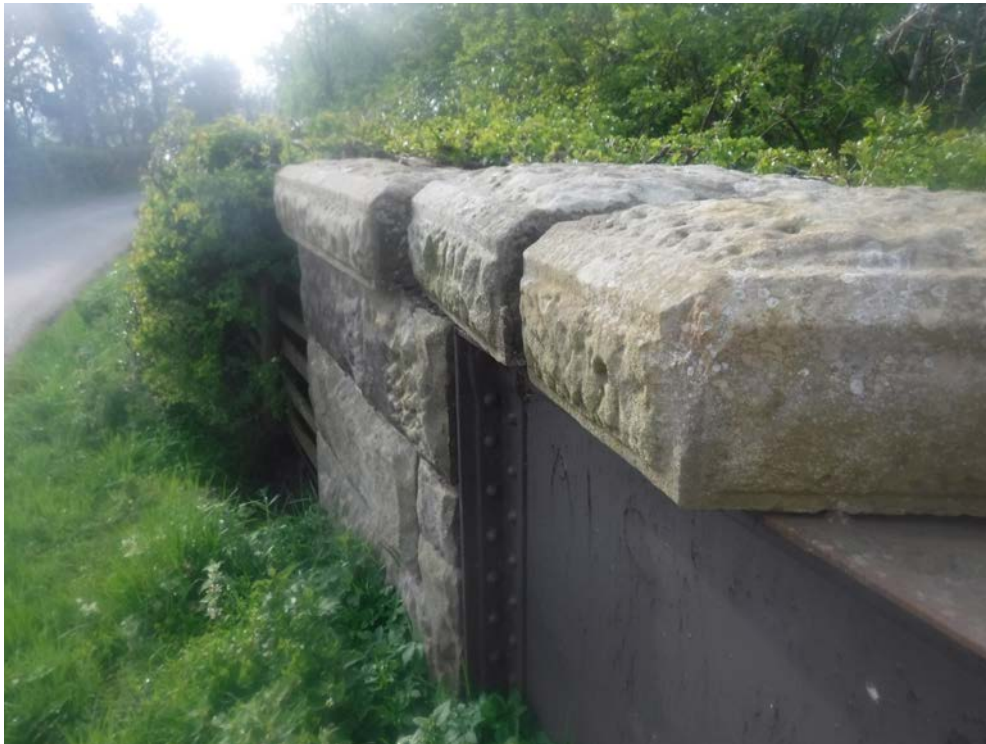
South West elevation pilaster cap displaced Ph No17

Photo No.17. South West elevation pilaster displaced

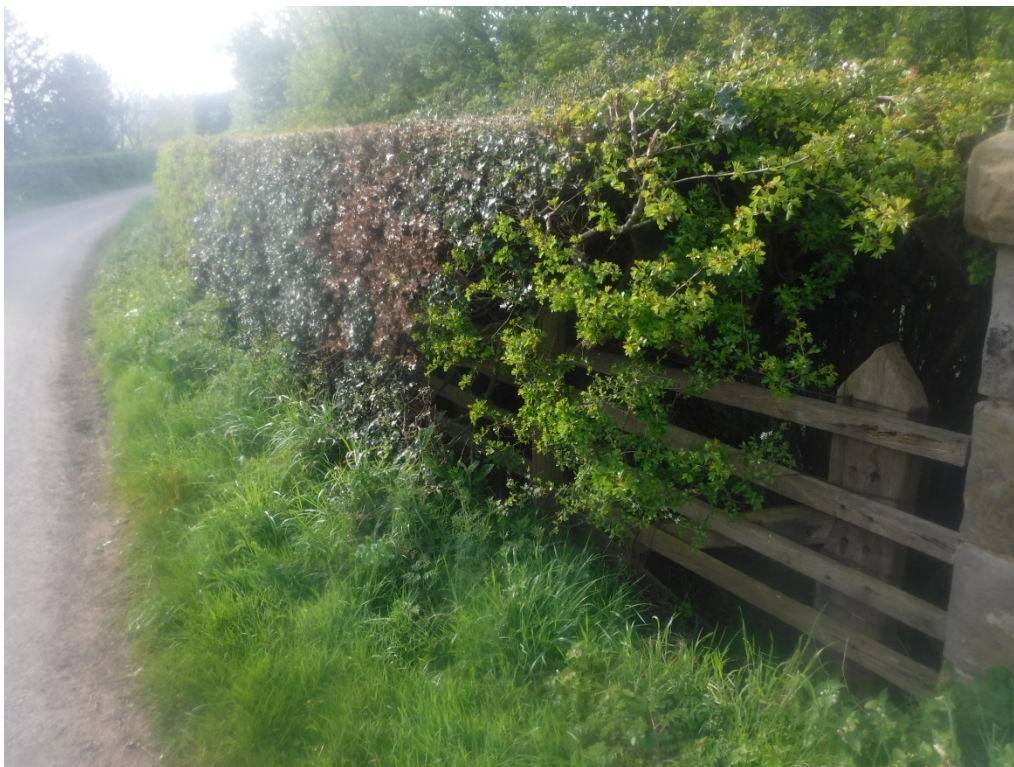
All approach fences covered with vegetation Ph No18

Photo No.18. Approach fences covered with vegetation
