<b>ELR:</b> AGB	<b>Structure No:</b> 3	<b>Mileage:</b> Unknown	<b>Examination date:</b> 01/05/19
<b>Route:</b> Gullane to Longniddry		<b>OS ref:</b> NT483797	
<b>Name:</b> Luffness Mains		<b>Type:</b> Overbridge

<p><b>Examiner Comments on Structure Condition:</b></p> <p><b>STRUCTURE</b> Single span, steel parapet main girders, cross girders, plate deck, masonry abutments, wing walls and pilasters</p> <p><b>PARAPET MAIN GIRDERS</b> East elevation, moderate to severe corrosion at bearing on both abutments. Slight to moderate surface corrosion over 100% of area. Web plate holed at south elevation Ph No6 - Ph No8 West elevation, moderate to severe corrosion at bearing on both abutments. Slight to moderate surface corrosion over 100% of area. Bottom flange notched at bearing on South elevation bearing plate Ph No9 - Ph No10</p> <p><b>CROSS GIRDERS</b> Moderate to severe corrosion at bearing on both abutments. Ph No11 Web plate holed at South west bearing on abutment at West elevation parapet main girder Ph No12</p> <p><b>PLATE DECK</b> Moderate to severe corrosion at connection with main girders / cross girders Plate deck holed at West elevation parapet girder Ph No13</p> <p><b>WING WA

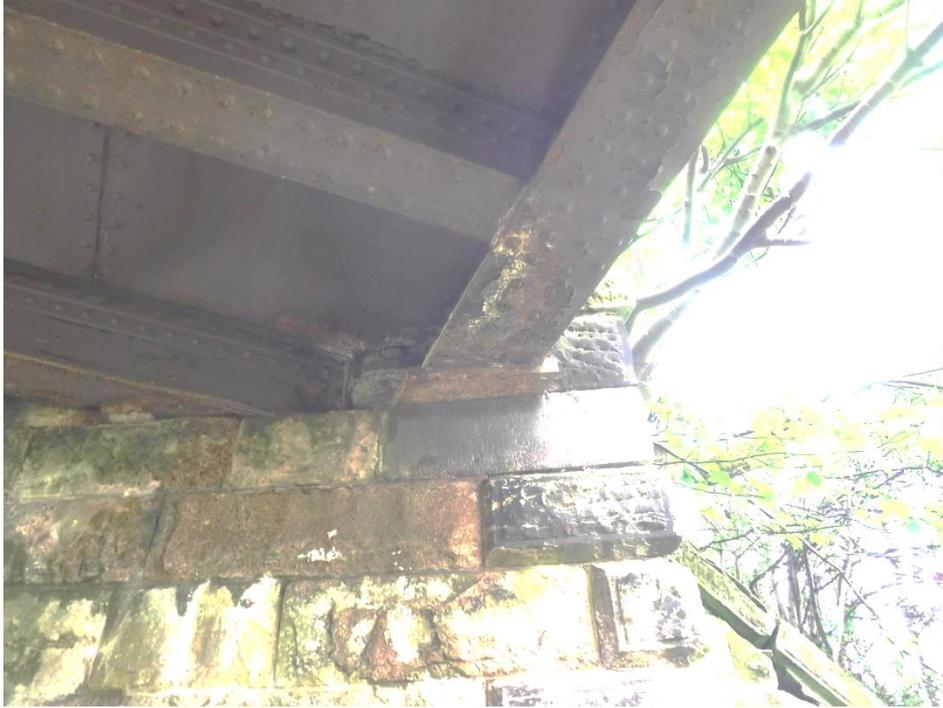
**Photo No.7. East elevation parapet girder corrosion**

<p><b>Access Hazards:</b> Road traffic, working at height</p>	
<p><b>Recommendations:</b> Check assessment status and (repair losses of section to cross and parapet girders at NW and SE bearings) - P1 £n/a (£10k).</p>	
<p><b>Signed by Examining Engineer:</b>

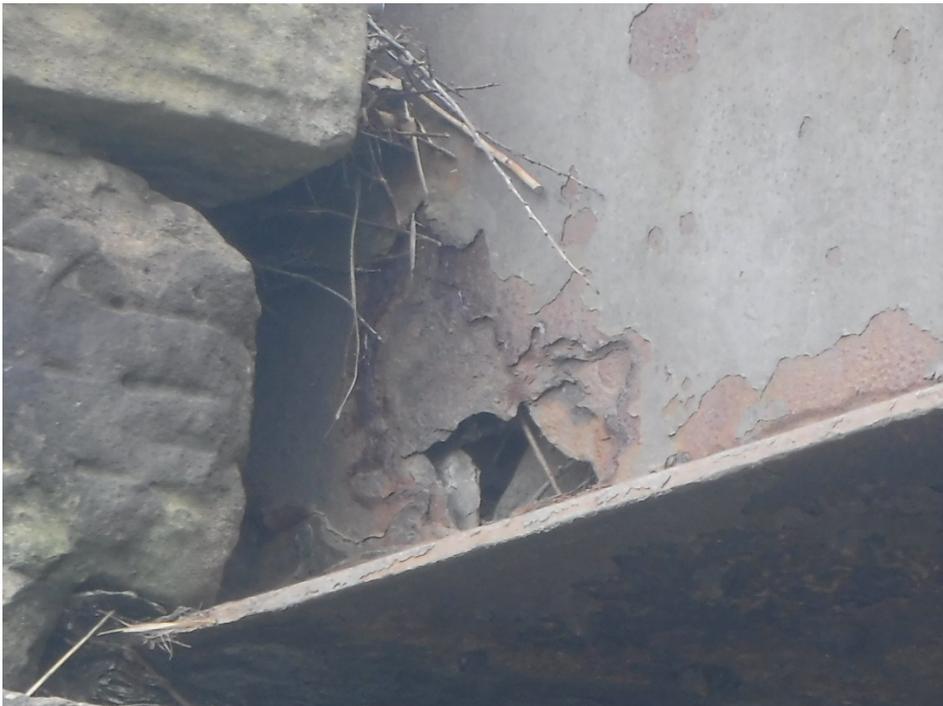
**Photo No.8. East elevation parapet girder web plate holed**

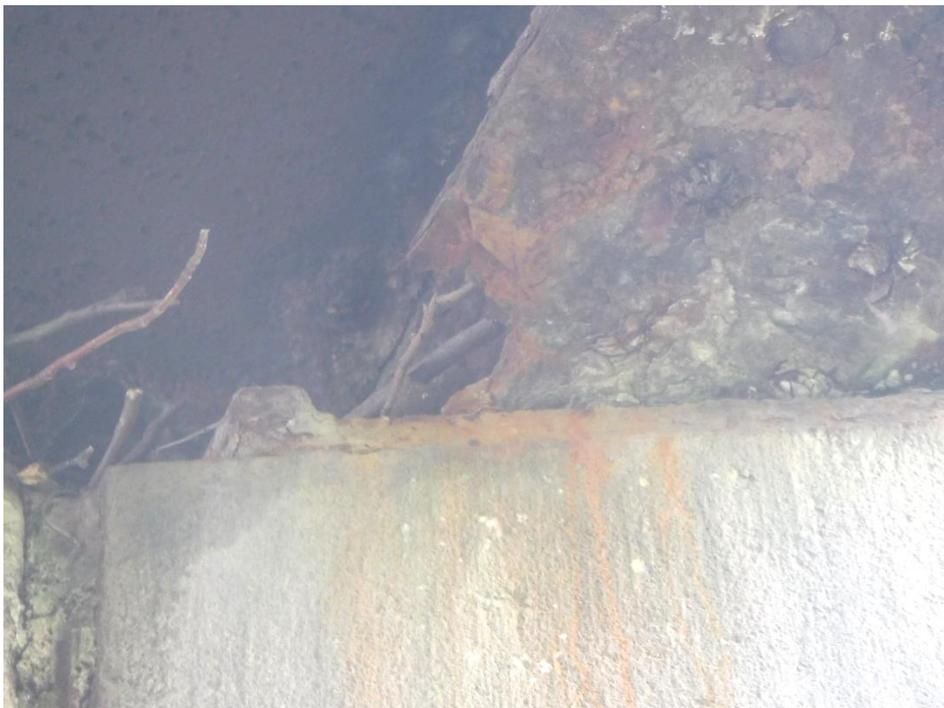
**Photo No.10. West elevation parapet girder bottom flange notched**

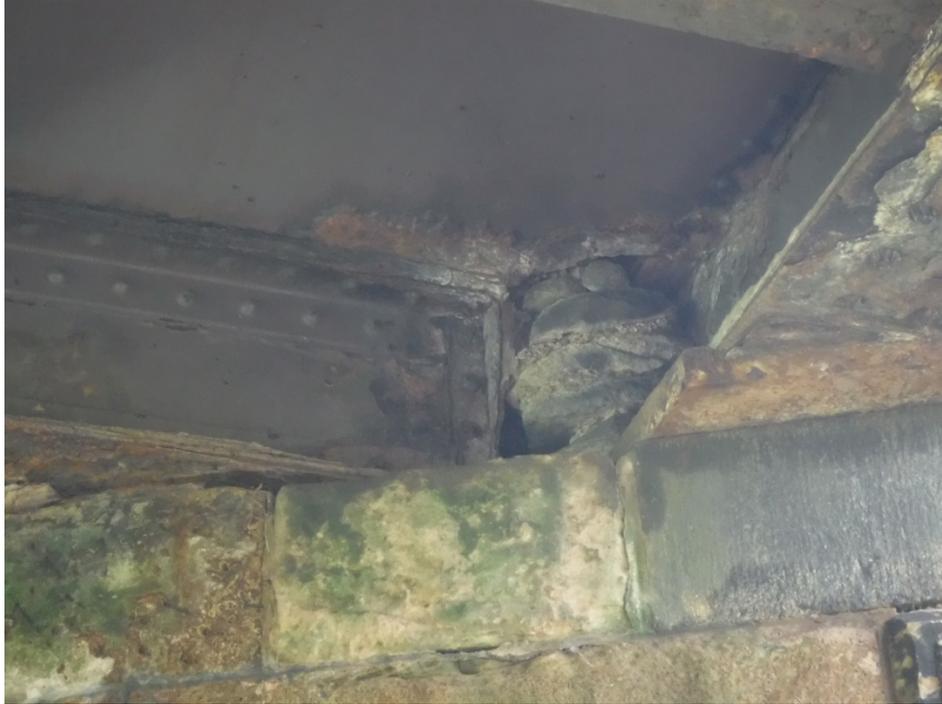
**Photo No.11. Cross girders corrosion at abutments**

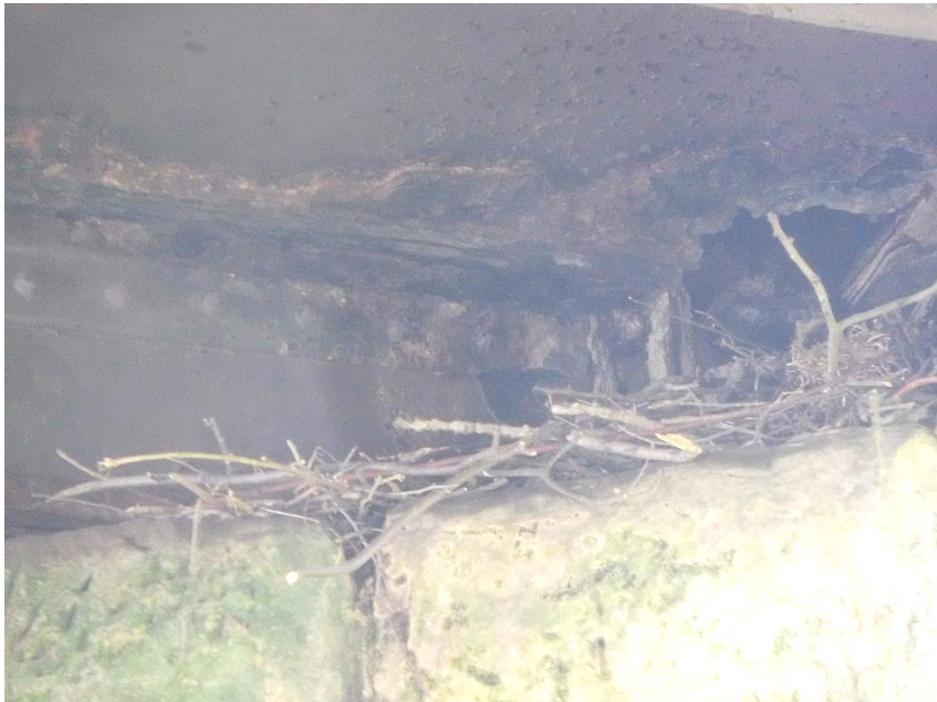
**Photo No.12. Cross girders corrosion web plate holed**

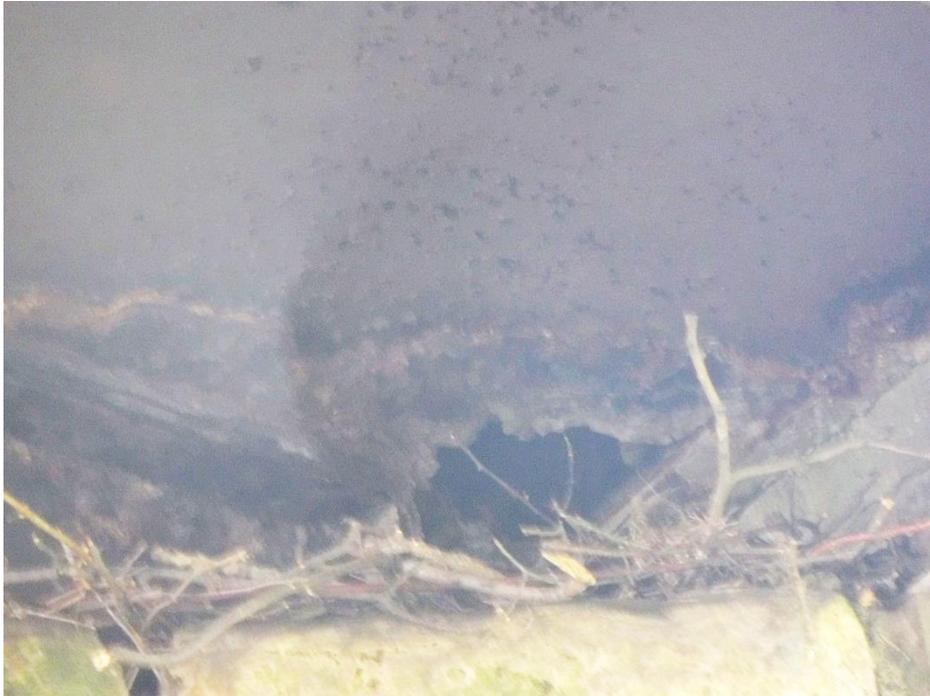
**Photo No.13. Deck plate holed**

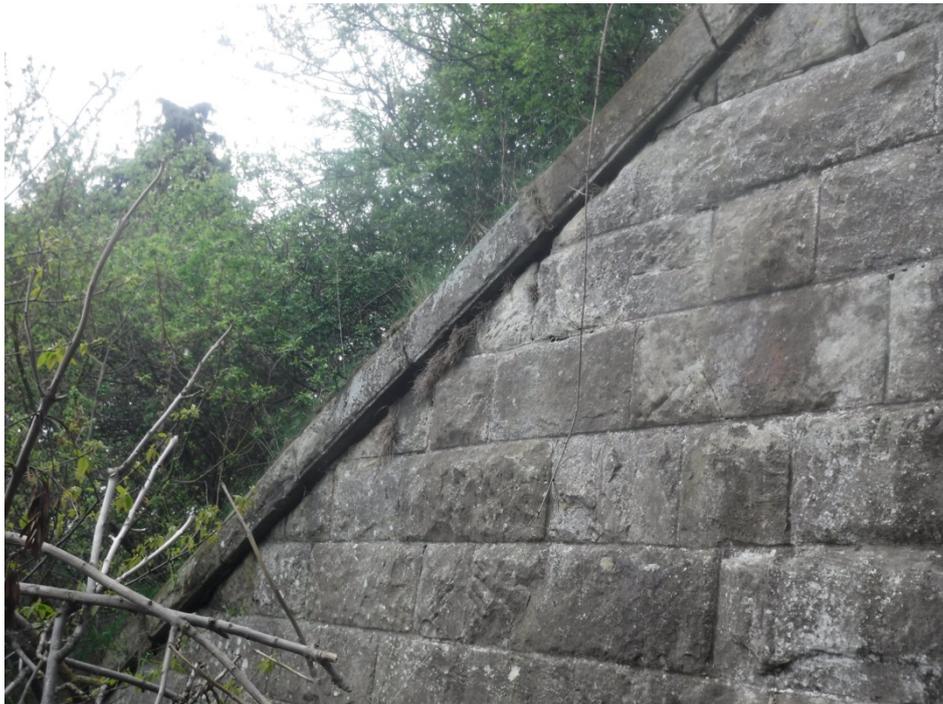
**Photo No.14. South East elevation wing wall open joints**

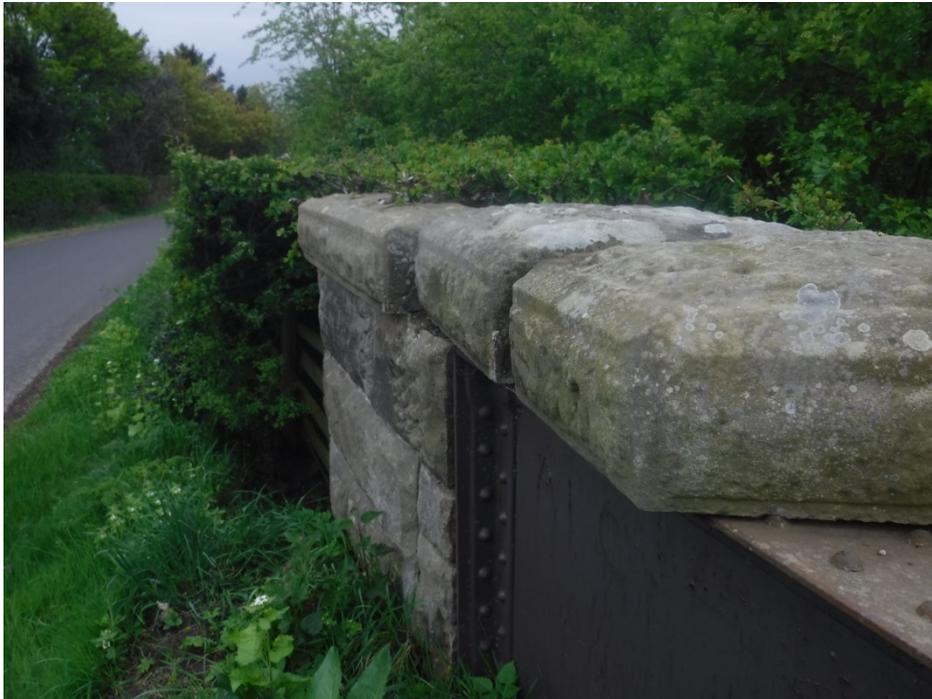
**Photo No.15. South West elevation pilaster displaced**

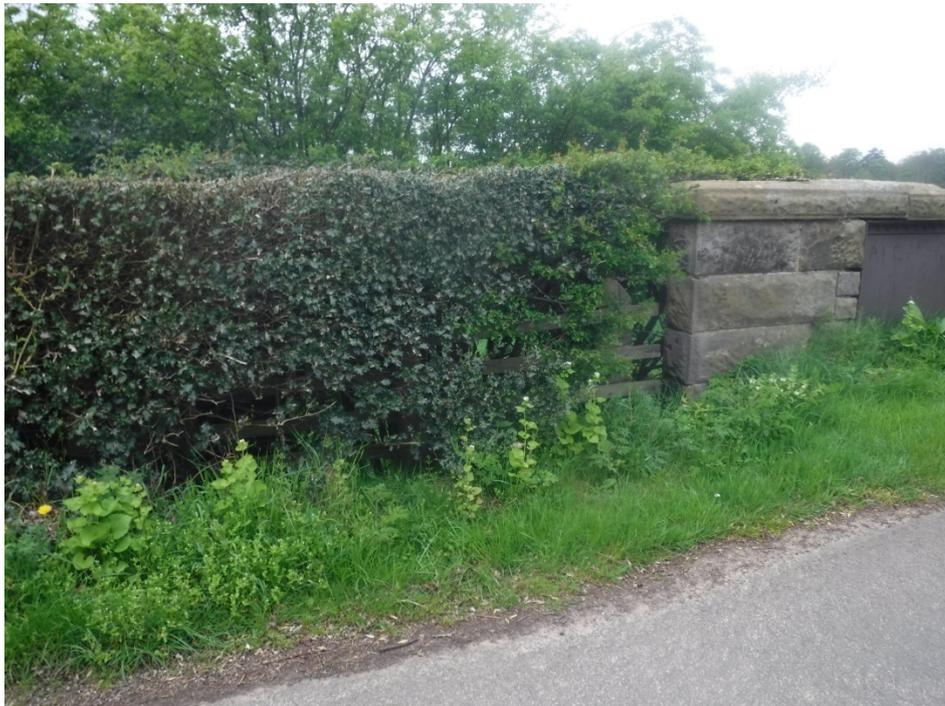
**Photo No.16. Approach fences covered with vegetation**
