Lutterworth Swinford Road STR\_318 /M1//137.50//  
M1 137.50

## 1. Structure Summary - STR\_318

Inspection Type	Inspection Date	Inspection Description
Structures Principal Inspection	21/02/2025	<p>Where observed the structure was in fair condition overall with minor to moderate defects recorded. The previously recorded defects did not appear to have significantly deteriorated since the last inspection. Since the previous inspection numerous areas of significant spalling have been repaired.</p> <p>Recorded defects consisted of cracking, delamination and spalling to the service bays on all four spans to both the north and south ends of the deck. Within spalled areas there was exposed reinforcement that exhibited moderate corrosion throughout. The largest area of spalling measured 850 x 210 x 180mm and delamination measured up to 840 x 160mm. There was cracking throughout the service bays up to 2mm wide. Within the hinge joints there was cracking up to 2mm wide and on the upper inner face of the east outer hinge joint there were minor areas of spalling and delamination measured up to 430 x 240 x 10mm. Within the deck soffit over southbound lane 2 there was spalling measuring 940 x 2

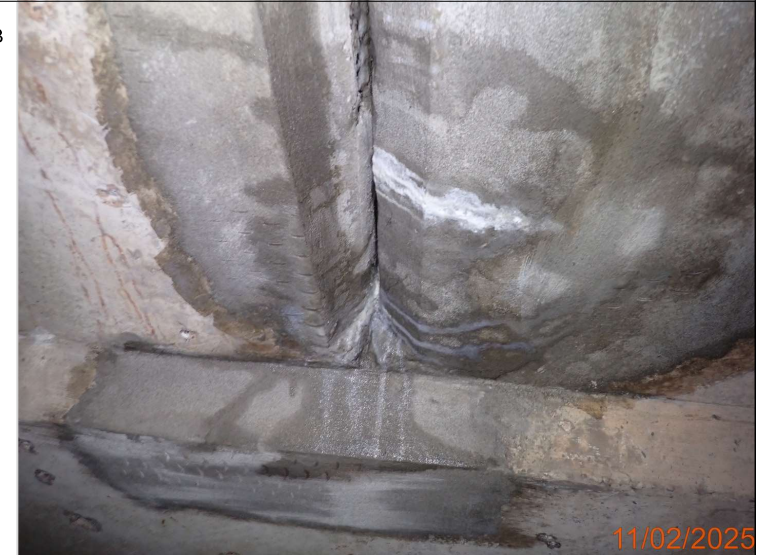
<b>Priority</b>	Low		
<b>Comments</b>	There is leachate staining and stalactites along the service bay joints across all deck spans.		
<b>Cause</b>	Moisture Egress	<b>Certainty</b>	High
<b>Comment on Cause</b>			
<b>Document ID</b>	4586825	<b>Document Title</b>	STR_318 PI Defect photos 21/02/2025

Leachate emanating between the south service bays over NB L2.JPG

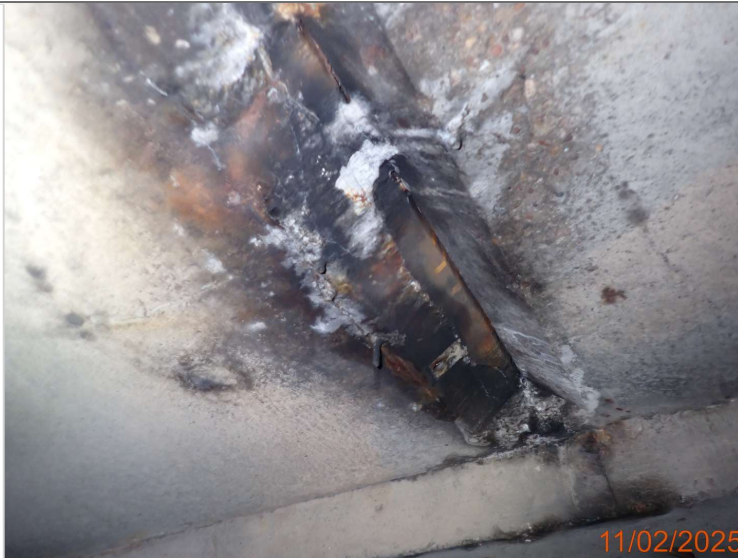
Leachate emanating between the north service bays over SB L1.JPG

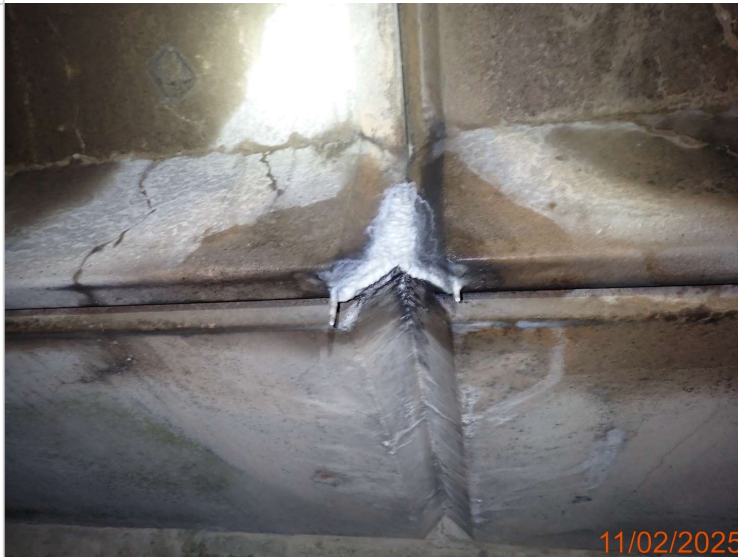
Leachate emanating between service bays over NB L1.JPG

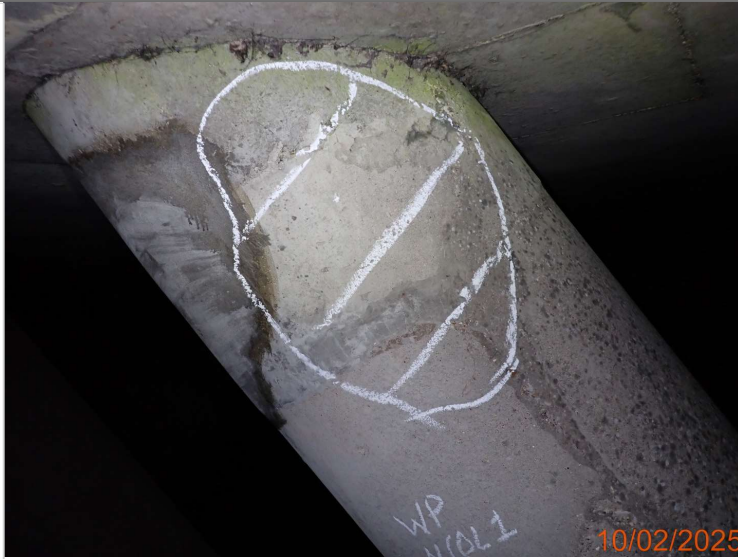
Delamination to the upper column 1 on the west pier - 400 x 530mm.JPG

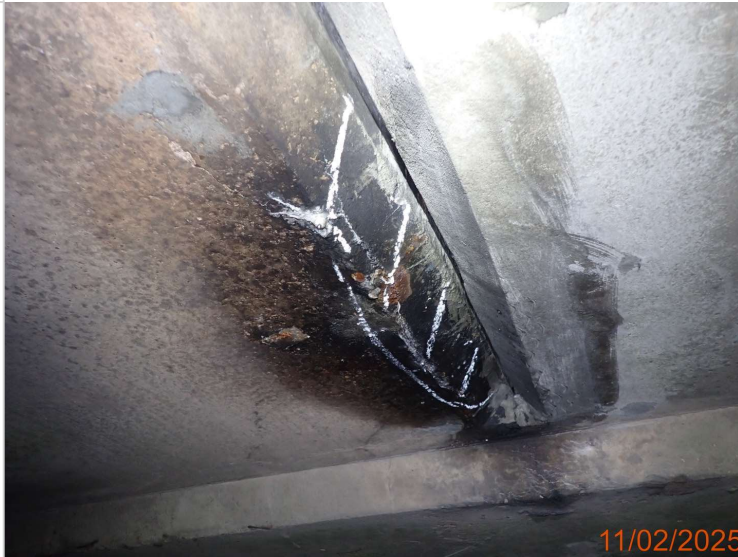
Delamination to the south service bay over SB L1 - 510 x 120mm.JPG

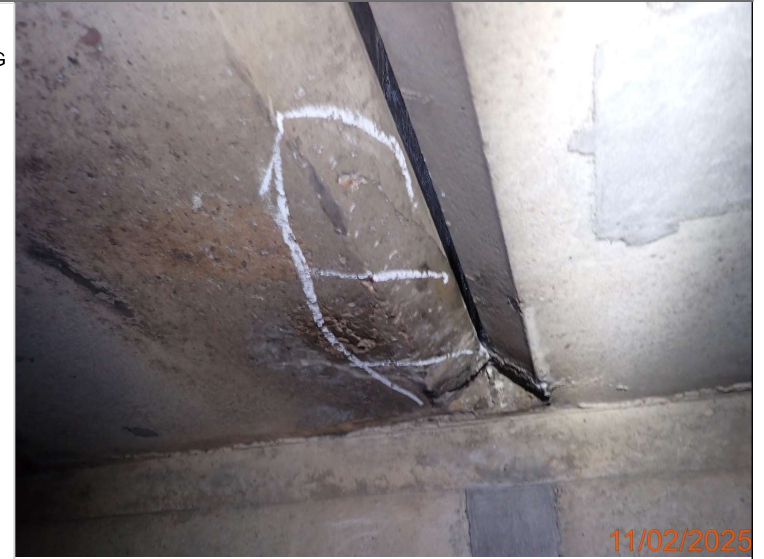
Delamination to the north service bay over the centre reservation - 510 x 160mm.JPG

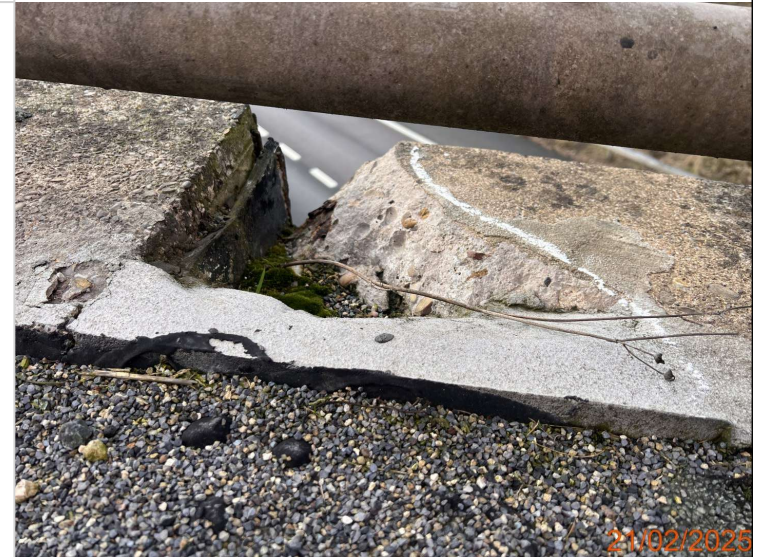
Spalling to the upper service bay over NB L3 - 350 x 240 x 70m.JPG

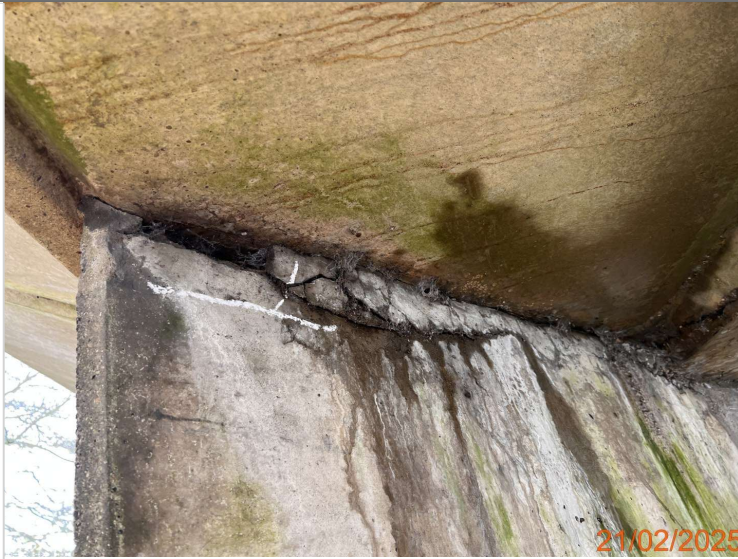
Delamination to the west bankseat - 730 x 110 x 10mm.JPG

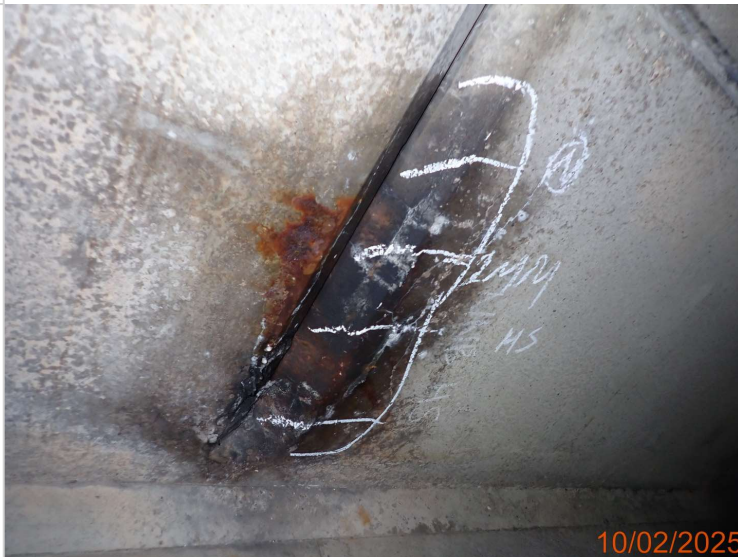
Delamination to the north service bay over NB L1 - 690 x 220mm.JPG

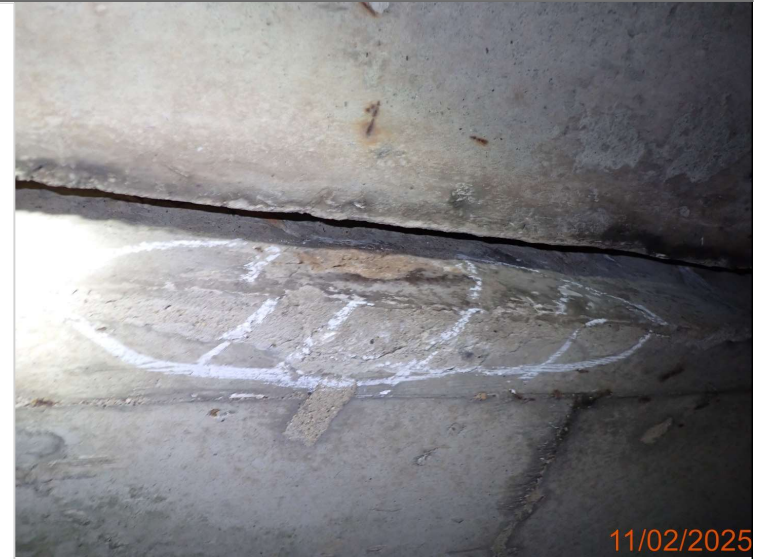
Delamination to the west hinge joint over the slip - 200 x 600mm.JPG

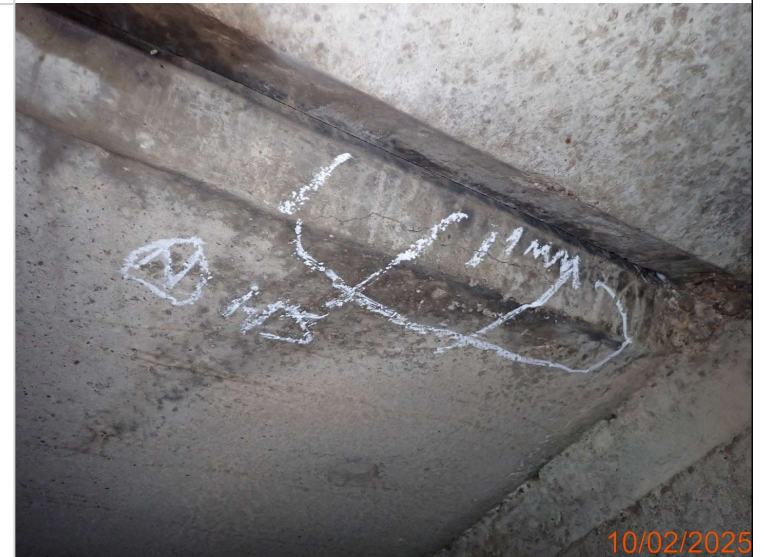
Delamination to the north service bay over NB L1 - 400 x 150mm.JPG

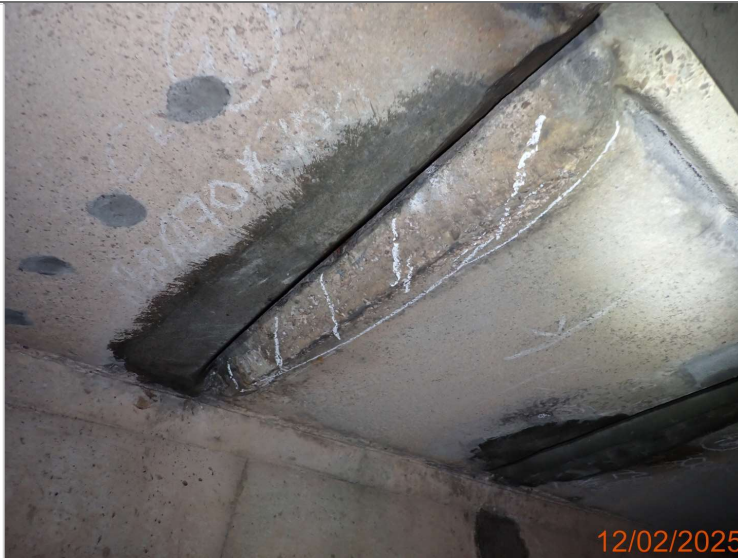
Delamination to the south service bay over NB L3 - 840 x 160mm.JPG

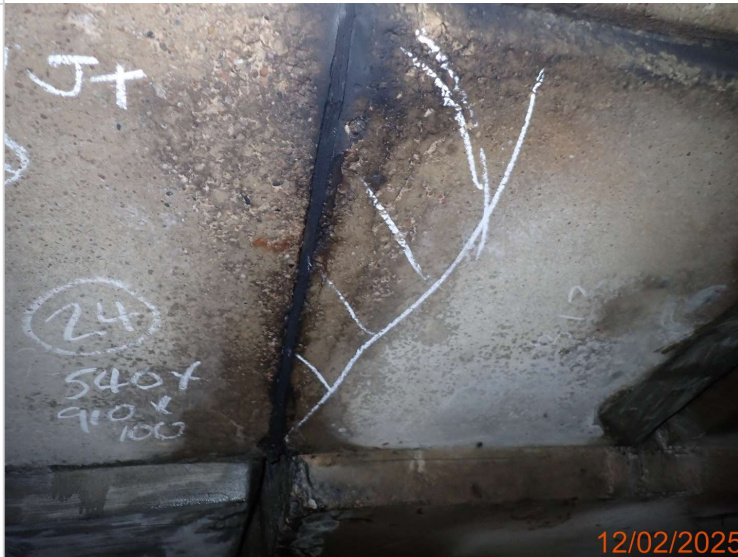
Delamination to the south service bay on the outer west hinge joint over NB L3 - 850 x 200mm.JPG

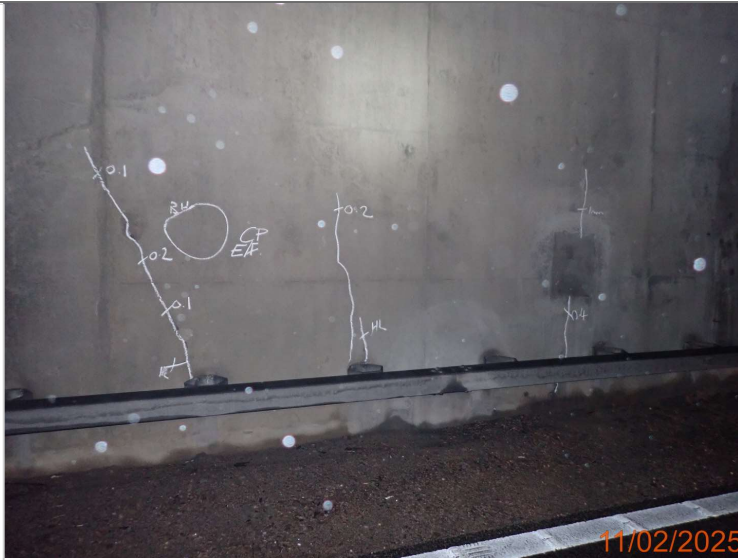
Cracking to the east face of the centre pier up to 1mm wide.JPG

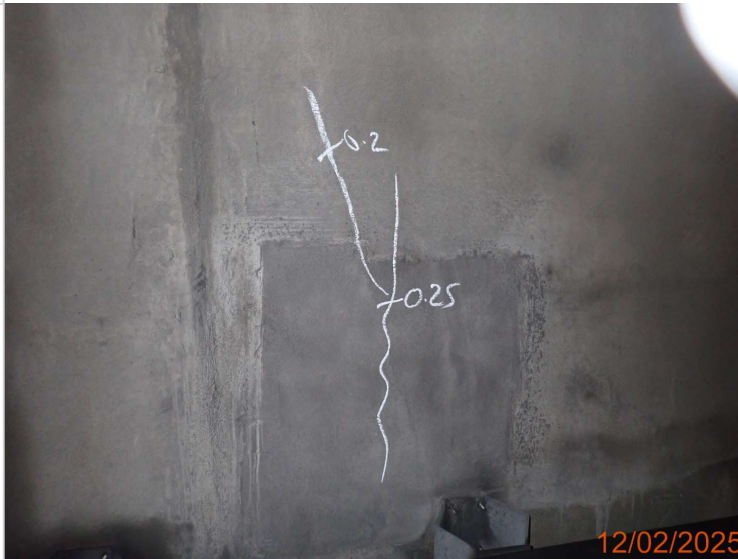
Cracking up to 0.25mm wide to the west face of the centre pier.JPG

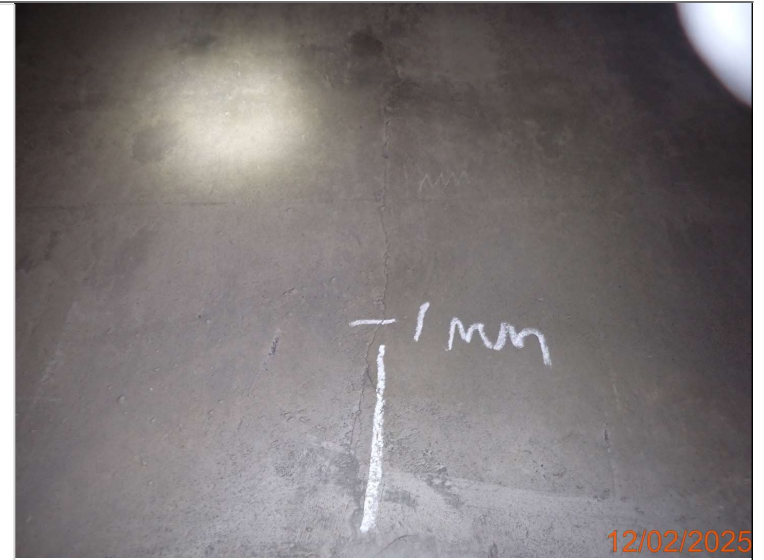
Vertical cracking 1mm wide to the west face of the centre pier.JPG

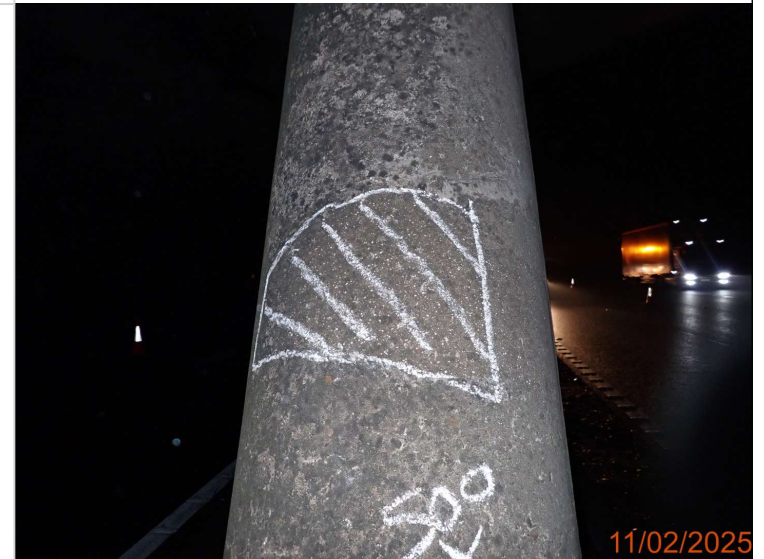
Delamination to the south end of the centre pier - 500 x 370mm.JPG

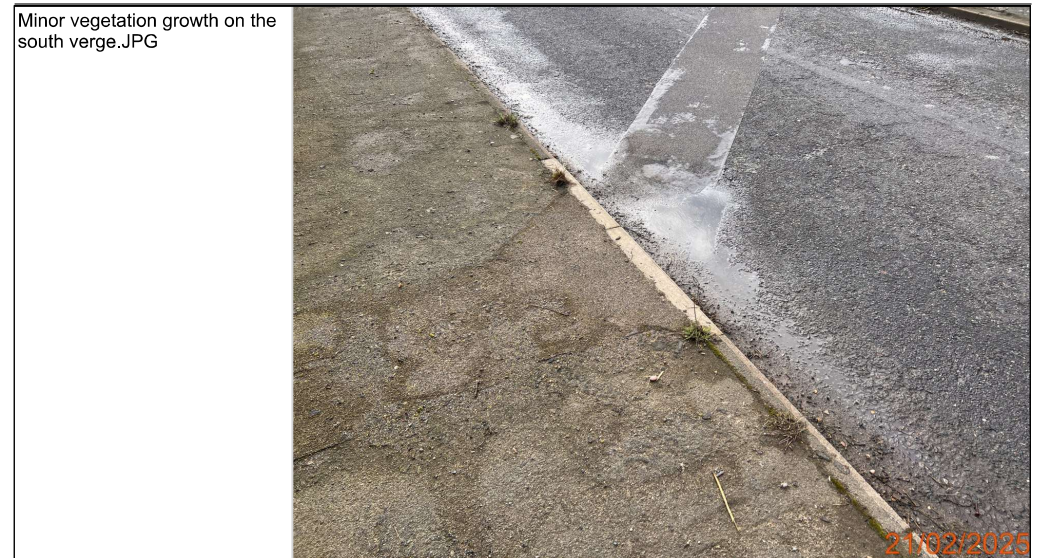
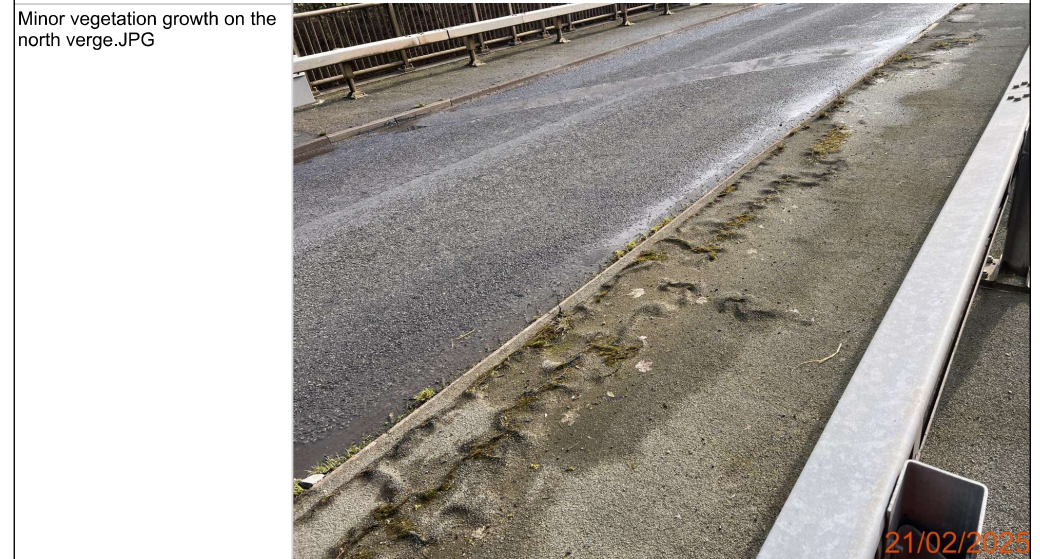
<b>Defect Code</b>	DEF_7771151-0001		
<b>Component</b>	Carriageway Surfacing	Carriageway Surfacing	
<b>Defect Type</b>	Veg - Vegetation growth on the structure or encroaching on the structure General defects		
<b>Extent</b>	SC - Defect present in 5% to not more than 20% of area or length of element		
<b>Severity</b>	X2 - Defects unlikely to affect condition of adjacent elements now or in the near future		
<b>Priority</b>	Low		
<b>Comments</b>	Minor vegetation grows along the edges of the carriageway and on the verges.		
<b>Cause</b>	Maintenance Issue	<b>Certainty</b>	High
<b>Comment on Cause</b>

<b>Type</b>	Structures Defect Permanent Repair		
<b>Maintenance Object</b>	Surfacing	<b>Maintenance Action</b>	Remove Vegetation
<b>Maintenance Classification</b>	Preventative	<b>Recommended Action Date</b>	22/07/2024
<b>Origin of Works</b>	Routine Inspection	<b>Addressed By</b>	Routine Maintenance
<b>Outline Works Cost</b>	£1.00		
<b>Comments</b>	Remove the vegetation from the carriageway edges.		
<b>Description</b>	Remove the vegetation from the carriageway edges.

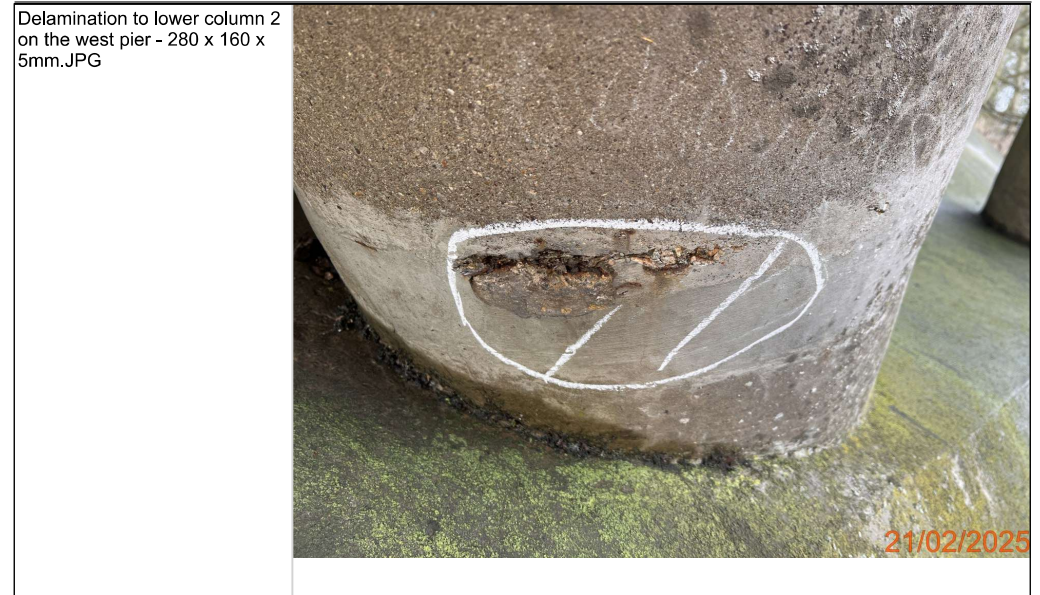
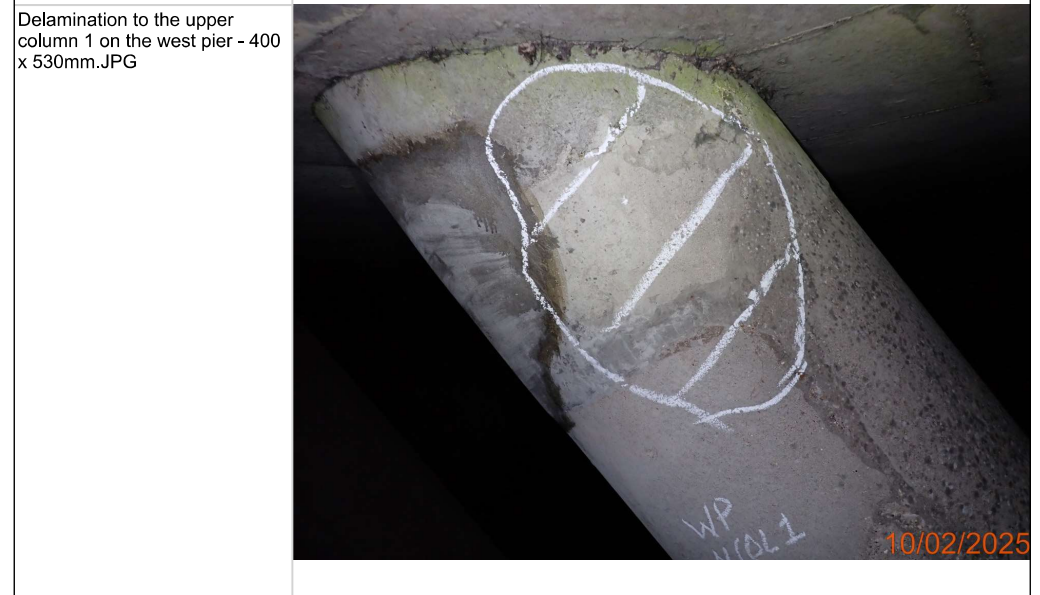
<b>Defect Code</b>	DEF_2130574-0008		
<b>Component</b>	COL - Column	West Columns	
<b>Defect Type</b>	Holl - Hollow (delaminated) area Loss of concrete or masonry		
<b>Extent</b>	SB - Defect present in not more than 5% of area or length of element		
<b>Severity</b>	D2 - Minor: Defect is unlikely to be causing damage to the element or structure now or unlikely to do so in the near future		
<b>Priority</b>	Medium		
<b>Comments</b>	The top of west columns 2, 3 and 4 suffer from spalling, with adjacent hollow sounding concrete, exposing reinforcement that exhibits severe corrosion and lamination, totalling 1.11m2.  2025 PI - All the spalling has been repaired and is no longer present. There was minor delamination to column 1 adjacent the repair measuring 400 x 530mm and the base of column 2 measuring 280 x 160 x 5mm.		
<b>Cause</b>	Reinforcement Corrosion	<b>Certainty</b>	High
<b>Comment on Cause</b>

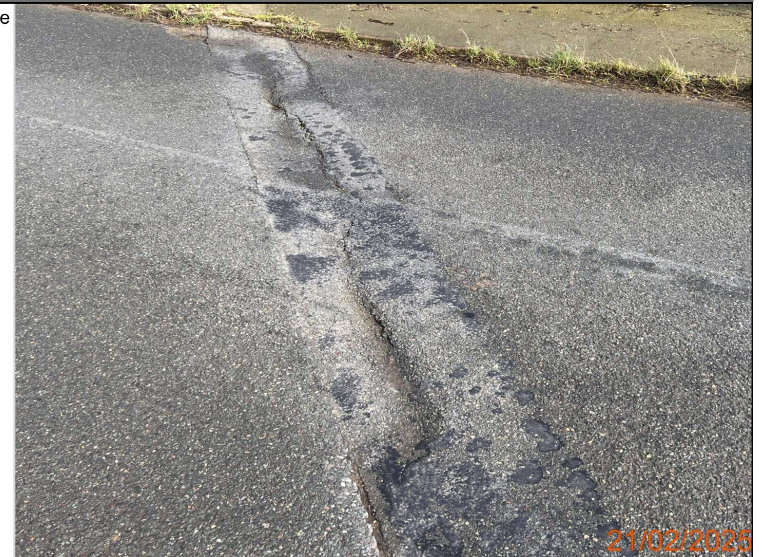
<b>Defect Code</b>	DEF_2130600-0006		
<b>Component</b>	Expansion Joint	West outer hinge (plug)	
<b>Defect Type</b>	CrCo - Cracked Defects in components		
<b>Extent</b>	SB - Defect present in not more than 5% of area or length of element		
<b>Severity</b>	D2 - Minor: Defect is unlikely to be causing damage to the element or structure now or unlikely to do so in the near future		
<b>Priority</b>	Low		
<b>Comments</b>	Within the west joint there was minor settlement and transverse cracking through the joint.		
<b>Cause</b>	Not Applicable	<b>Certainty</b>	
<b>Comment on Cause</b>

Transverse cracking through the west joint.JPG

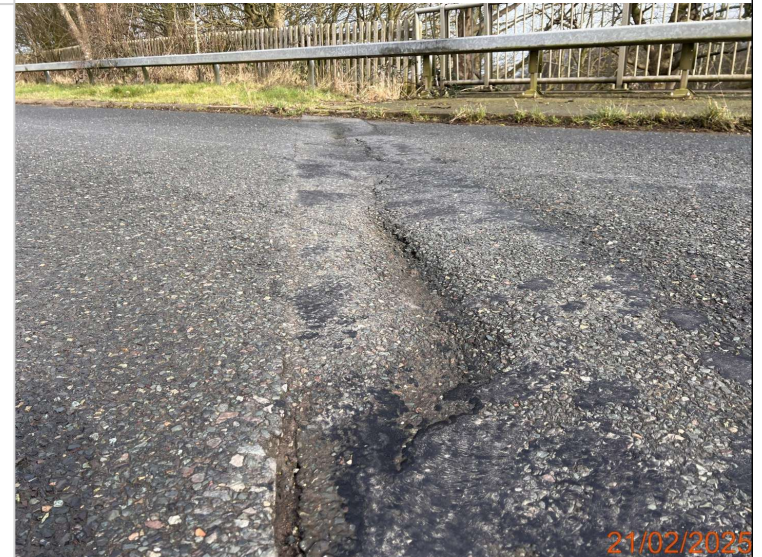
Settlement and cracking on the west joint.JPG
