**Trub**  
**STR\_4272 /M62//63.40//**

**Structures General Inspection Report**  
**13/02/2023**  
**Completed**

**Structure Name** Trub **Maintaining Agent** National Highways Area 10/Area 10  
**Structure Key** STR\_4272 **Geographical Area** Manchester  
**Structure Number** /M62//63.40// **Custodian/Region** NH\_OWNED / North West  
**OS Grid** 388500 / 409880 **Structure Type** Bridge And Large Culvert

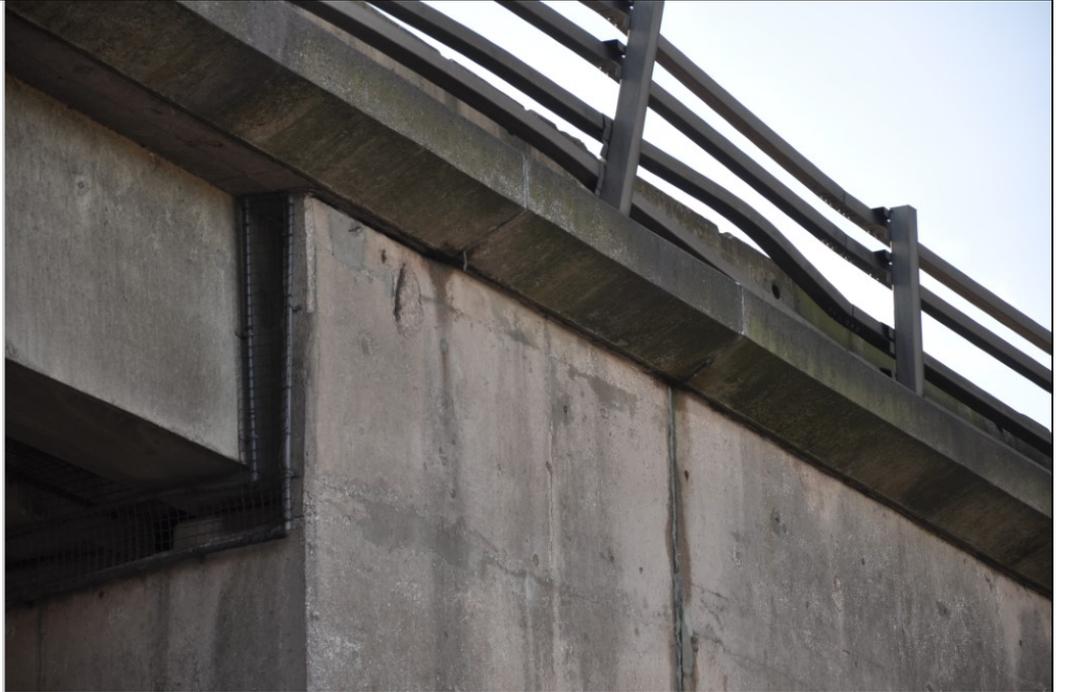
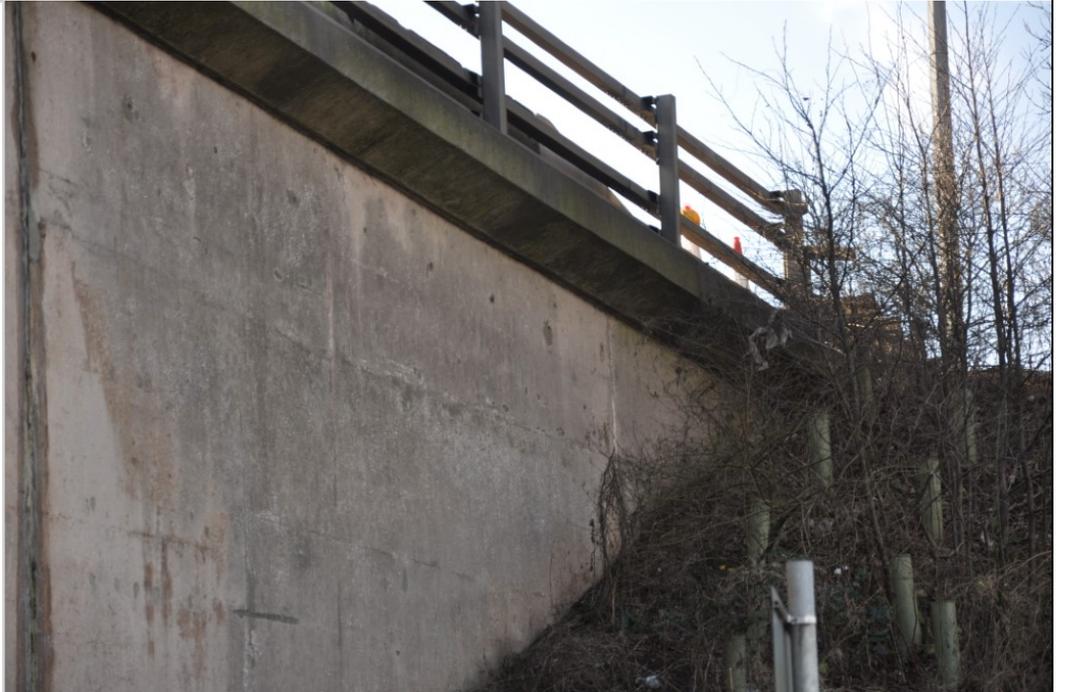
**Defect Code** DEF\_6621643-0001

**Component** Wing Wall

North West wing wall

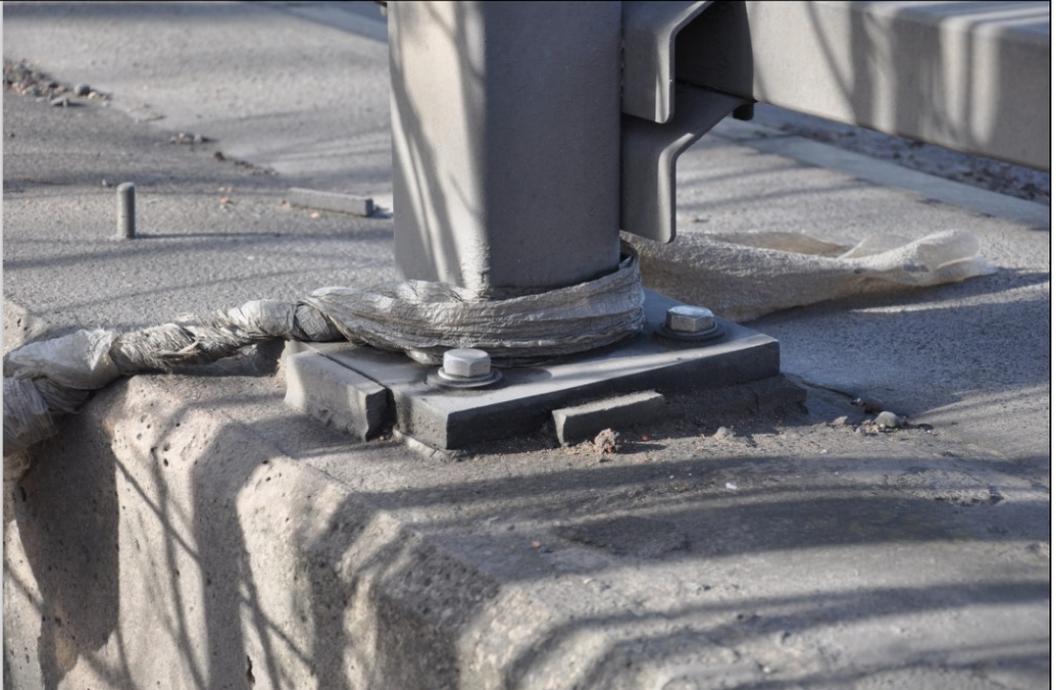
<b>Defect Code</b>	DEF_6621540-0001	
<b>Component</b>	Road Vehicle Restraint System	North Parapet
<b>Defect Type</b>	Sp - Spalled area Loss of concrete or masonry	
<b>Extent</b>	SC - Defect present in 5% to not more than 20% of area or length of element	
<b>Severity</b>	D2 - Minor: Defect is unlikely to be causing damage to the element or structure now or unlikely to do so in the near future	
<b>Priority</b>	Low	
<b>Comments</b>	The grout beneath the parapet post base plates was found to be cracked and spalled.	
<b>Cause</b>	<b>Certainty</b>	
<b>Comment on Cause</b>		
<b>Document ID</b>	4291984	<b>Document Title</b> STR_4272 GI Defect photos 13/02/2023
DSC_0610.JPG

<b>Work Order Number</b>	183956	<b>Priority</b>	Medium
<b>Maintenance Object</b>	Parapet	<b>Maintenance Action</b>	Replace
<b>Estimated Cost</b>	£30,000.00	<b>Recommended Action Date</b>	
<b>Comments</b>	Replace 6m of middle parapet rail. Replace 12m of bottom parapet rail.
