Client: Historical Railways Estate on behalf of the DfT

Project: HRE Works Framework

Drawing title: STRUCTURE AGB/3
STRUCTURAL REPAIRS
PROPOSED REPAIR DETAILS

Drawing number: B38380DE-FK-0002a

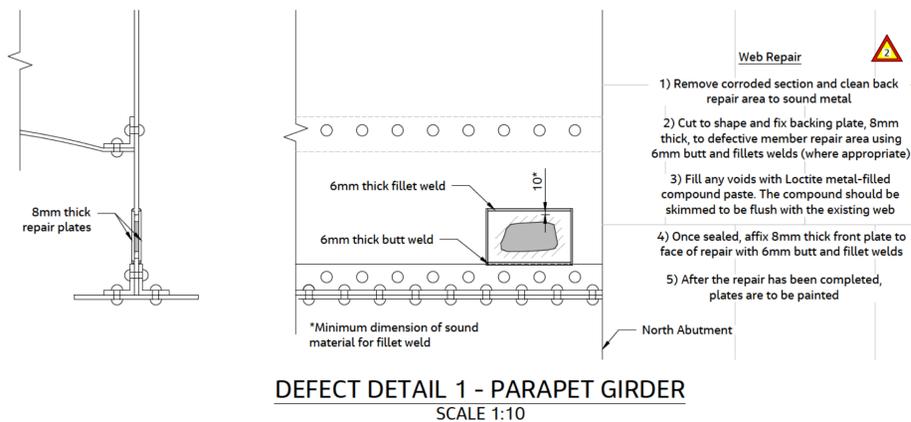
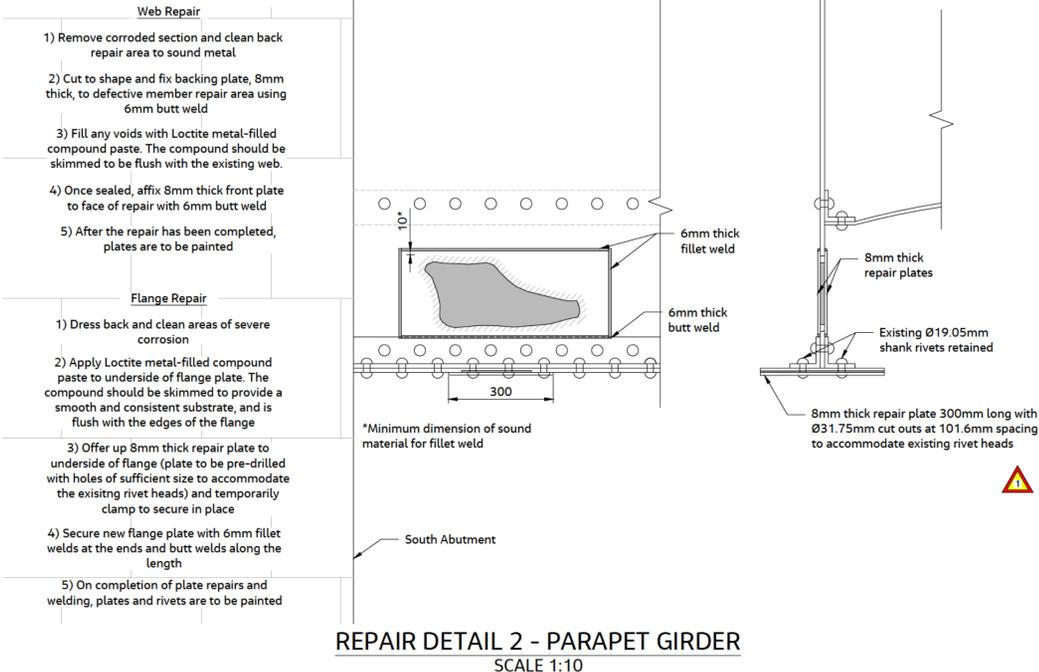
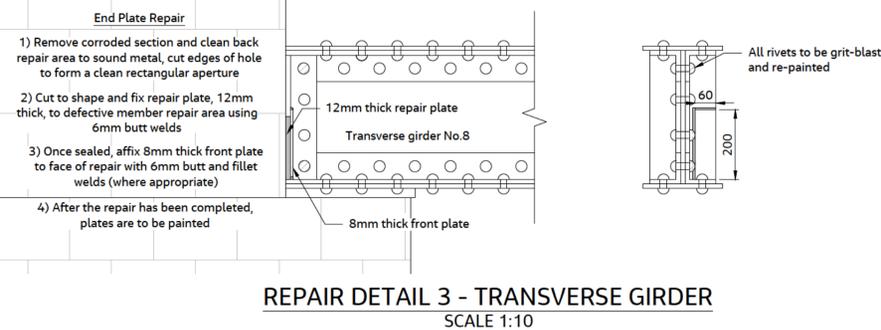
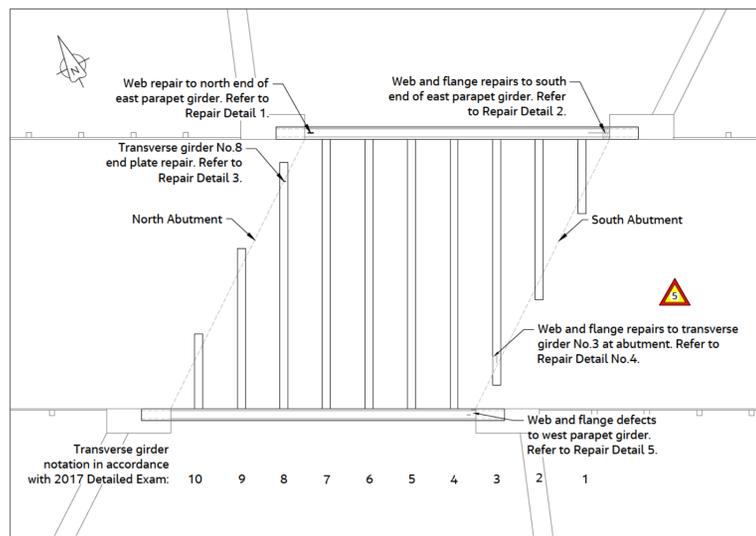
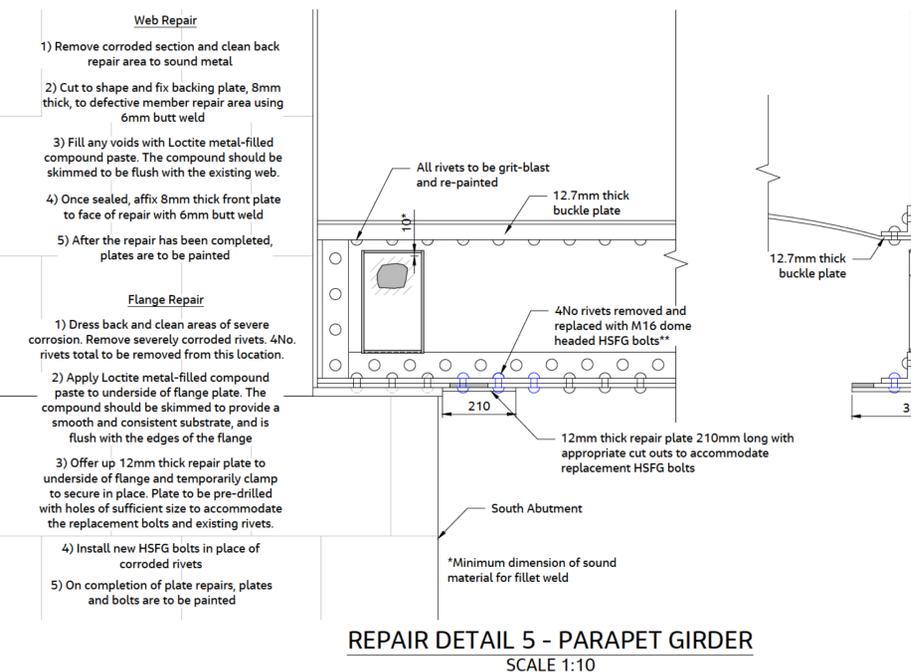
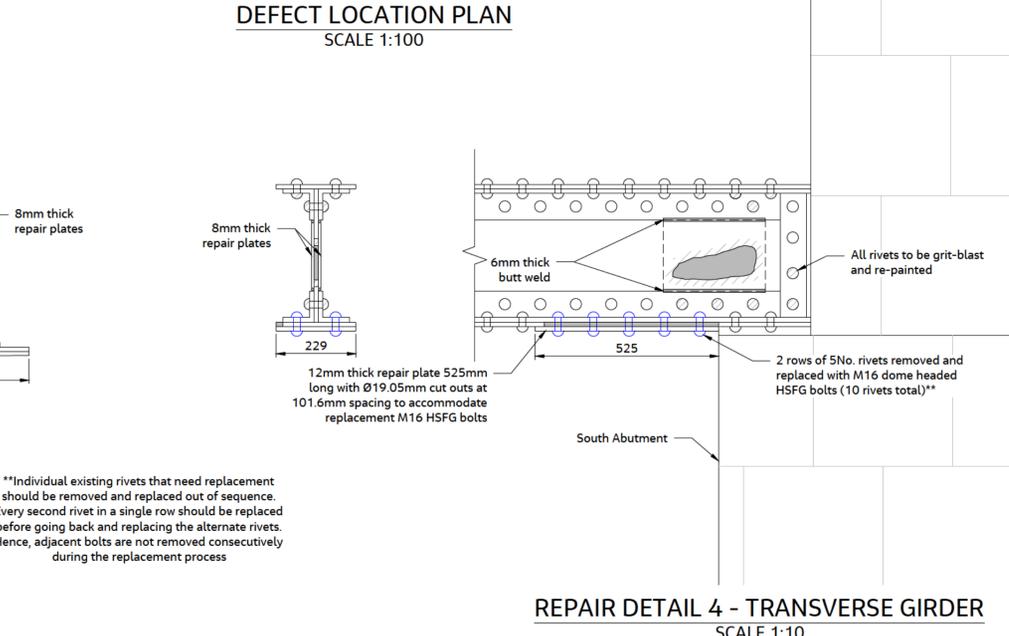
4. The defects shown are based on an inspection survey undertaken by Jacobs on 28/11/2022 and a detailed examination report provided by HRE. Additional defects are likely to be identified following grit blasting works. It is recommended that an additional defect survey is carried out with the Contractor in advance of the works commencing to identify any further deterioration of existing defects and confirm the repair requirements. A tactile inspection of defective areas should be undertaken at the commencement of the works on site. The Contractor remains responsible for establishing the exact dimensions and materials of the members to be replaced.

6. Heavily corroded steel to be cut out and replaced with new S355 steel. Replacement steel to be welded to the existing elements by a 6mm thick butt or fillet weld connection.

Holed metallic elements are to be over-plated with new S355 steel. Corroded material surrounding the hole should be cut out prior to repairing.

Heavily corroded rivets to be removed and replaced with dome headed HSFG bolts with the same diameter and similar appearance to the original.
 7. Metallic classification undertaken as part of a 2004 site investigation confirmed that the footbridge is constructed from weldable mild steel. A unit weight of 7850kg/m³ is assumed for structural steel as per by the Specification for Highway Works.

**Individual existing rivets that need replacement should be removed and replaced out of sequence. Every second rivet in a single row should be replaced before going back and replacing the alternate rivets. Hence, adjacent bolts are not removed consecutively during the replacement process
