| <b>ELR:</b> AGB | <b>Structure No:</b> 3 | <b>Mileage:</b> Unknown | <b>Examination date:</b> 19/03/21 |
| <b>Route:</b> Gullane to Longniddry | | | <b>OS ref:</b> NT483797 |
| <b>Name:</b> Luffness Mains | | | <b>Type:</b> Overbridge |

A **Monitor Examination** of this structure has been carried out and any deterioration in condition or development of defects or other factors, which might place at risk the public at large, is recorded in the Examiner’s Comments section of this document.

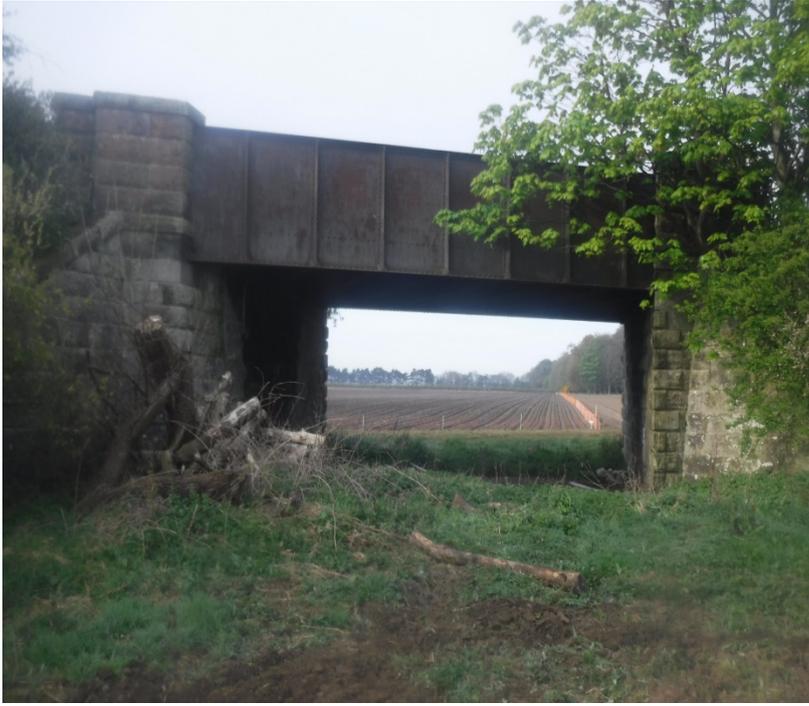
| <p><b>General view of structure: East elevation</b></p> | <p><b>Examiner comments:</b></p> <p><b>Services</b><br/>There is no evidence in the HE (HRE) 2015 Health and Safety File, previous examination reports or as noted on site to confirm the presence of any statutory services affecting the structure.</p> <p><b>Access Route to Structure</b> –private road off A6137 access farm gate west of structure</p> <p><b>Site Issues and Impediments to carrying out repairs, DE’s or other works-</b> Ladders</p> <p><b>Date of Last Examination</b> – 24/04/21</p> <p><b>Structure Examined within 12 months</b> – Yes</p> <p><b>Reason for Exceeding 12 month’s interval</b> – None</p> |

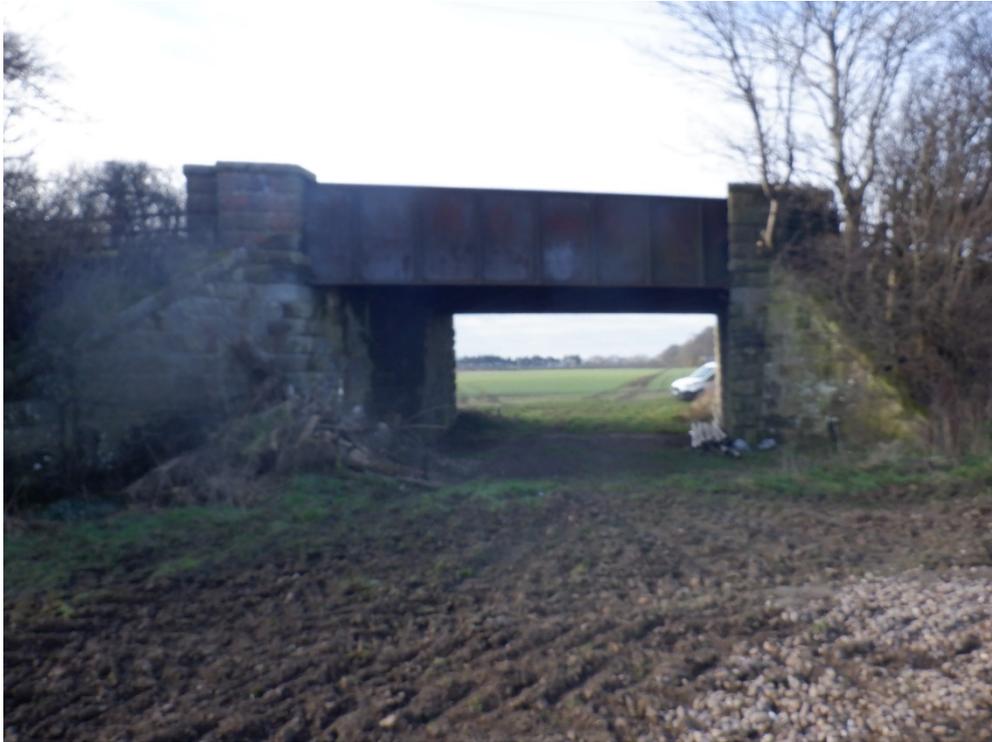
**Photo No.1. East Elevation.**

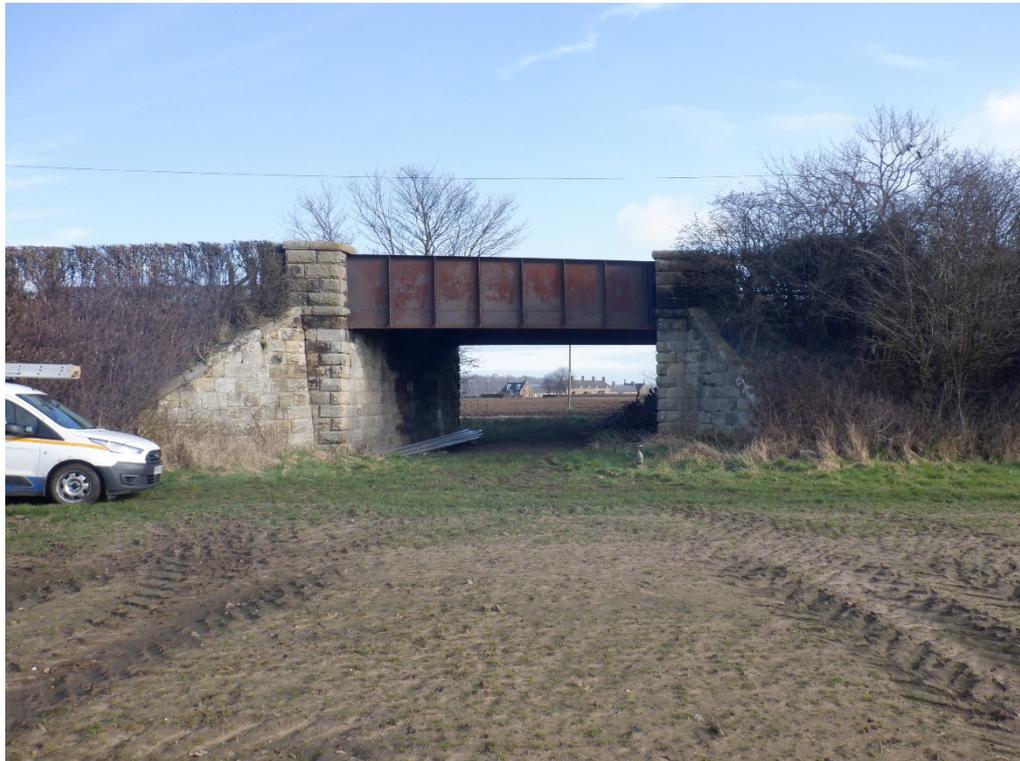
**Photo No.2. West Elevation.**

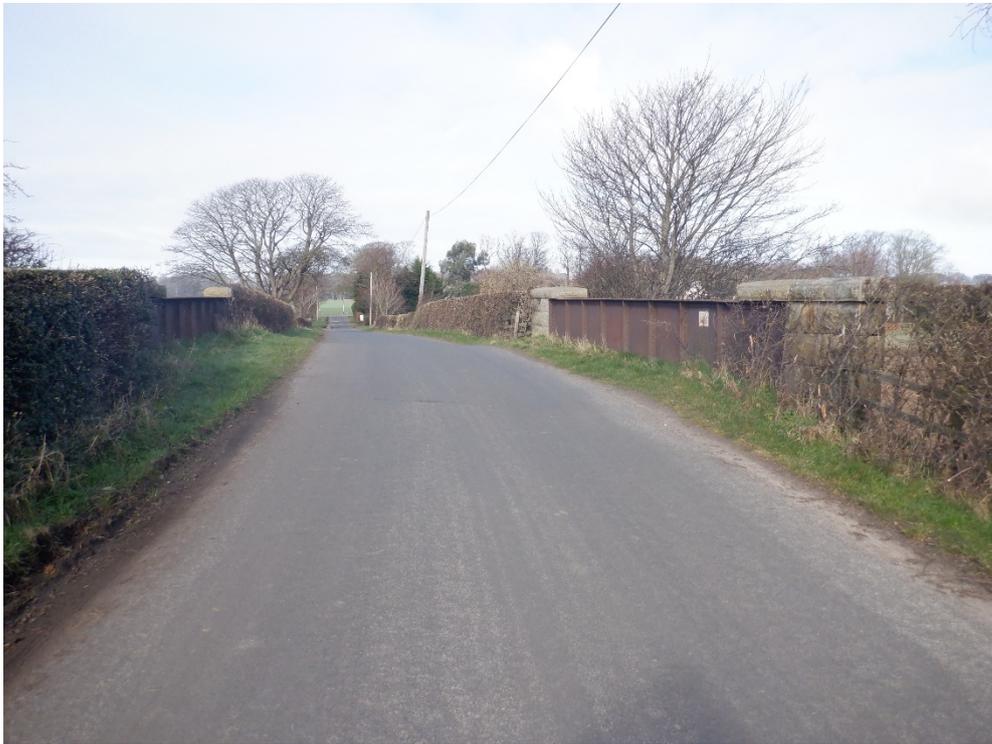
**Photo No.3. View looking North over the structure.**

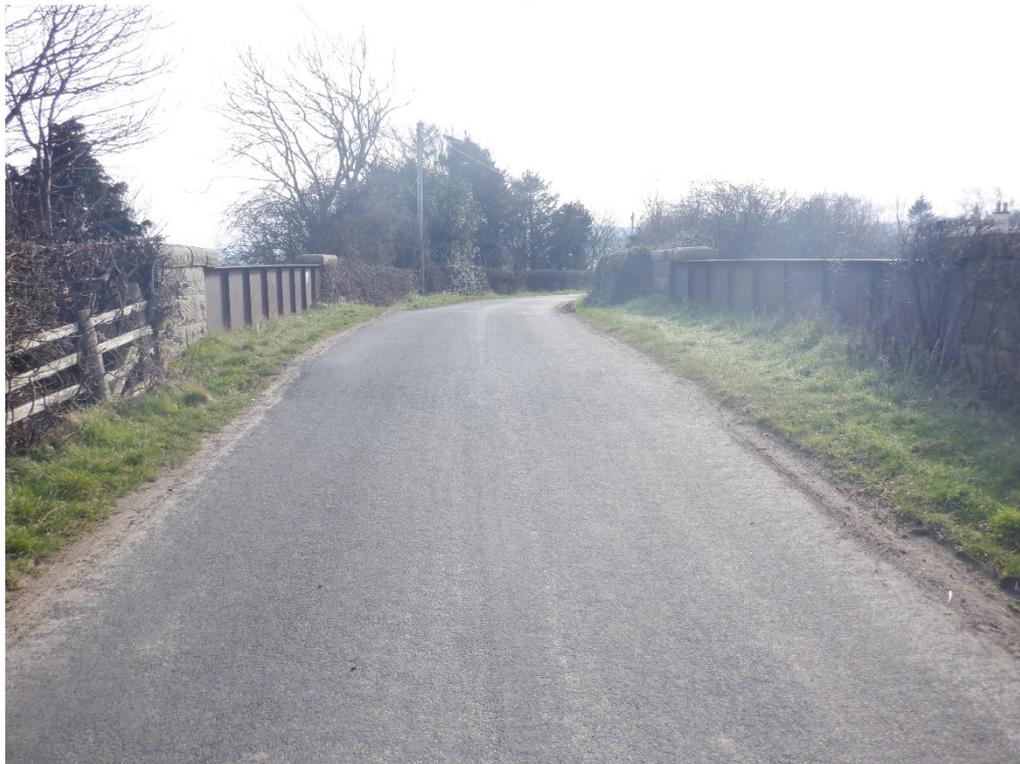
**Photo No.4. View looking South over the structure.**

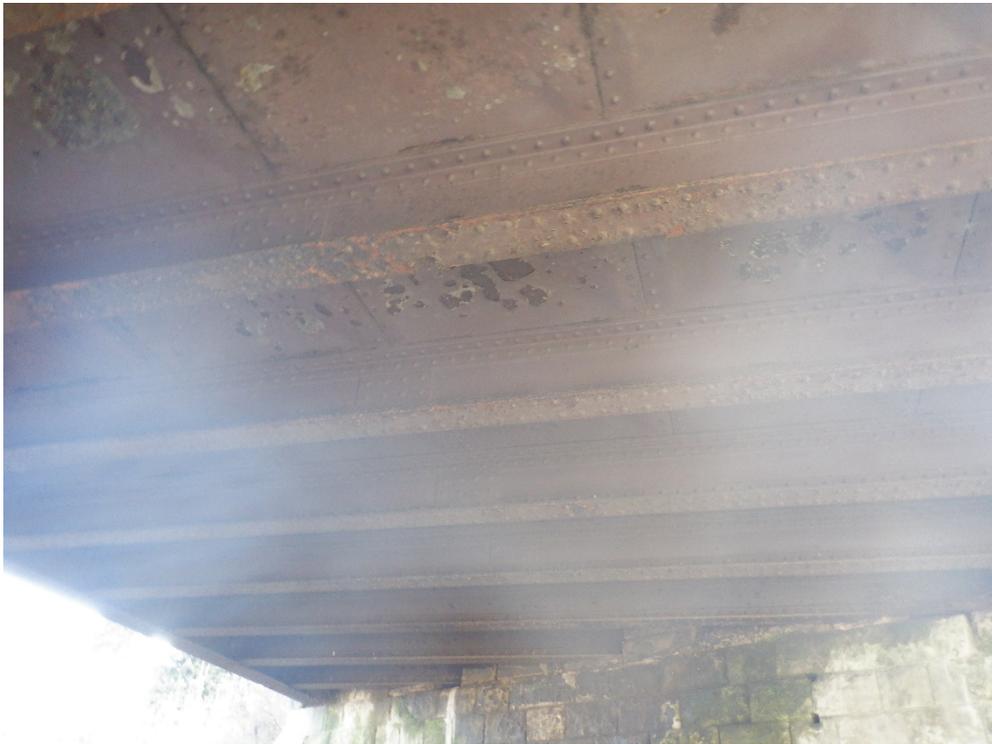
Moderate to severe corrosion at connection with main girders / cross girders

**Photo No.5. Deck**

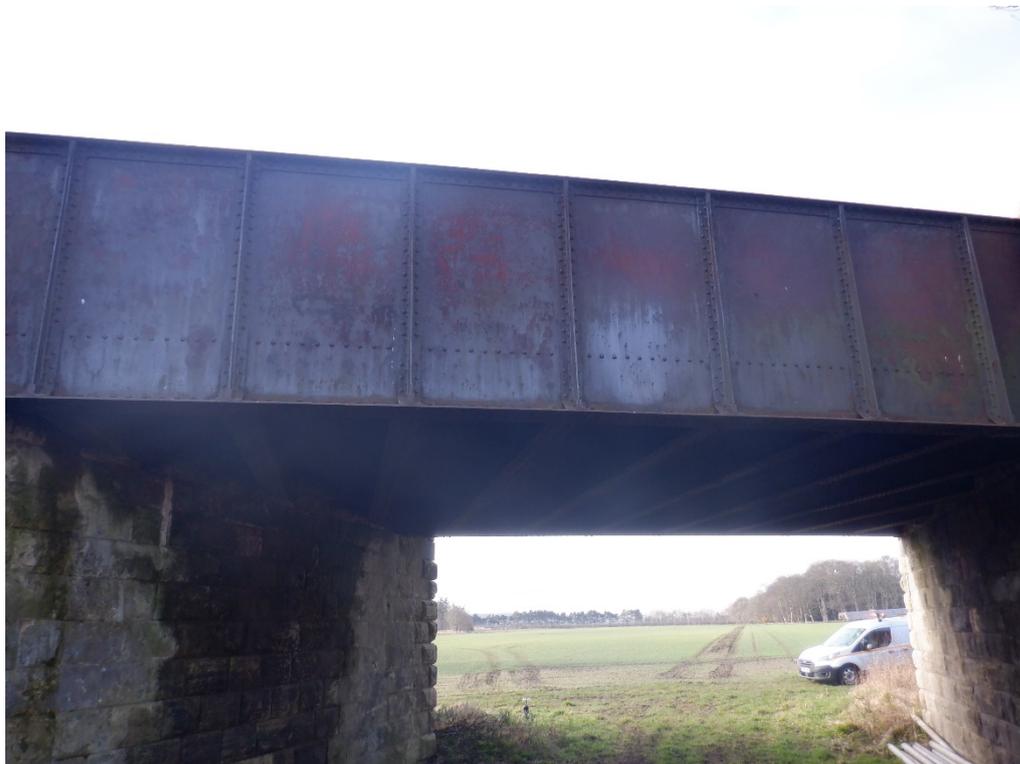
East elevation, moderate to severe corrosion at bearing on both abutments. Slight to moderate surface corrosion over 100% of area. Web plate holed at south elevation Ph No6 - Ph No9

**Photo No.6. East elevation parapet girder soffit face**

Carry out metalwork repairs to various corroded members throughout the structure - P1.

Delaminate/ clean all corroded metalwork and apply anti-rust coating to same throughout the structure - P1.

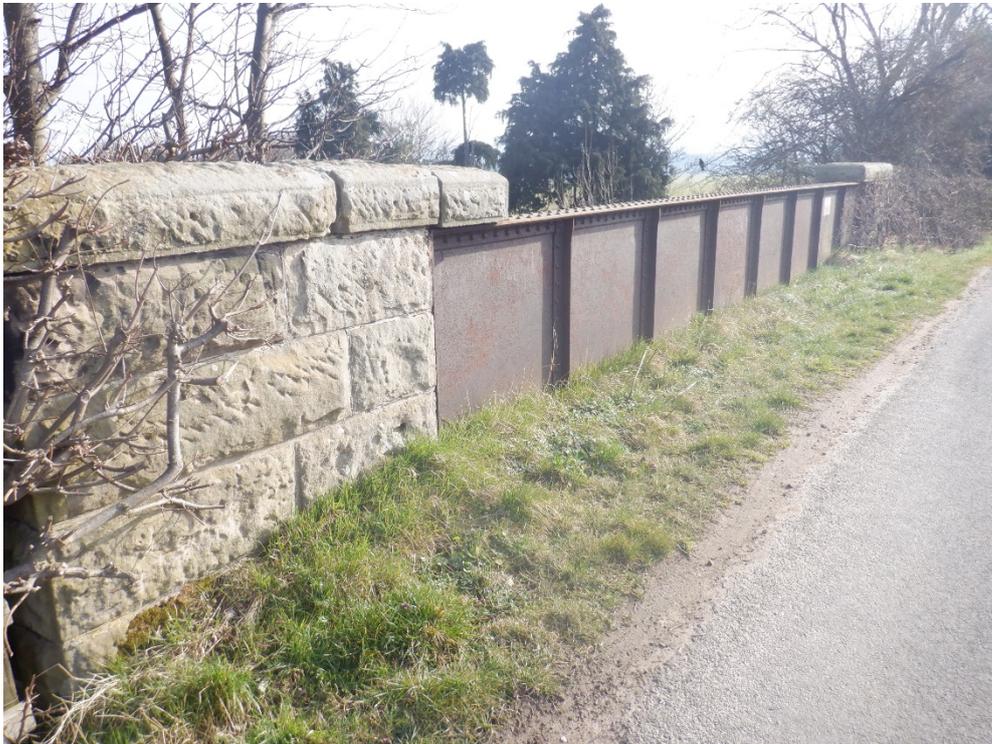
**Photo No.7. East elevation parapet girder road face**

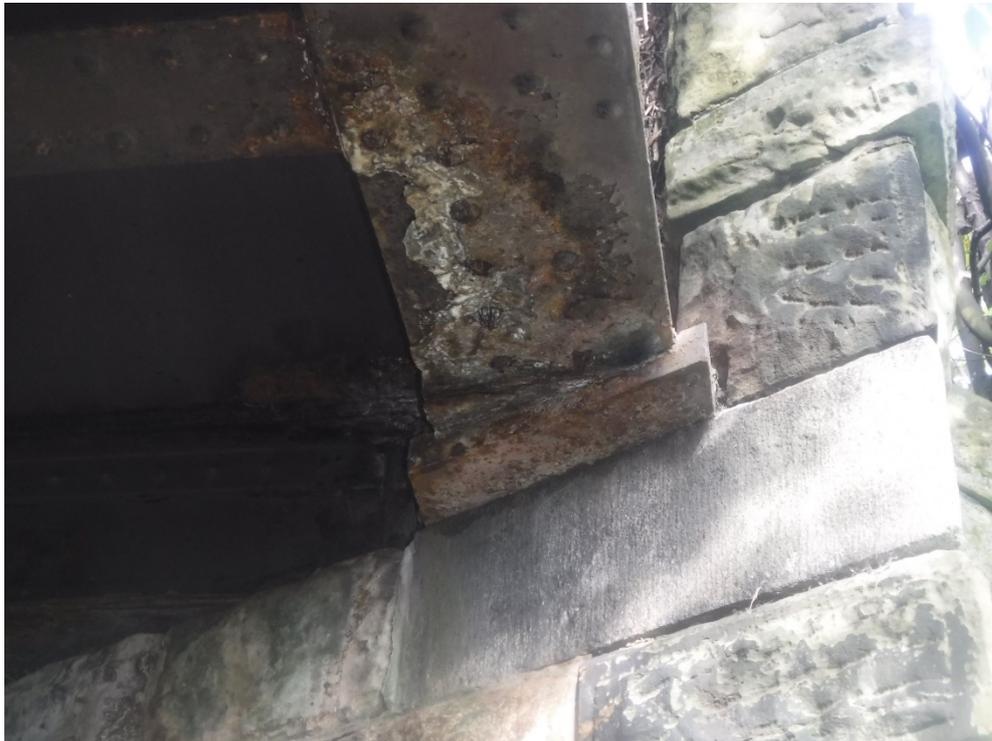
**Photo No.8. East elevation parapet girder corrosion**

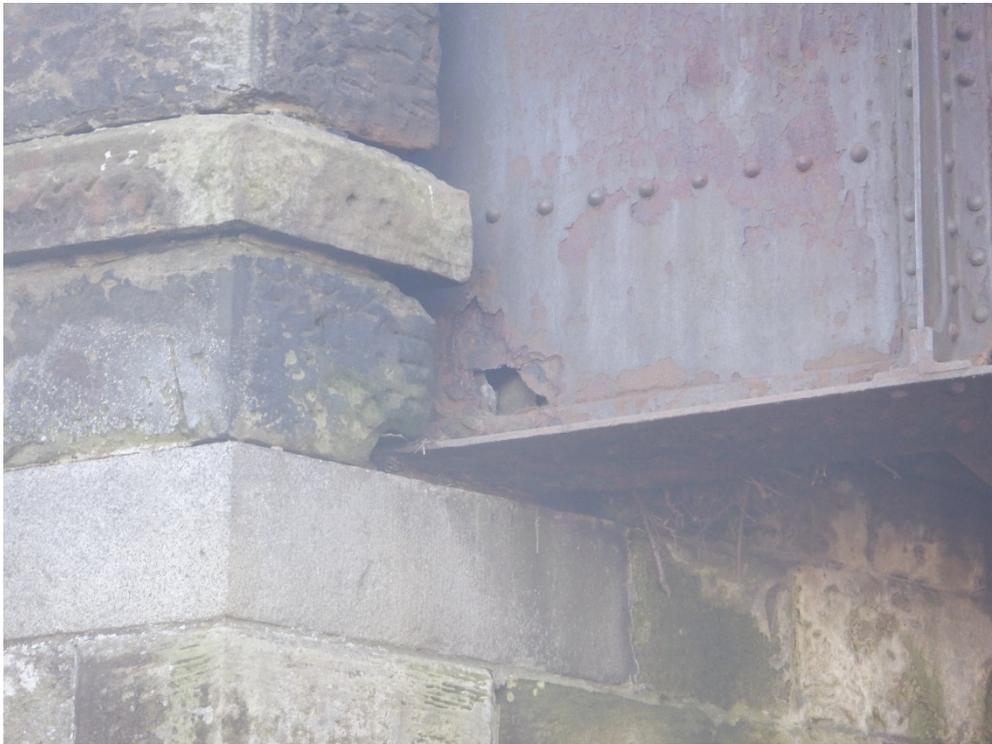
**Photo No.9. East elevation parapet girder web plate holed**

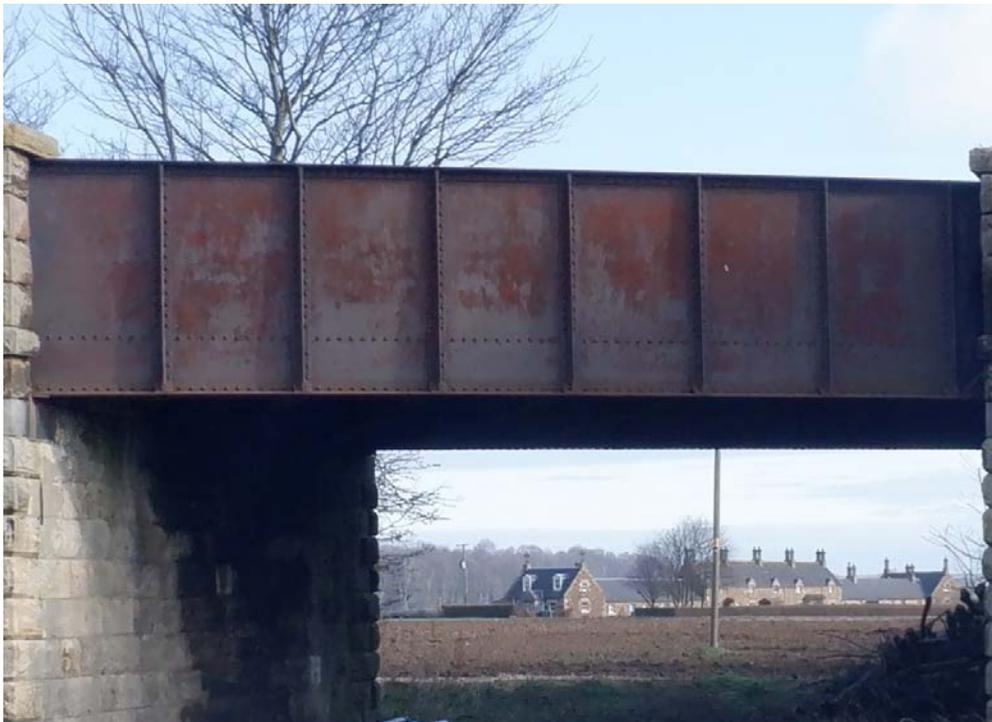
West elevation, moderate to severe corrosion at bearing on both abutments. Slight to moderate surface corrosion over 100% of area. Bottom flange notched at bearing on South elevation bearing plate Ph No10 - Ph No12

**Photo No.10. West elevation parapet girder solum face**

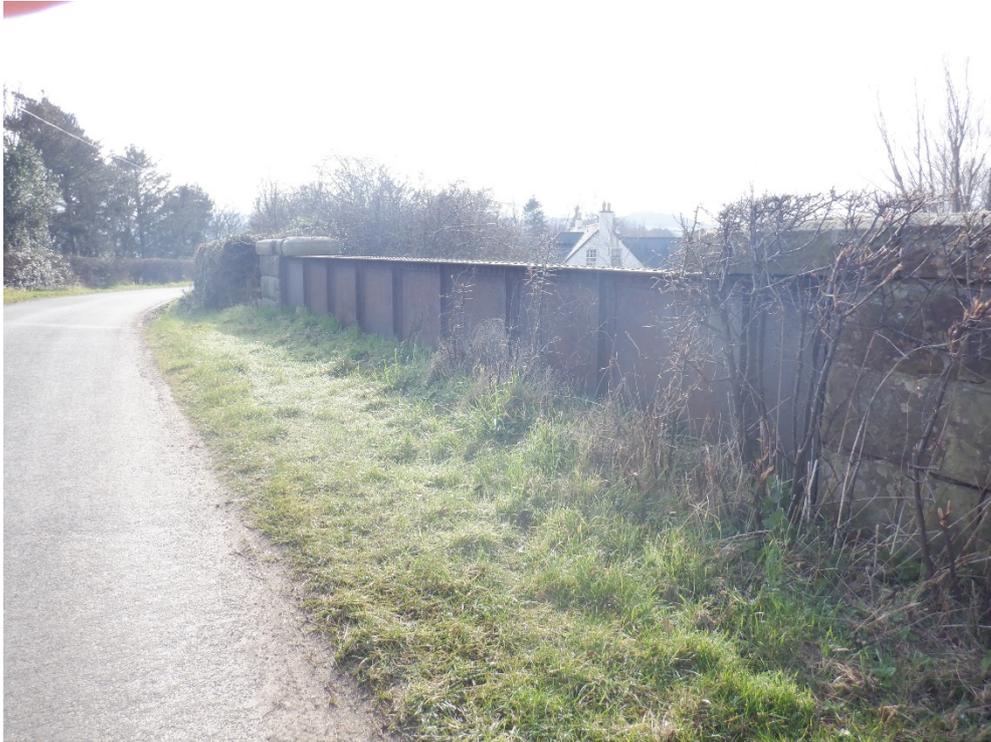
**Photo No.11. West elevation parapet girder road face**

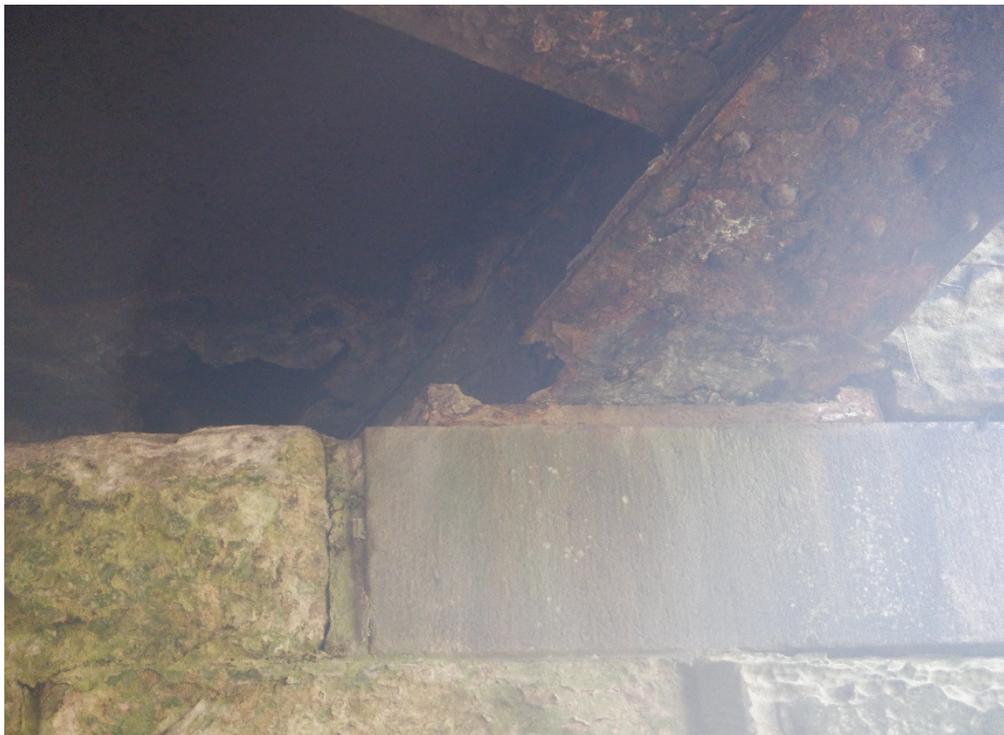
**Photo No.12. West elevation parapet girder bottom flange notched**

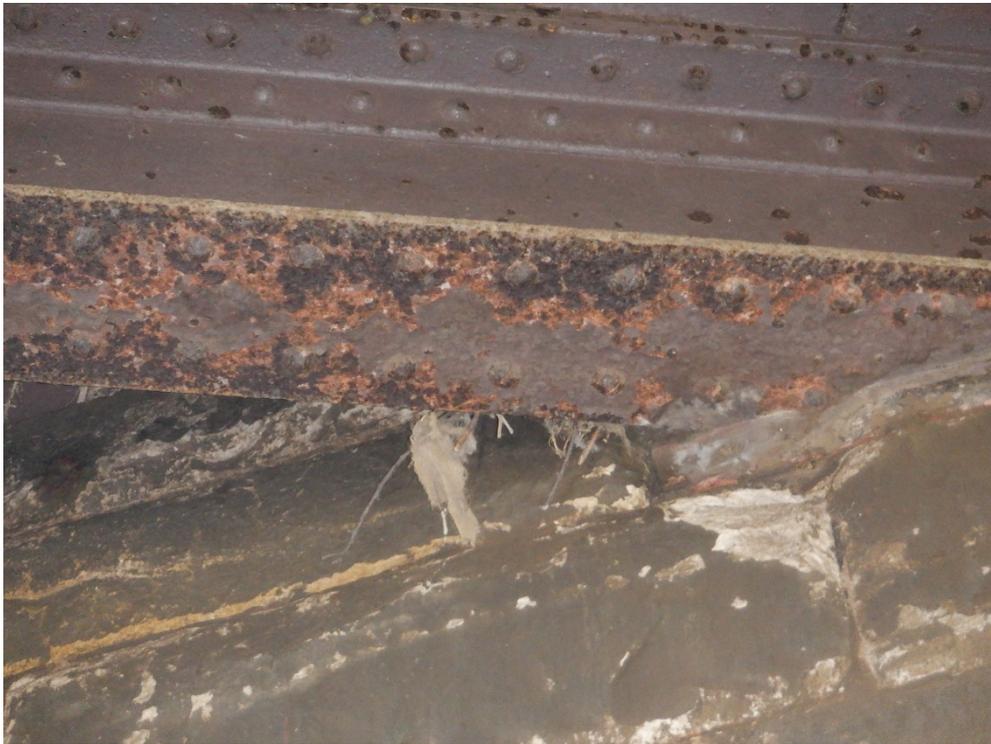
Moderate to severe corrosion to bottom flanges at random intervals throughout area. Ph No13

**Photo No.13. Cross girders corrosion**

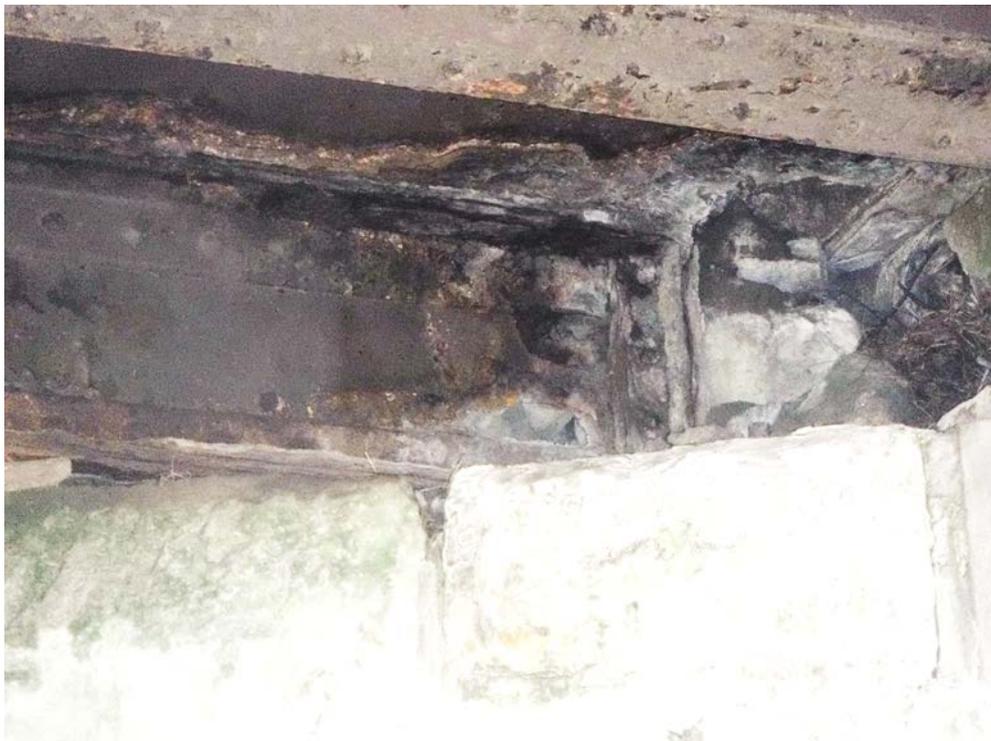
Web plate holed at South west bearing on abutment at West elevation parapet main girder Ph No14

**Photo No.14. Cross girders corrosion web plate holed at abutment**

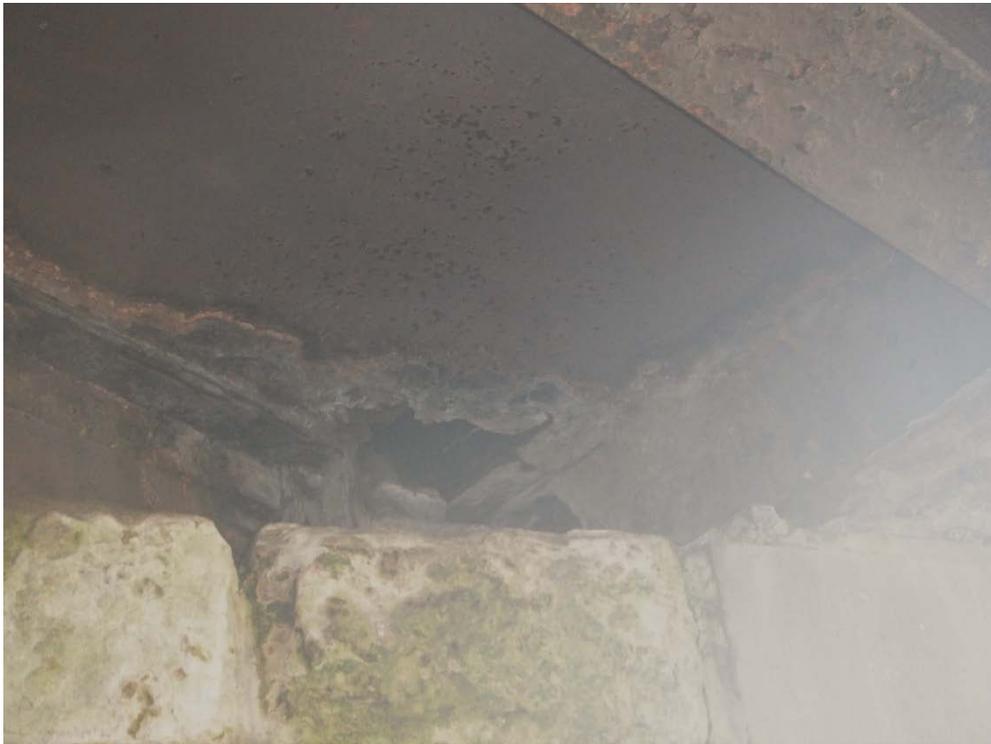
Plate deck holed at West elevation parapet girder Ph No15

**Photo No.15. Deck plate holed**

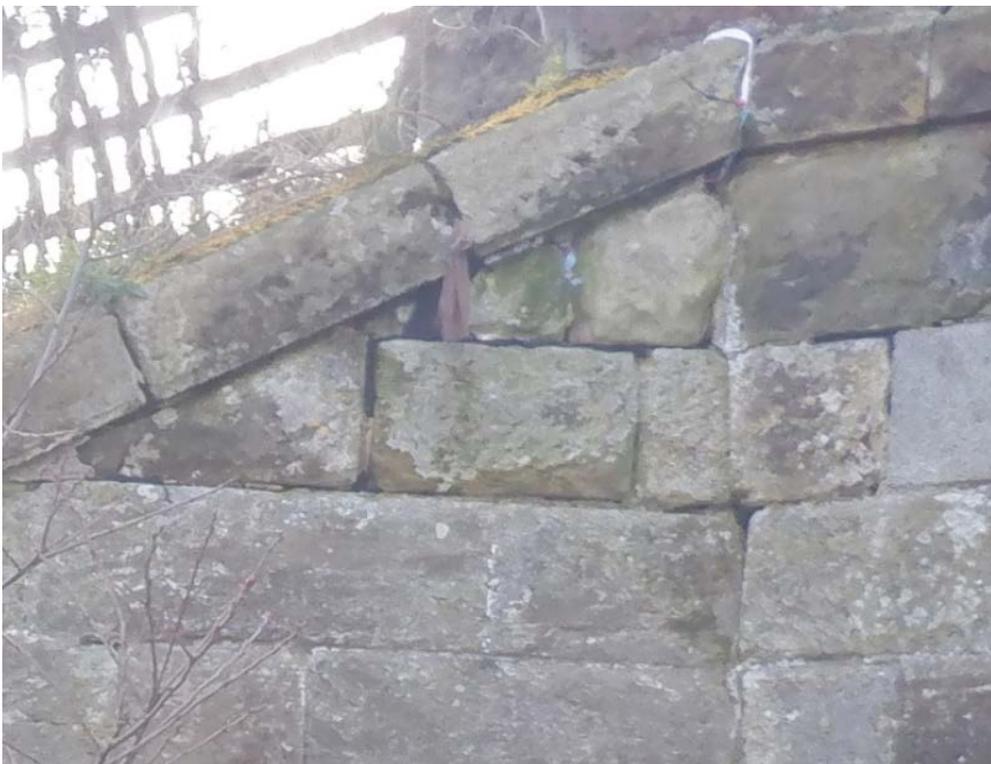
South East elevation, deep open joints under cope stones Ph No16

**Photo No.16. South East elevation wing wall open joints**

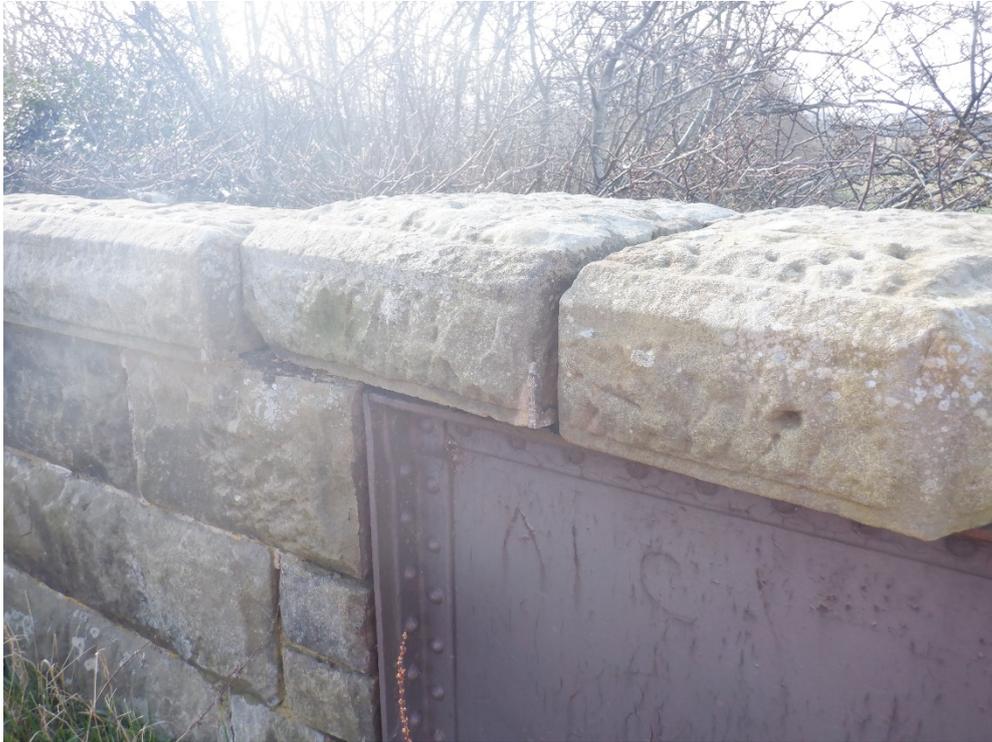
South West elevation pilaster cap displaced Ph No17

**Photo No.17. South West elevation pilaster displaced**

Re-bed south west coping's to Pilaster - P1.

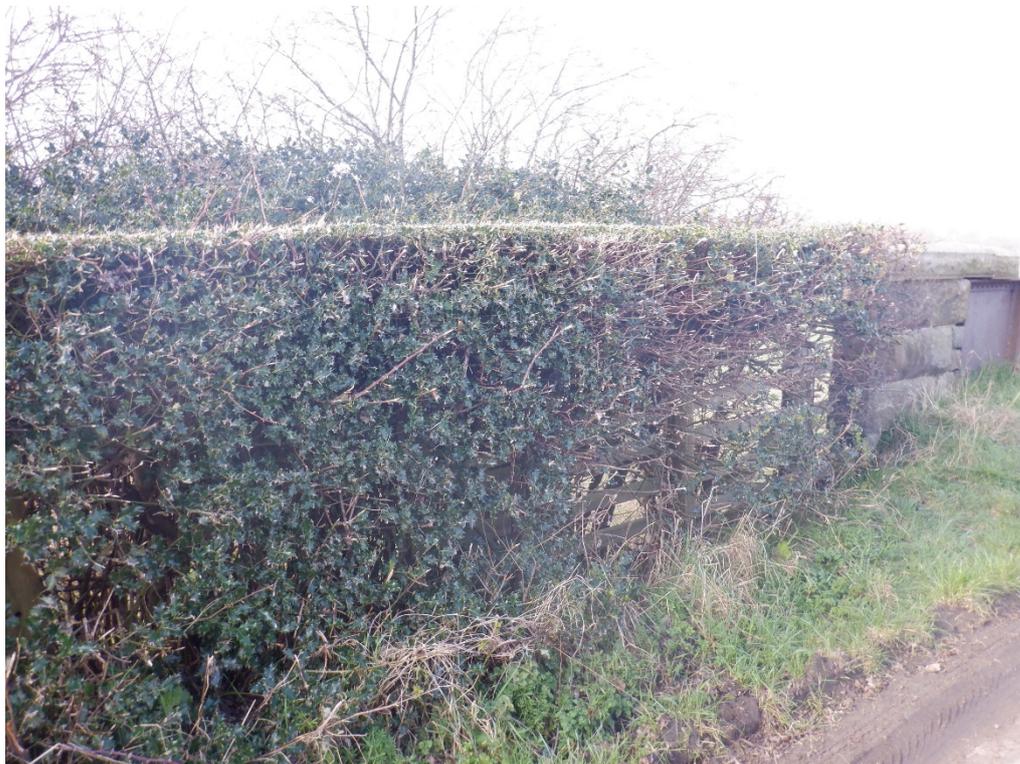
All approach fences covered with vegetation Ph No18

**Photo No.18. Approach fences covered with vegetation**
