ELR:	AGB	Structure No:	3	Mileage:	Unknown	Examination date:	16/11/22
Route:	Gullane to Longniddry					OS ref:	NT483797
Name:	Luffness Mains					Type:	Overbridge

Examiner Comments on Structure Condition:

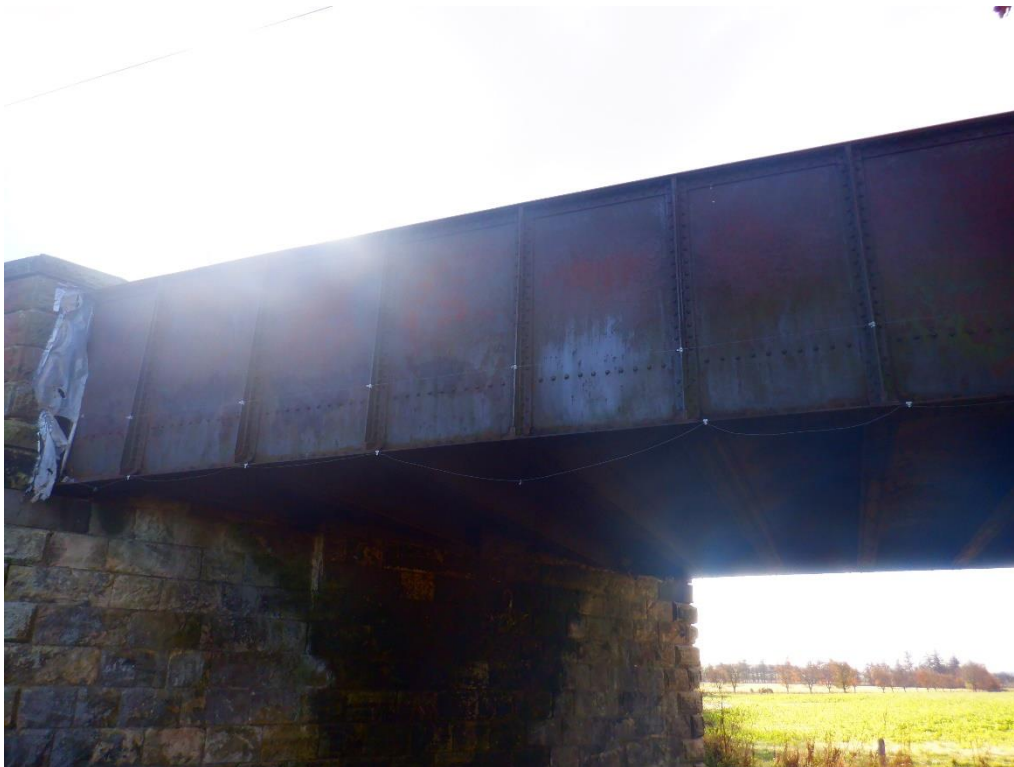
Photo No.6. East elevation parapet girder solum face

East elevation, moderate to severe corrosion at bearing on both abutments. Slight to moderate surface corrosion over 100% of area. Web plate holed at south elevation Ph No6 - Ph No9

<p>Recommendations:</p> <p>(Generally as previous examination): De-scale all metalwork, replace any heavily corroded/ missing elements and apply anti-corrosion coating to all exposed metalwork - P1.</p> <p>Re-bed south west coping's to Pilaster - P1.</p> <p>Signed by Examining Engineer:</p>

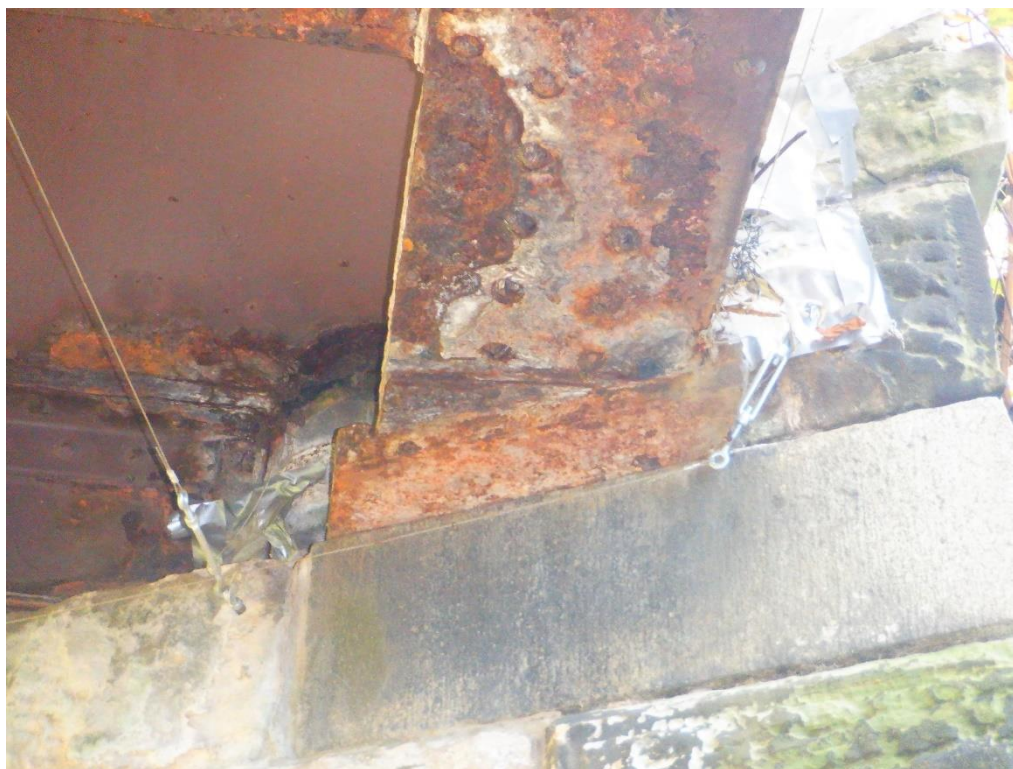
Photo No.8. East elevation parapet girder corrosion

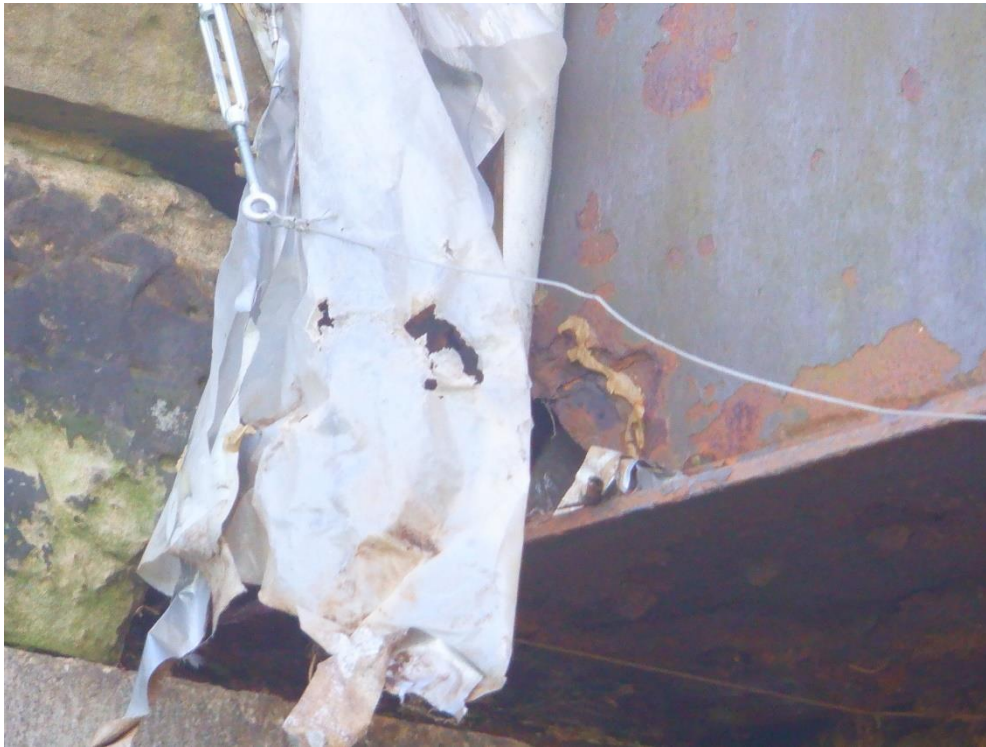
Photo No.9. East elevation parapet girder web plate holed

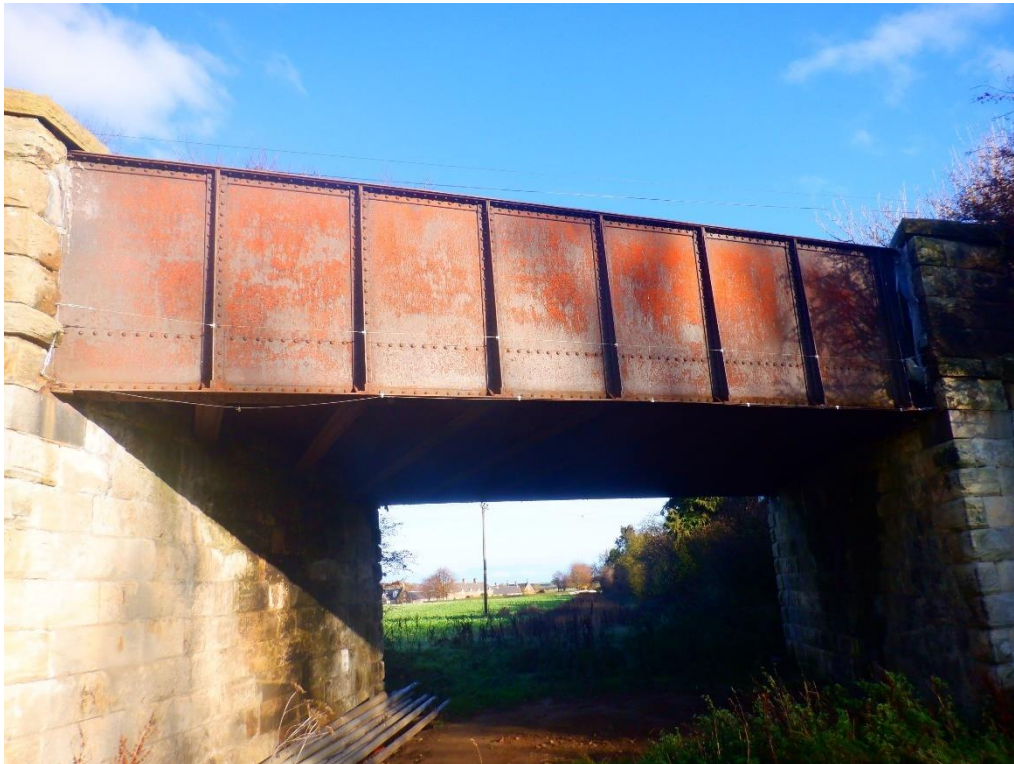
Photo No.10. West elevation parapet girder solum face

West elevation, moderate to severe corrosion at bearing on both abutments. Slight to moderate surface corrosion over 100% of area. Bottom flange notched at bearing on South elevation bearing plate Ph No10 - Ph No12

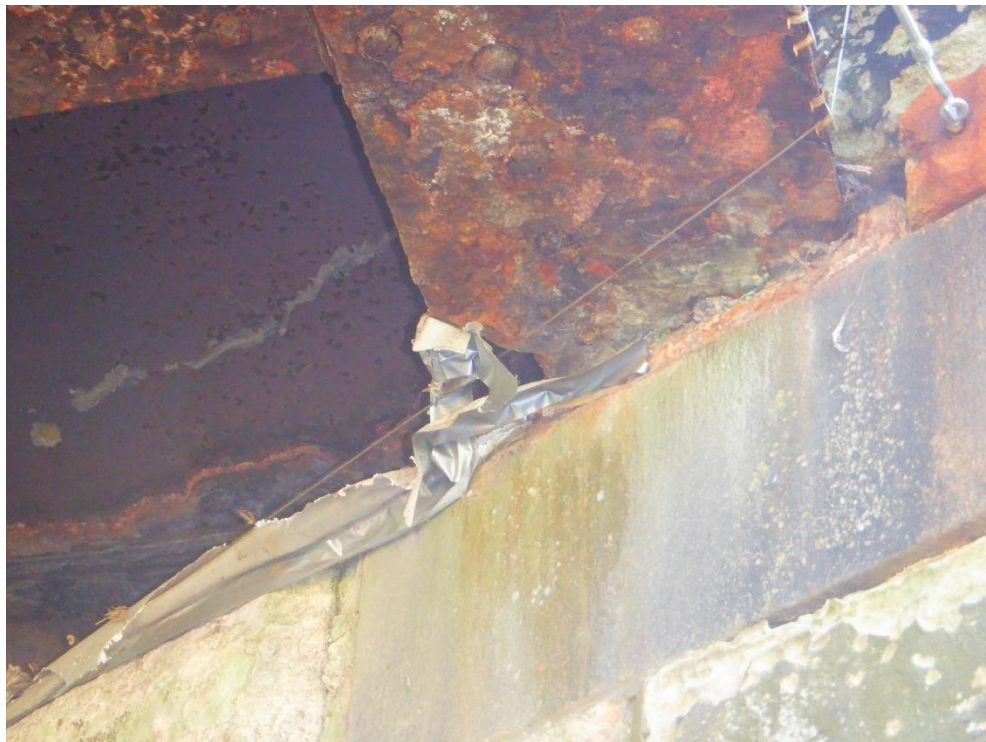
Photo No.12. West elevation parapet girder bottom flange notched

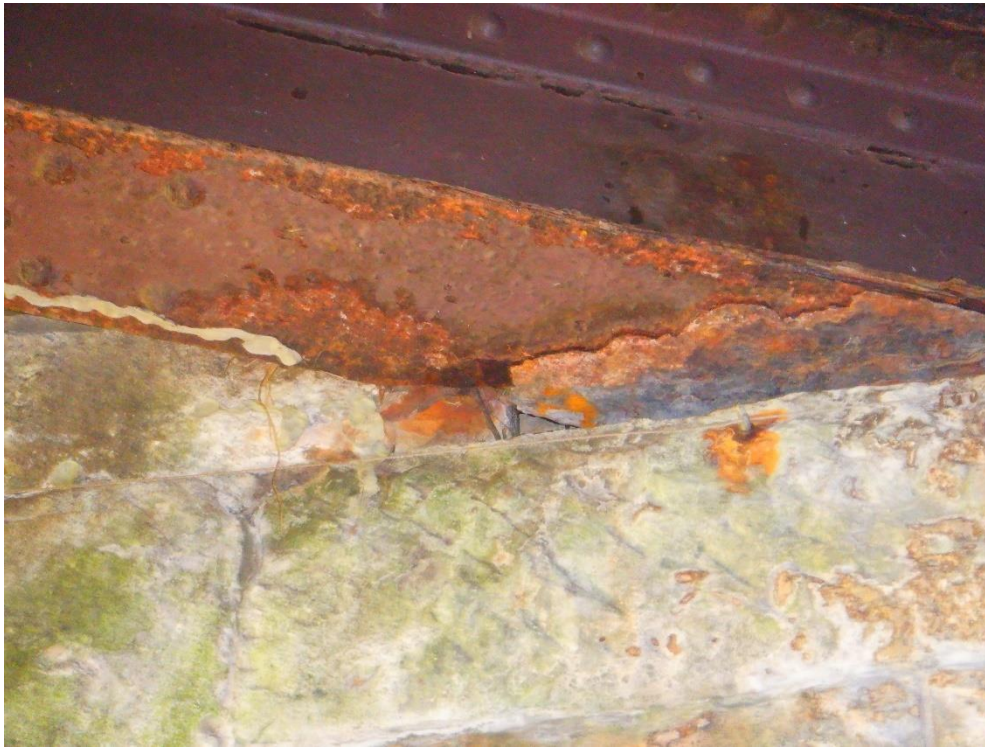
Moderate to severe corrosion to bottom flanges at random intervals throughout area. Ph No13

Photo No.13. Cross girders corrosion

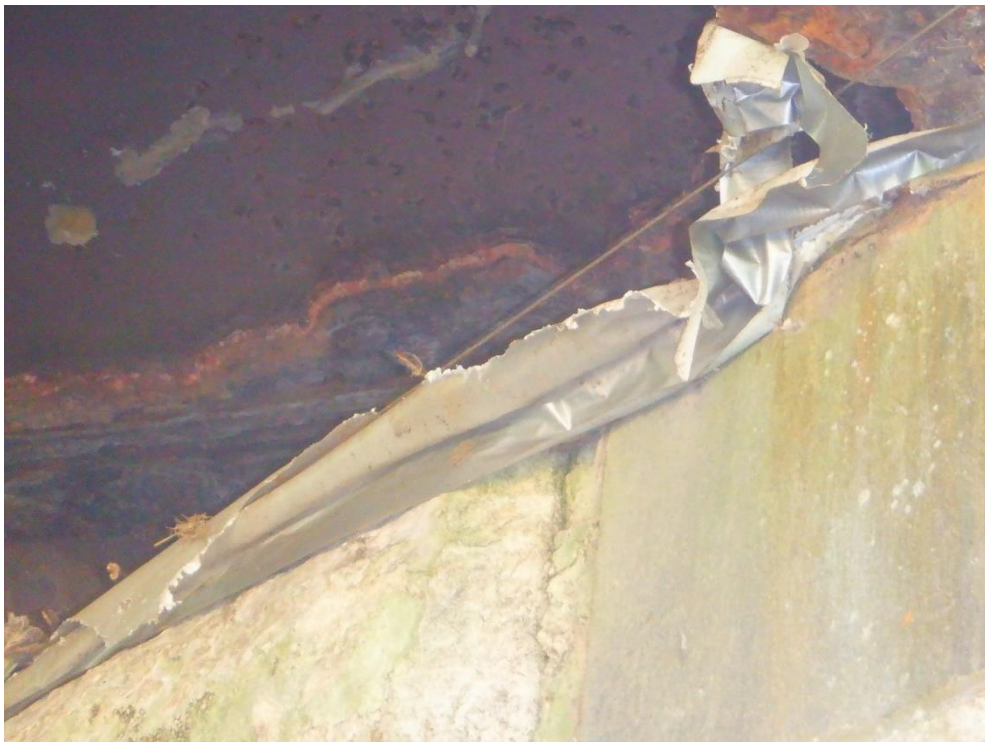
Web plate holed at South west bearing on abutment at West elevation parapet main girder not visible covered with polythene Ph No14

Photo No.14. Cross girders corrosion web plate holed at abutment not visible covered with polythene

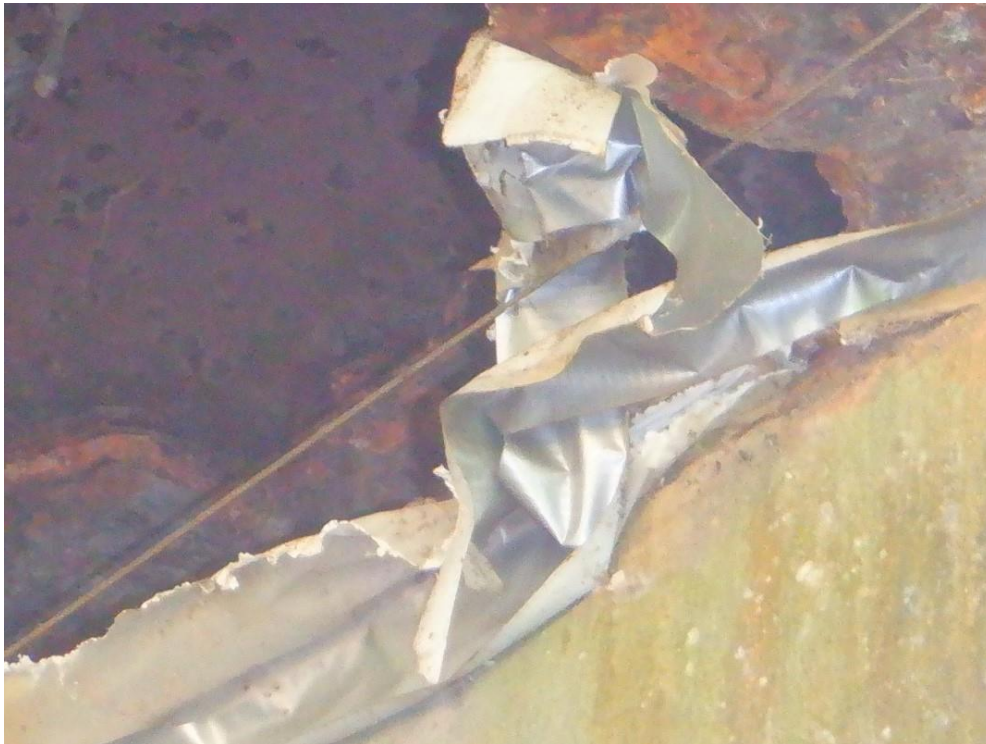
Plate deck holed at West elevation parapet girder not visible covered with polythene Ph No15

Photo No.15. Deck plate holed covered with polythene

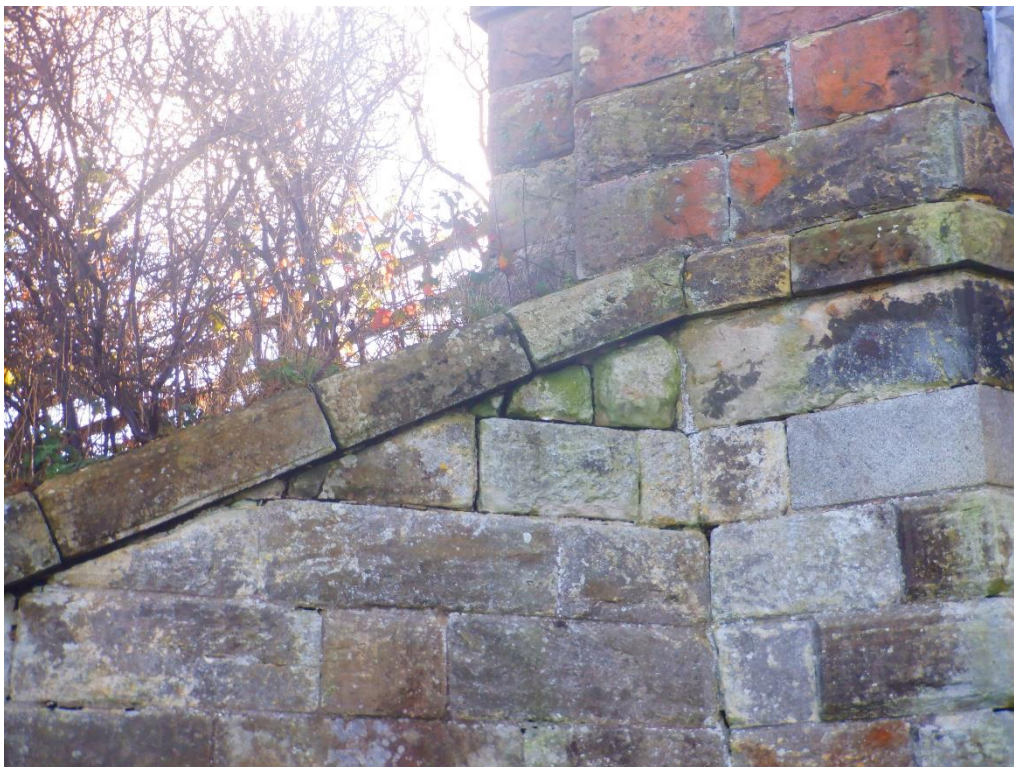
South East elevation, deep open joints under cope stones Ph No16

Photo No.16. South East elevation wing wall open joints

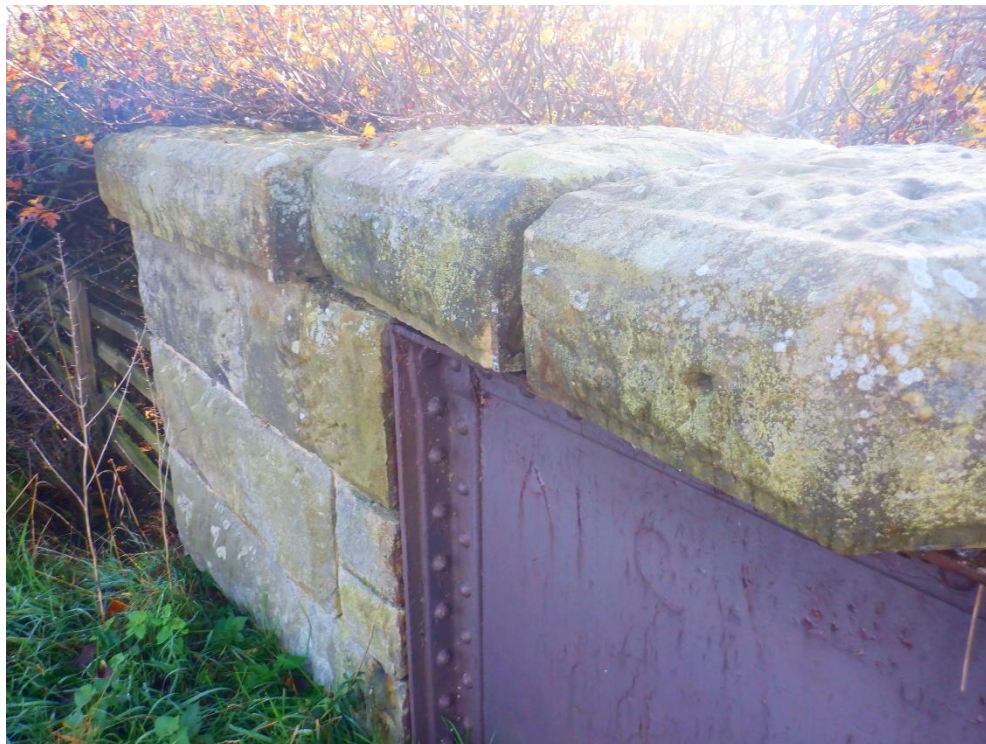
South West elevation pilaster cap displaced Ph No17

Photo No.17. South West elevation pilaster displaced

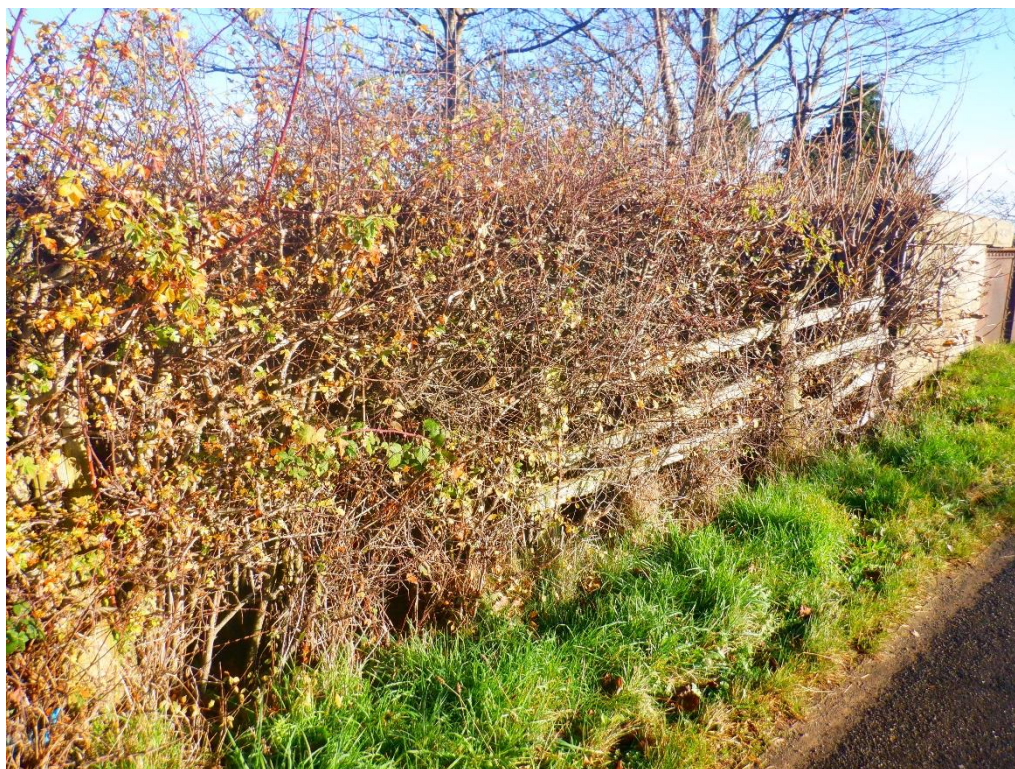
All approach fences covered with vegetation Ph No18

Photo No.18. Approach fences covered with vegetation
