## Lutterworth Swinford Road STR\_318 /M1//137.50//

# Structures Principal Inspection Report

**21/02/2025**  
**Completed**

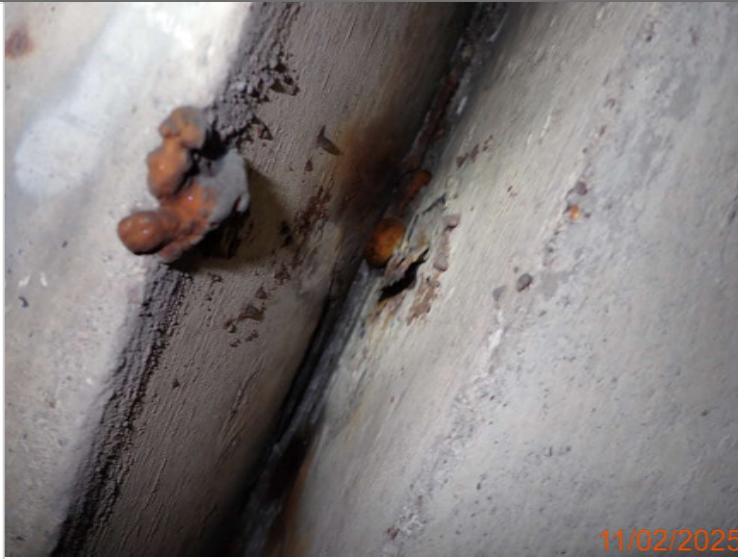
<b>Defect Code</b>	DEF_2130573-0008		
<b>Component</b>	Structural Joint	East Outer Hinge Joint	
<b>Defect Type</b>	ER - Exposed reinforcement Loss of concrete or masonry		
<b>Extent</b>	SC - Defect present in 5% to not more than 20% of area or length of element		
<b>Severity</b>	D2 - Minor: Defect is unlikely to be causing damage to the element or structure now or unlikely to do so in the near future		
<b>Priority</b>	Low		
<b>Comments</b>	To the inner face of the east outer hinge joint there was minor spalling and delamination, exposing moderately corroded reinforcement. Measured up to 430 x 240 x 10mm.		
<b>Cause</b>	Reinforcement Corrosion	<b>Certainty</b>	High
<b>Comment on Cause</b>

Minor spalling to the east outer hinge joint.JPG

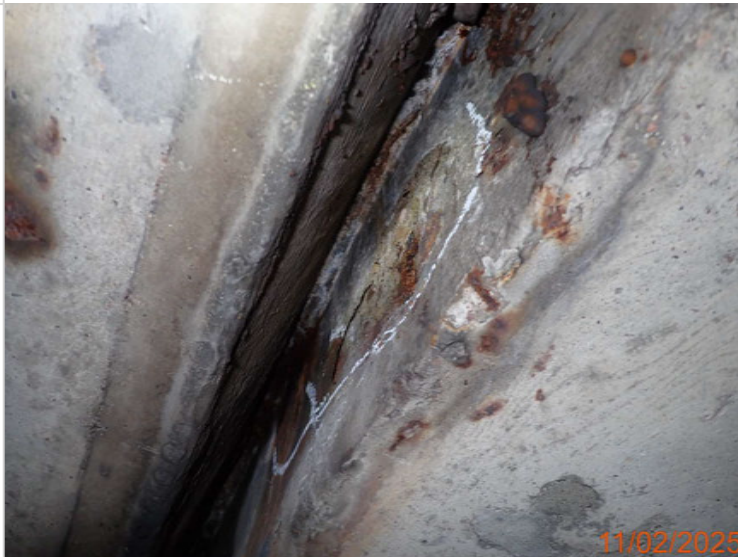
Spalling and delamination to the east outer hinge joint - 430 x 240 x 10mm.JPG

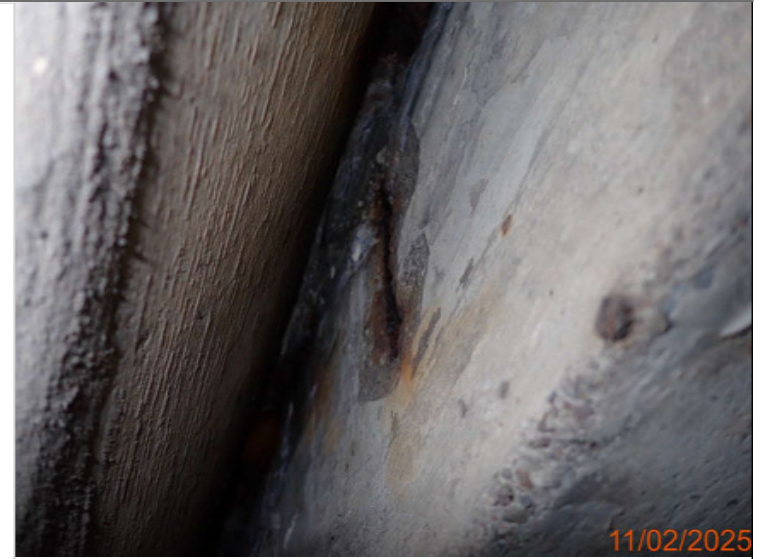
Spalling to the outer east hinge joint.JPG

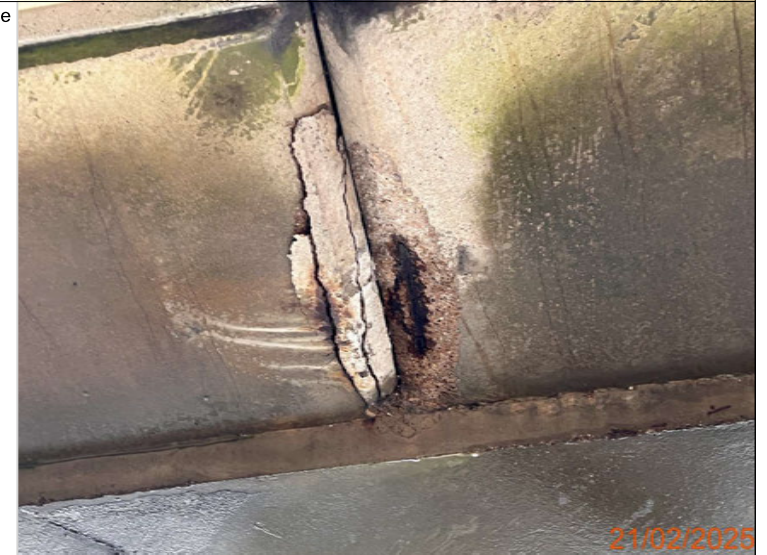
Delamination and spalling to the north service bay on the east span soffit.JPG

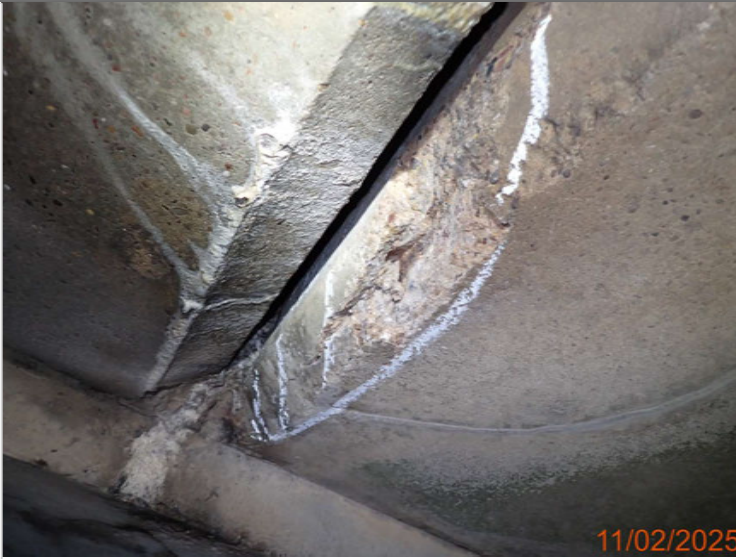
Spalling and delamination to the south service bay over SB slip - 530 x 140 x 50mm.JPG

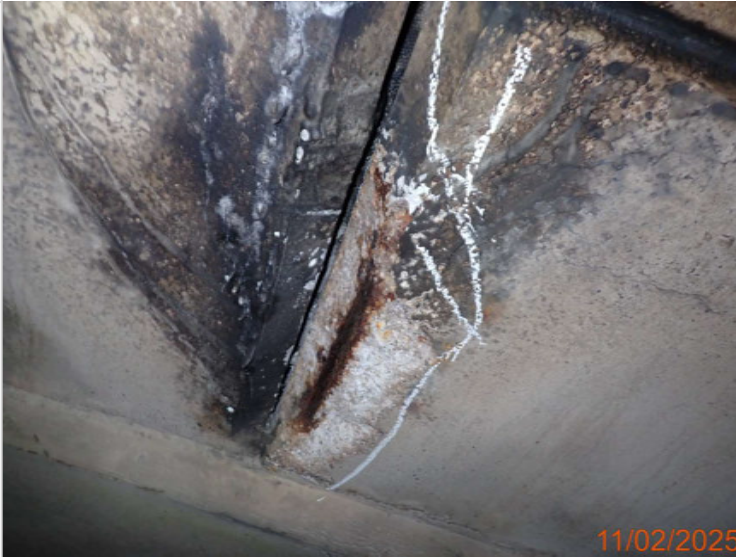
Spalling and delamination to the south service bay over SB L1 - 850 x 210 x 180mm.JPG

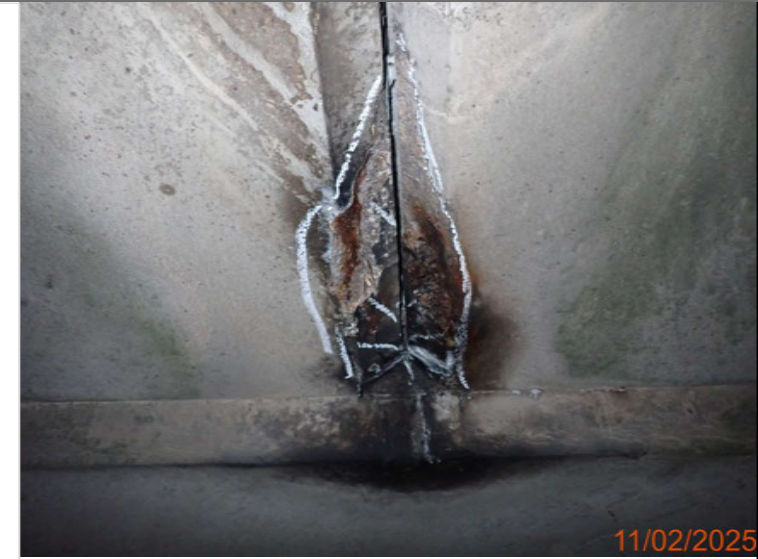
Spalling to the south service bay over NB L1-2 - 510 x 90 x 50mm.JPG

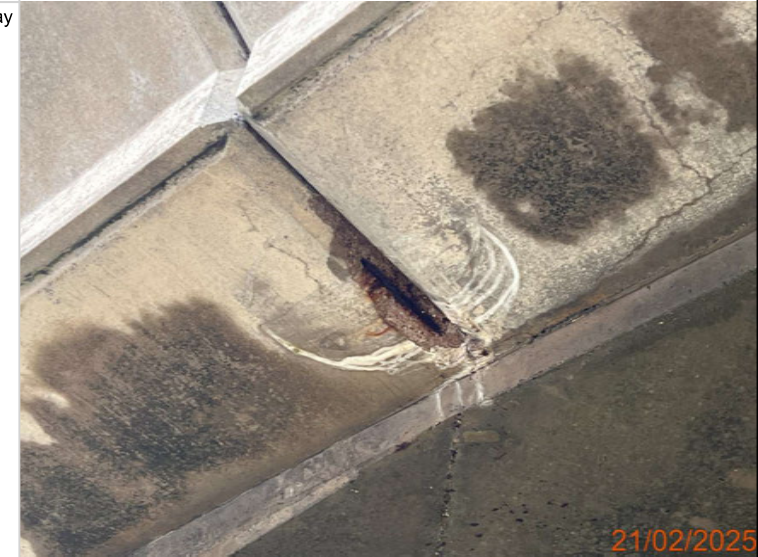
Spalling to the north service bay on the west span soffit.JPG

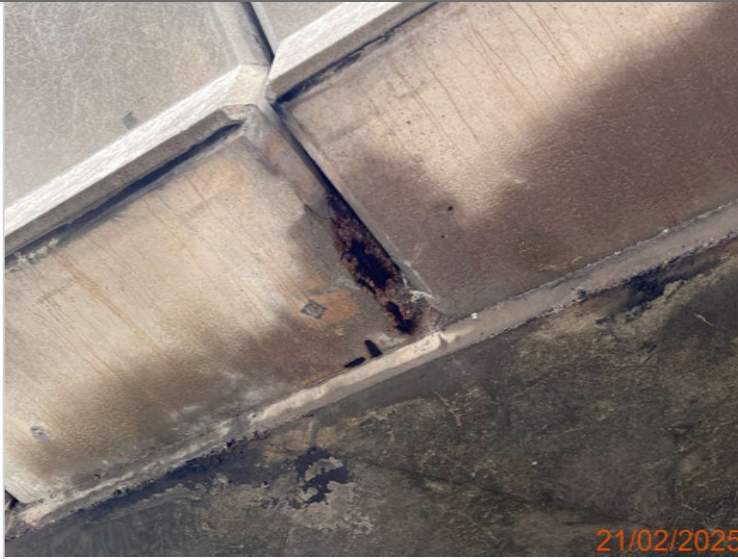
Spalling to the south service bay within the east span soffit.JPG

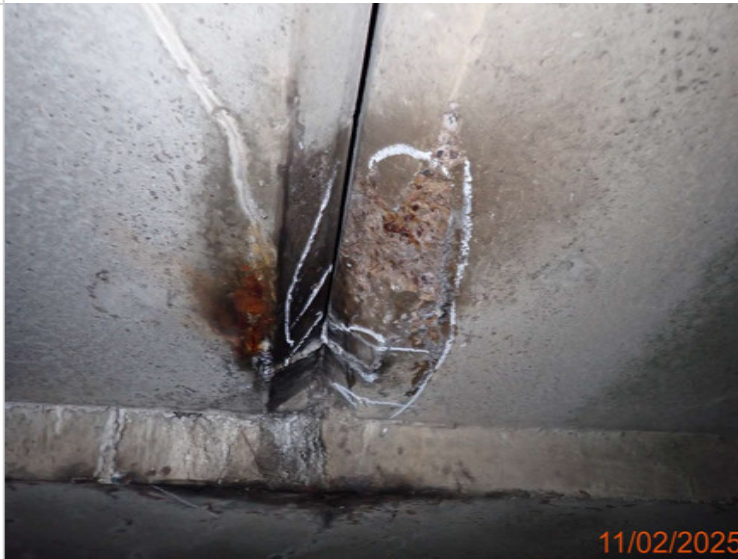
Spalling to the south service bay over NB slip - 440 x 170 x 20mm.JPG

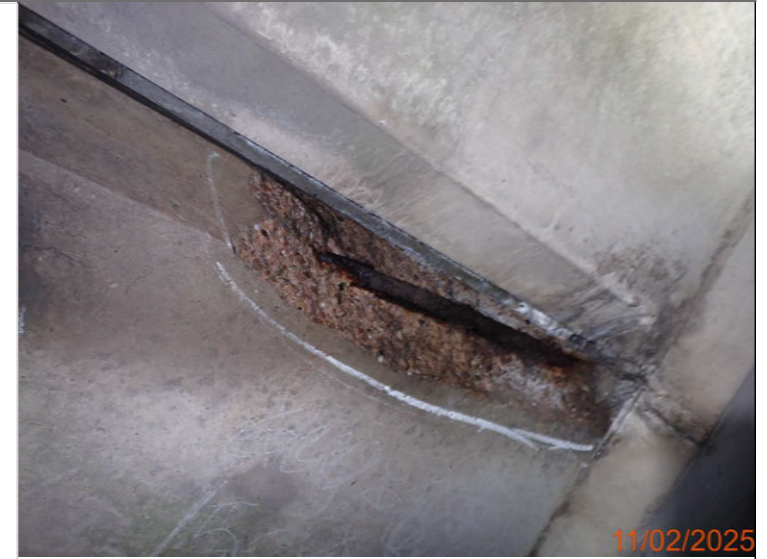
Spalling to the south service bay over SB L3 - 540 x 100 x 120mm.JPG

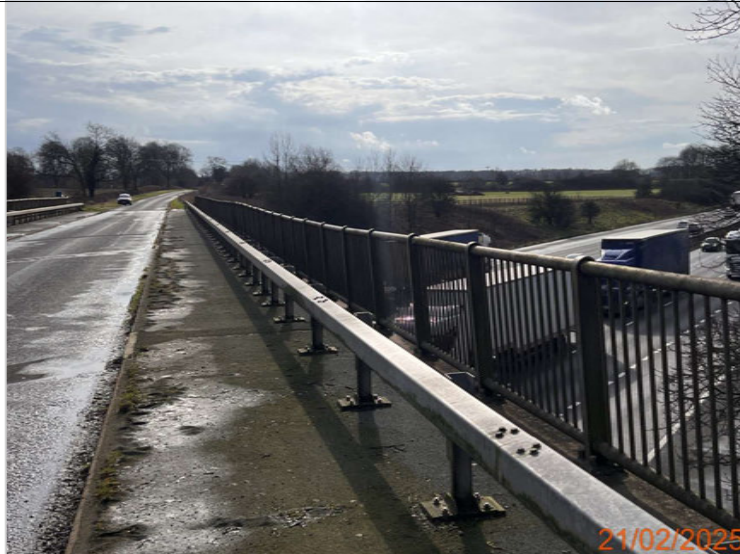
<b>Defect Code</b>	DEF_2130579-0007		
<b>Component</b>	Road Vehicle Restraint System	South Parapet	
<b>Defect Type</b>	DefG - Deformed General defects		
<b>Extent</b>	SD - Defect present in 20% to not more than 50% of area or length of element		
<b>Severity</b>	D2 - Minor: Defect is unlikely to be causing damage to the element or structure now or unlikely to do so in the near future		
<b>Priority</b>	Low		
<b>Comments</b>	The south parapet has an appearance of sagging over its western half.

<b>Cause</b>	Design Issue	<b>Certainty</b>	High
<b>Comment on Cause</b>

Sagging to the west end of the south parapet.JPG

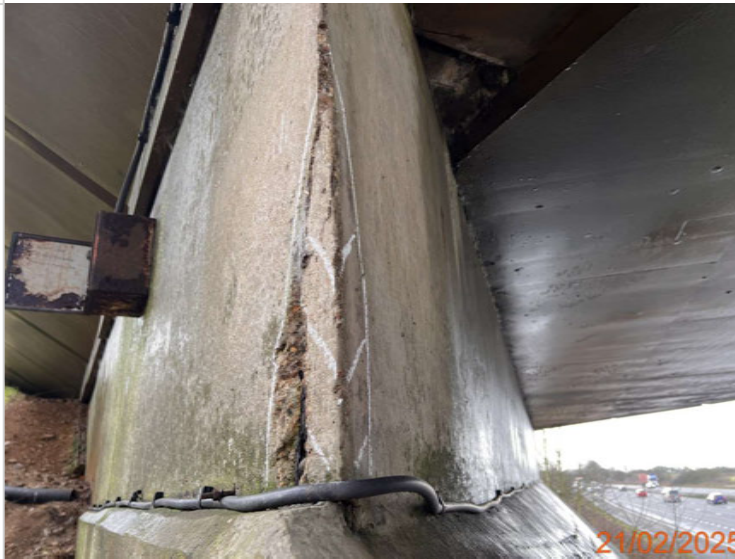
<b>Defect Code</b>	DEF_2130571-0005		
<b>Component</b>	Abutment Wall	East Abutment	
<b>Defect Type</b>	ER - Exposed reinforcement Loss of concrete or masonry		
<b>Extent</b>	SB - Defect present in not more than 5% of area or length of element		
<b>Severity</b>	D2 - Minor: Defect is unlikely to be causing damage to the element or structure now or unlikely to do so in the near future		
<b>Priority</b>	Low		
<b>Comments</b>	190 x 430 x 20mm spalled and delaminated area in the north corner of the east bankseat. There was a minor area on the west bankseat at the north end.

Delamination to the north end of the east bankseat - 190 x 430 x 20mm.JPG

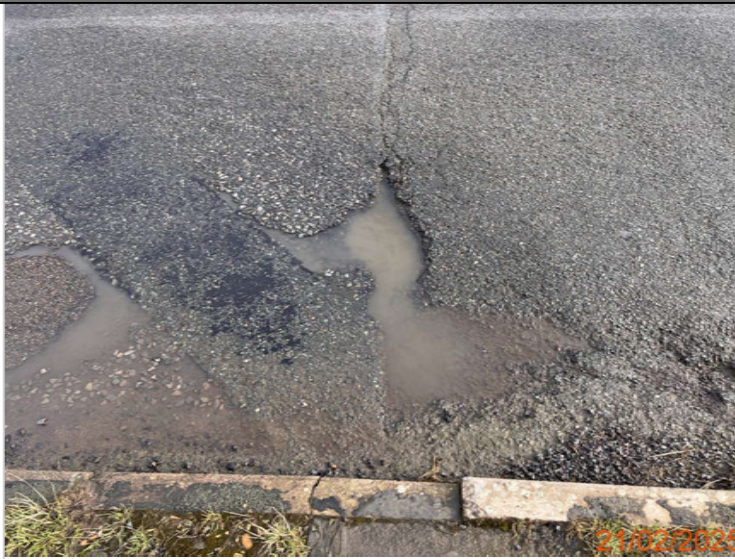
**Defect Type** PH - Pothole Defects in components  
**Extent** SB - Defect present in not more than 5% of area or length of element  
**Severity** D2 - Minor: Defect is unlikely to be causing damage to the element or structure now or unlikely to do so in the near future  
**Priority** Medium  
**Comments** There was one pothole adjacent to the east joint, measured 120 x 530 x 30mm. The approach to the east end of the structure also had pothole and minor transverse cracking.

**Comment on Cause** Material loss from vehicles passing over the structure.

Pothole adjacent the east joint - 120 x 530 x 30mm.JPG

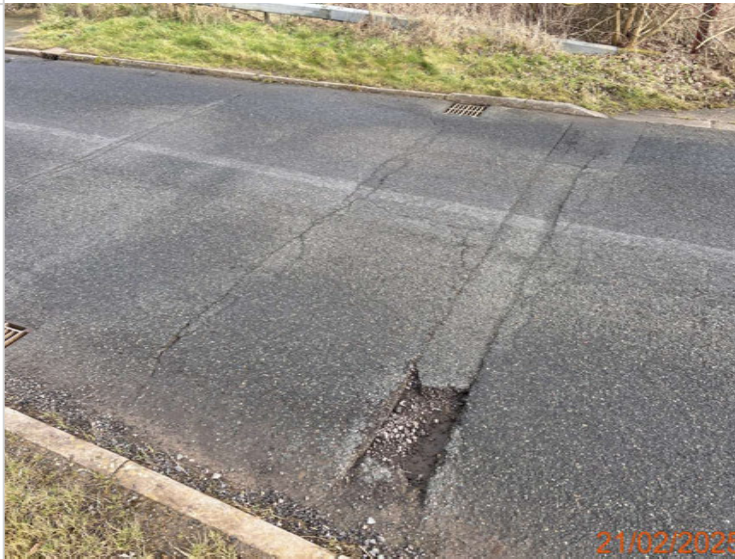
Pothole and transverse cracking on the east approach - 300 x 600 x 50mm.JPG

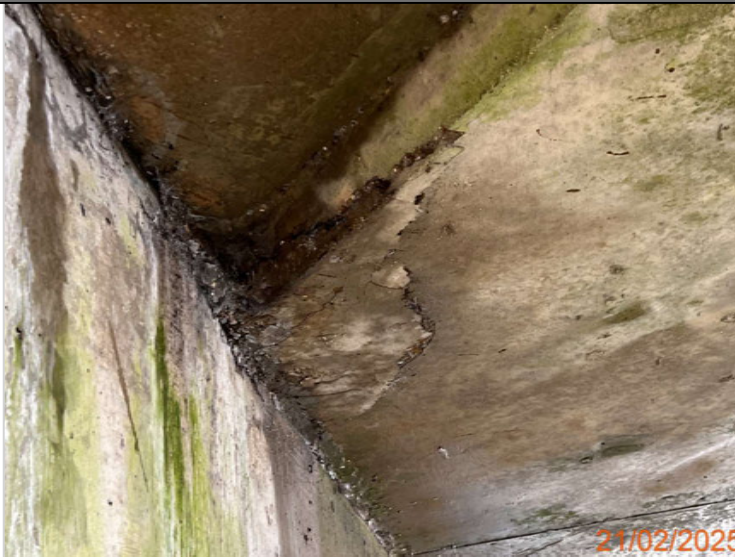
**Defect Type** Sp - Spalled area Loss of concrete or masonry  
**Extent** SB - Defect present in not more than 5% of area or length of element  
**Severity** D2 - Minor: Defect is unlikely to be causing damage to the element or structure now or unlikely to do so in the near future  
**Priority** Medium  
**Comments** Within the deck soffit over southbound lane 2 there was one area of spalling with moderately corroded reinforcement measuring 940 x 230 x 100mm and on the west span soffit adjacent the bankseat there was delamination approximately 750 x 800mm.

Delamination to the west span soffit adjacent the bankseat - 750 x 800mm approx.JPG

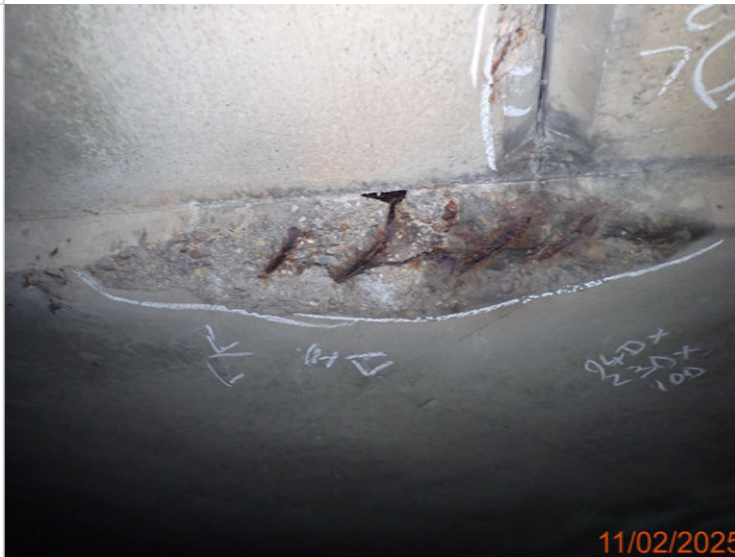
Spalling to the deck soffit over SB L2 - 940 x 230 x 100mm.JPG

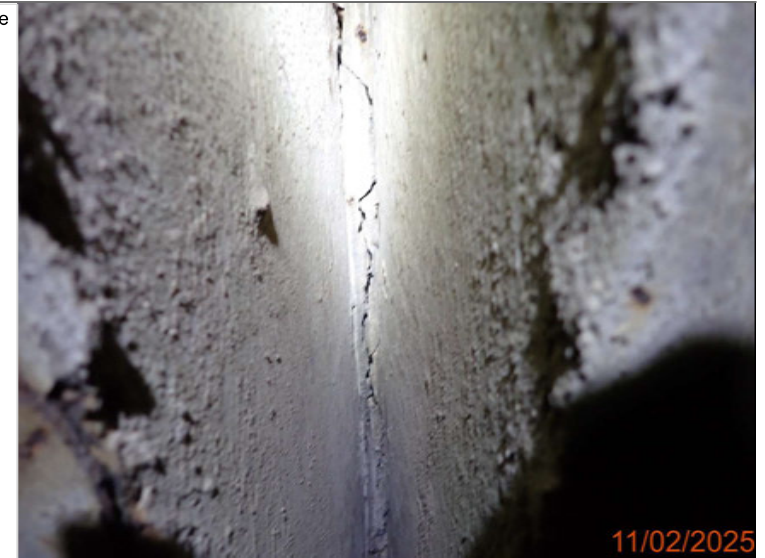
Cracking 2mm wide through the west hinge joint.JPG

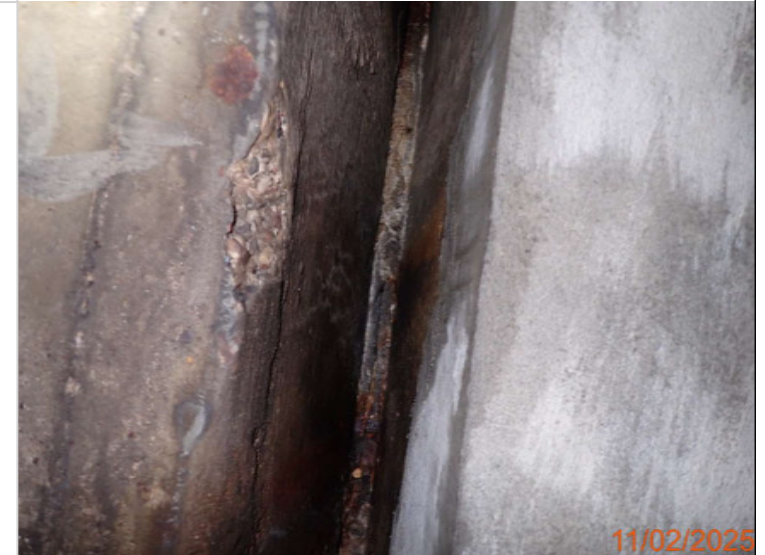
Cracking within the east hinge joint over SB L1.JPG

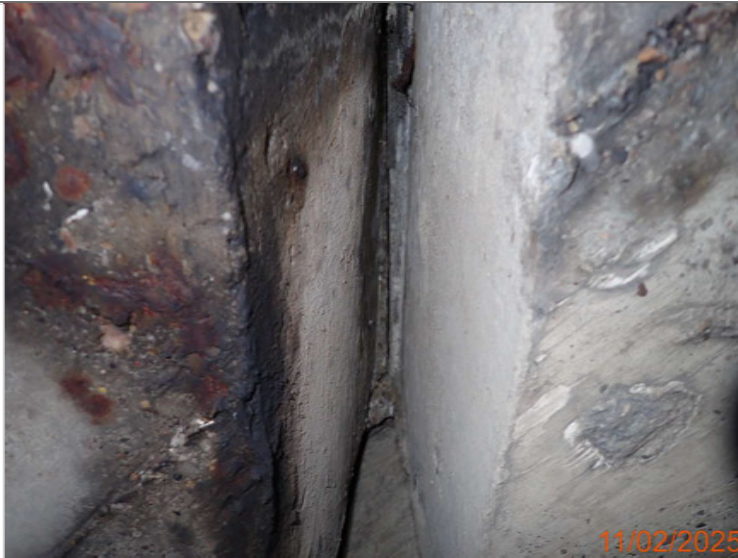
Cracking within the west hinge joint over NB L1.JPG

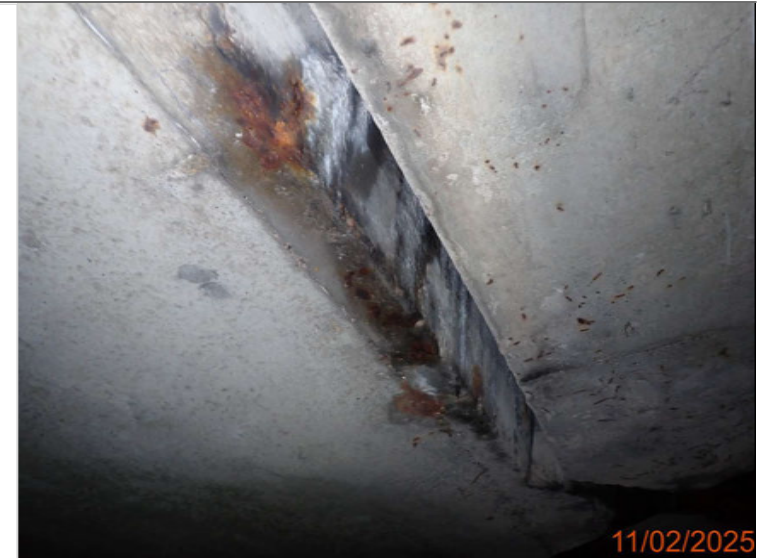
Water and leachate staining to the west hinge joint over NB L1.JPG

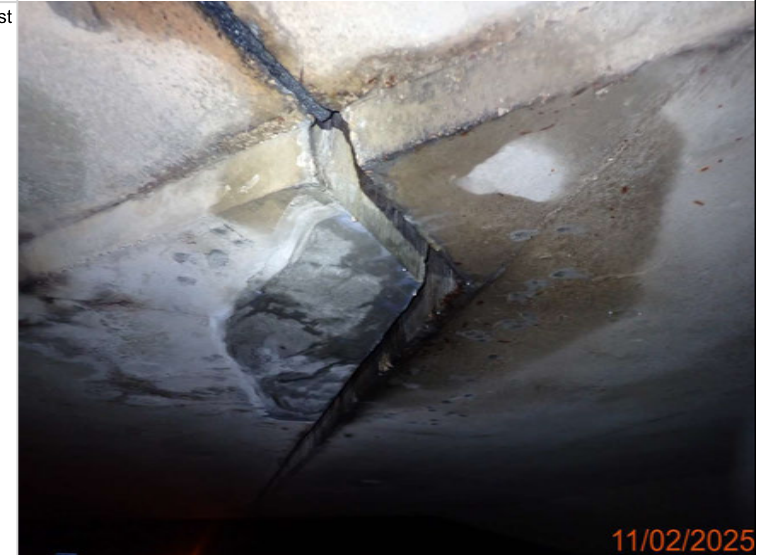
<b>Defect Code</b>	DEF_2130535-0006		
<b>Component</b>	Structural Joint	East Outer Hinge Joint	
<b>Defect Type</b>	WR - Running water Leaching/Staining		
<b>Extent</b>	SB - Defect present in not more than 5% of area or length of element		
<b>Severity</b>	D3 - Moderate: Defect is probably causing damage to element or structure, or is likely to do so in the near future		
<b>Priority</b>	Low		
<b>Comments</b>	There are isolated areas of water seepage and leaching at the ends of the hinge joints.		
<b>Cause</b>	Moisture Egress	<b>Certainty</b>	High
<b>Comment on Cause</b>			
<b>Document ID</b>	4586838	<b>Document Title</b>	STR_318 PI Defect photos 21/02/2025

Water seepage through the east hinge joint on the east span.JPG

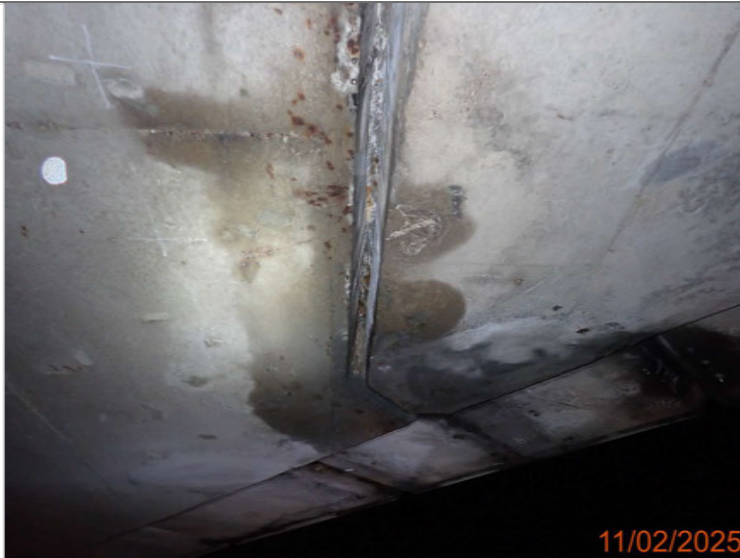
Water seepage through the east deck west hinge joint on the north end.JPG

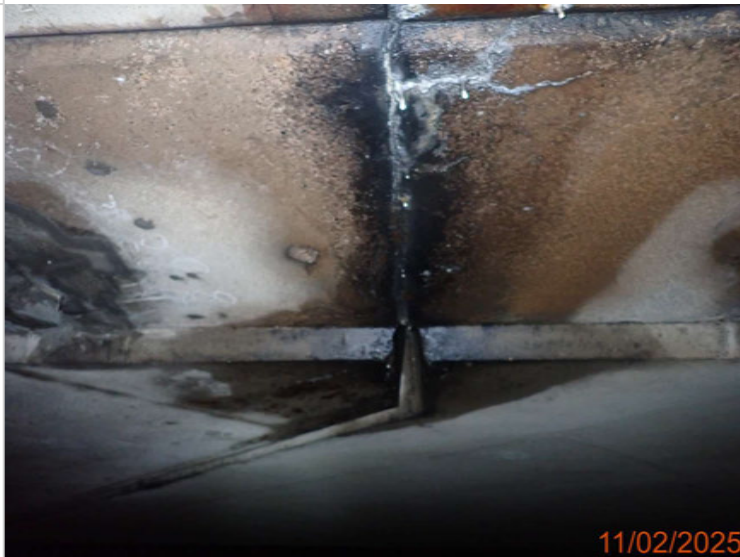
Water seepage through the east deck west hinge joint.JPG

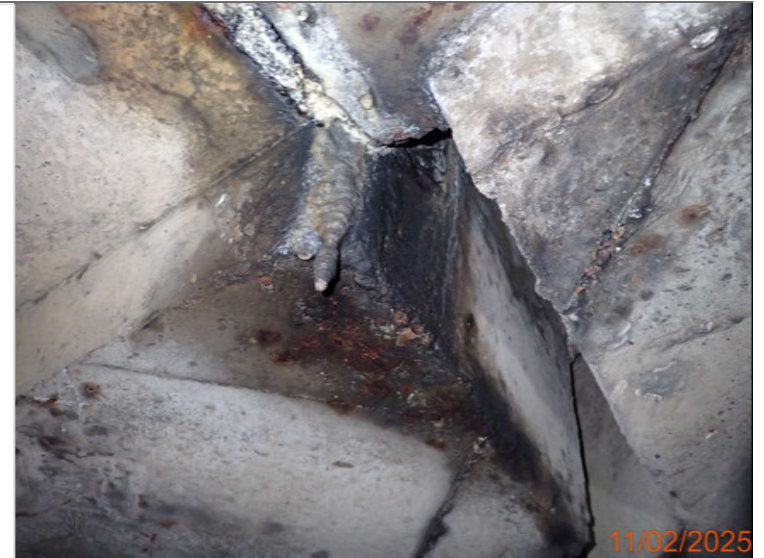
Water seepage through the south end of the west hinge joint.JPG

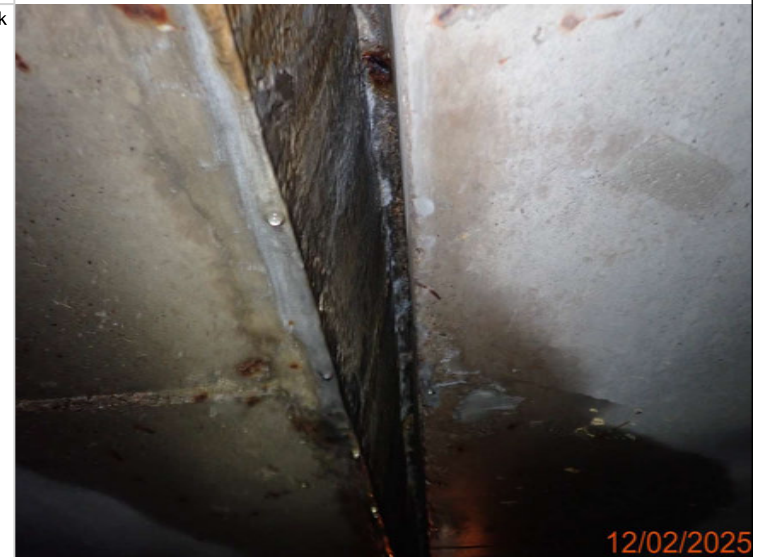
Leachate through the west deck east hinge joint.JPG

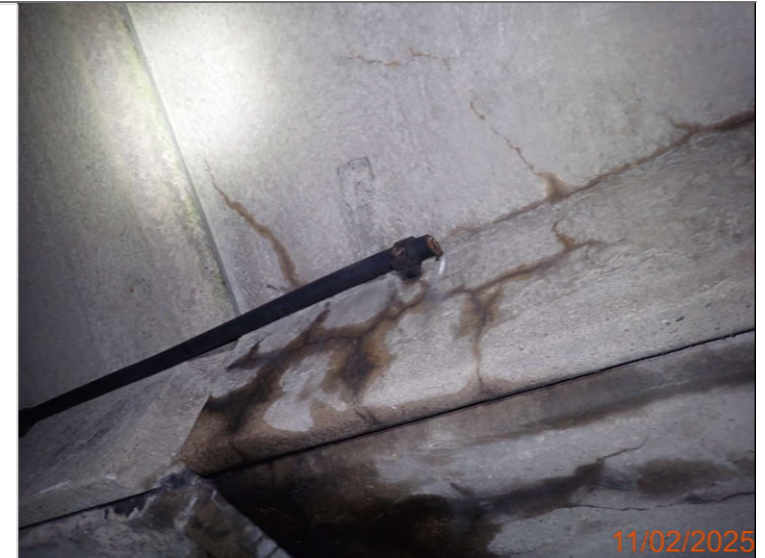
Hairline cracking to the north service bay over SB L1.JPG

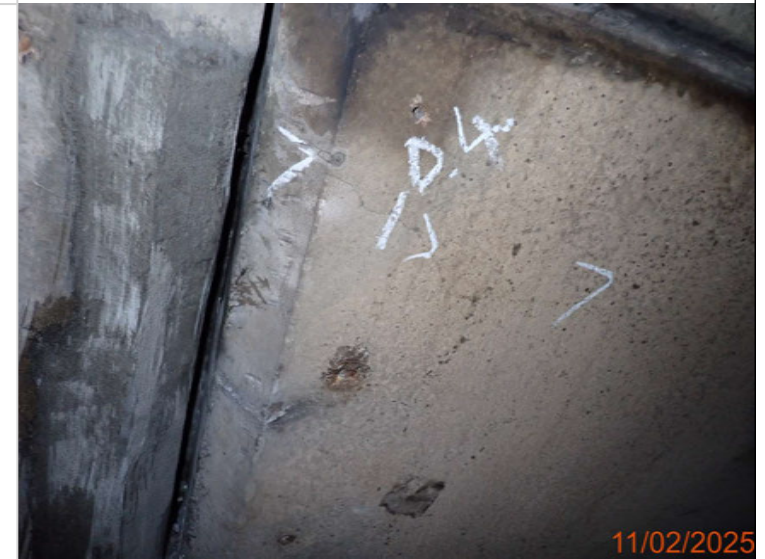
Cracking to the south service bay 0.4mm wide over NB L1.JPG

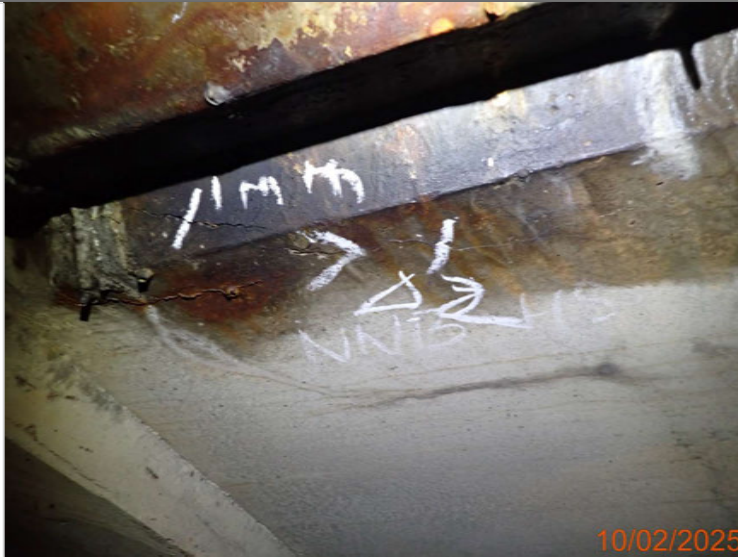
Cracking 1mm wide to the north service bay over NB L1.JPG

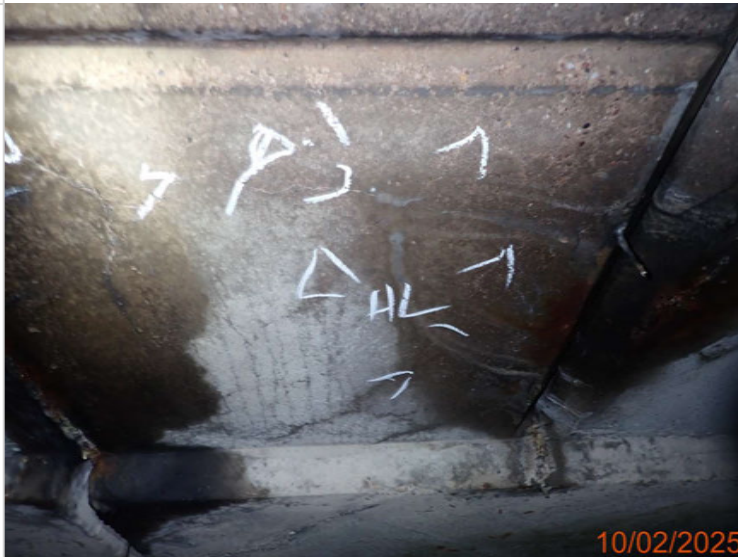
Hairline cracking to the north service bays over NB L1.JPG

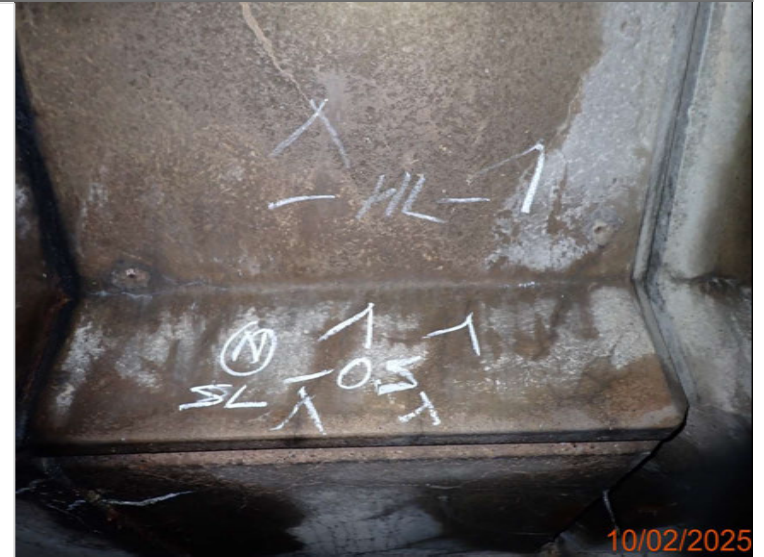
Cracking to the north service bay up to 0.5mm wide over NB L1.JPG

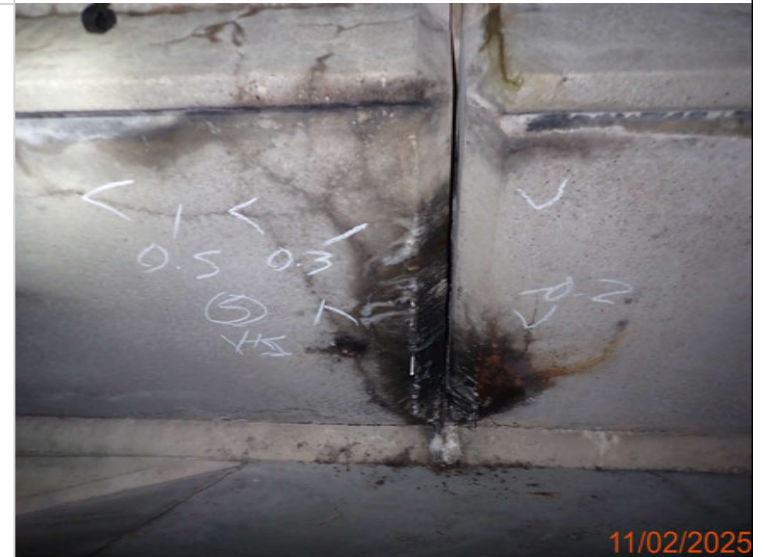
Cracking to the south service bay up to 0.5mm wide over SB HS.JPG

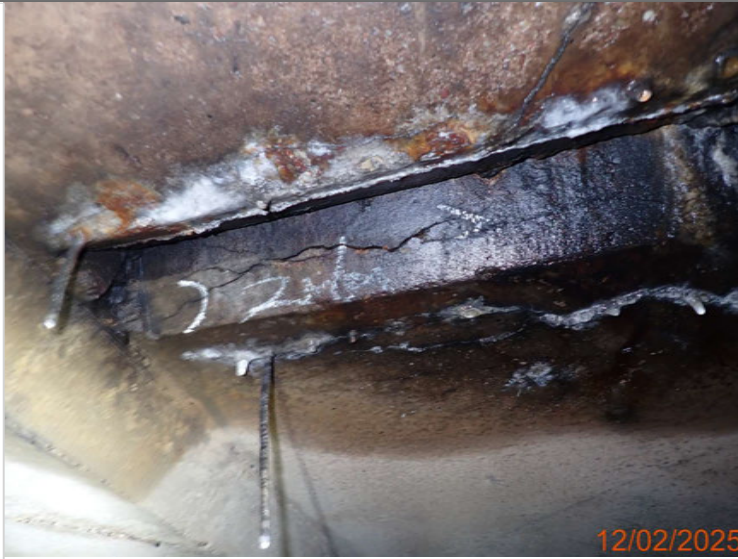
Cracking 2mm wide to the north service bay over NB L3.JPG

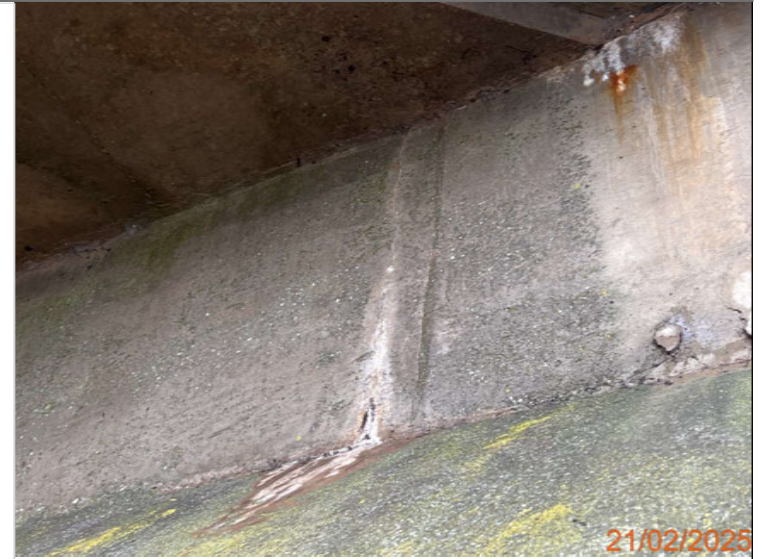
Vertical cracking to the west bankseat at the north end.JPG

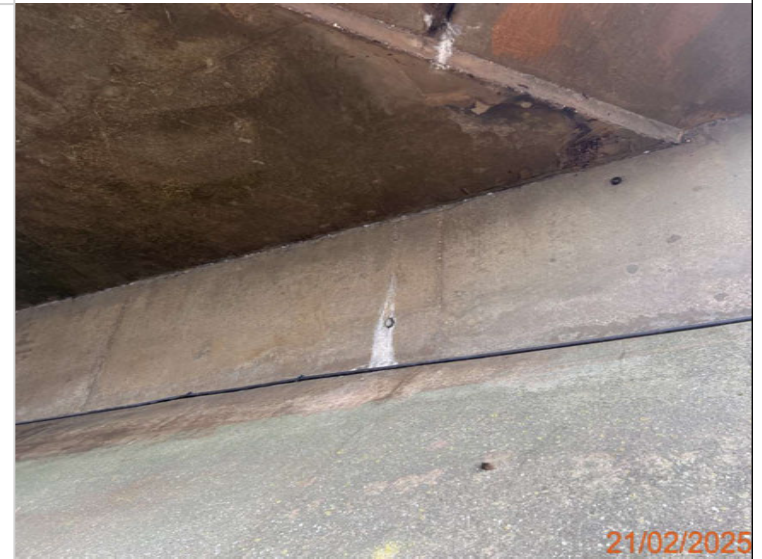
Vertical cracking to the east bankseat at the south end.JPG

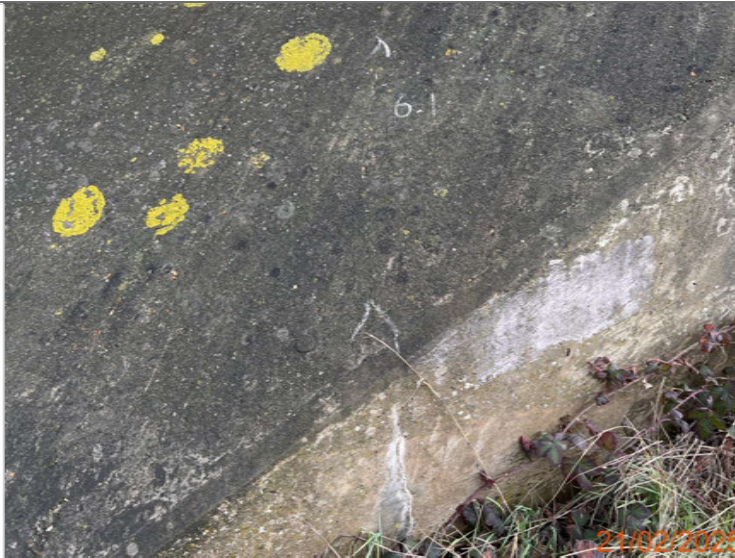
Cracking 0.1mm wide to the east revetment.JPG

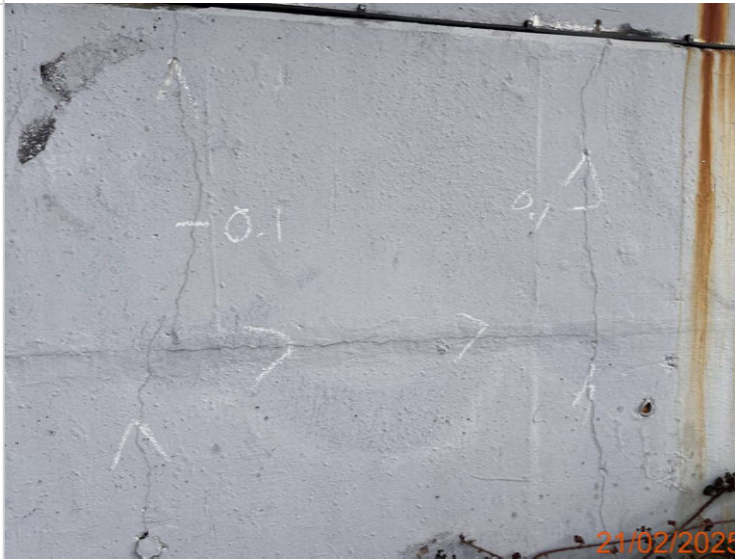
Cracking 0.1mm wide to the south return on the east bankseat.JPG

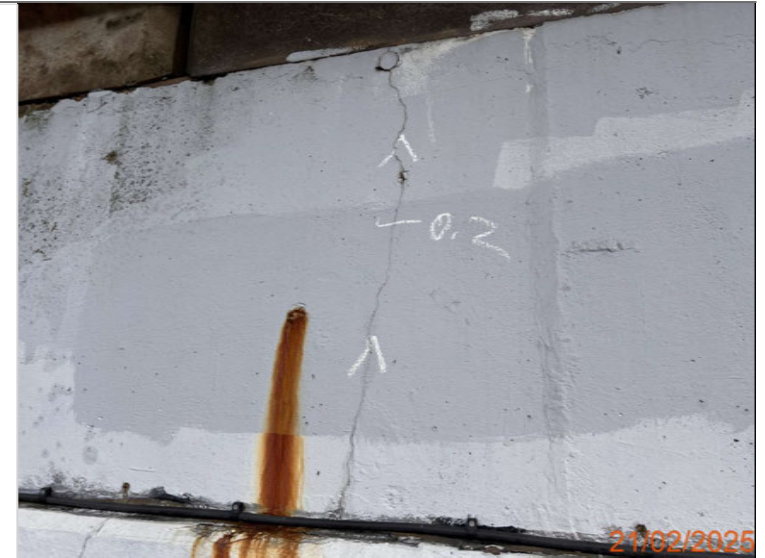
Cracking 0.2mm wide to the south return on the east bankseat.JPG

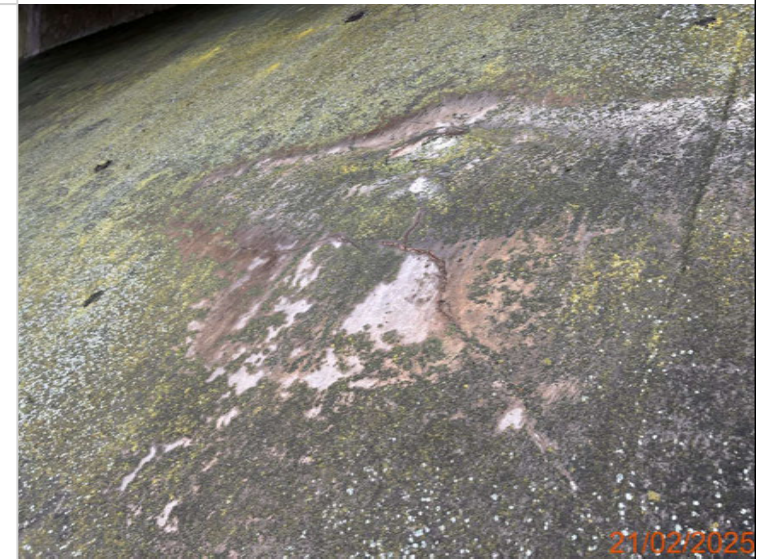
Cracking to the west revetment.JPG

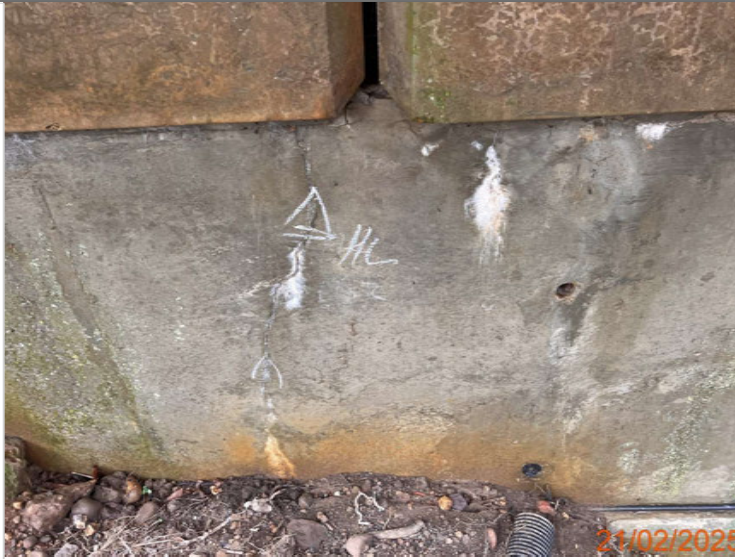
Hairline cracking to the north return on the east bankseat.JPG

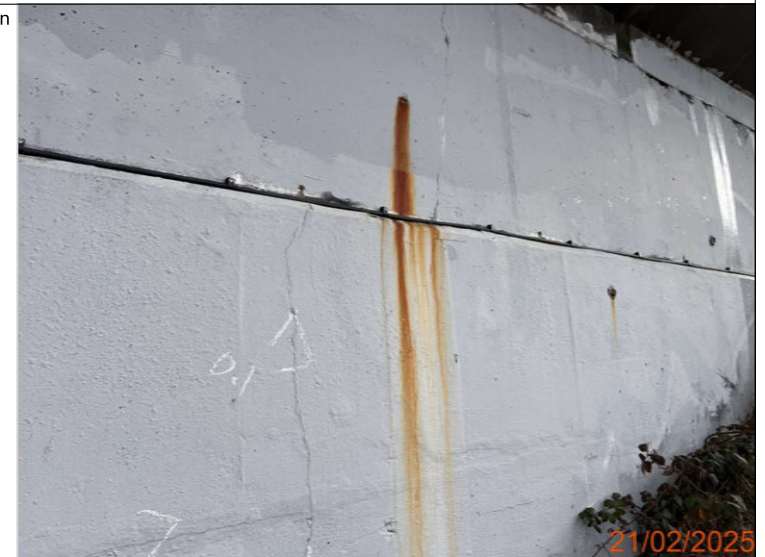
<b>Defect Code</b>	DEF_2130585-0008
<b>Component</b>	Abutment Wall East Abutment
<b>Defect Type</b>	RSt - Rust stain/streak/spot Leaching/Staining
<b>Extent</b>	SB - Defect present in not more than 5% of area or length of element
<b>Severity</b>	D2 - Minor: Defect is unlikely to be causing damage to the element or structure now or unlikely to do so in the near future
<b>Priority</b>	Low
<b>Comments</b>	A rust stain from a small piece of exposed corroded rebar can be found in the south return of the east bankseat.
<b>Cause</b>	Reinforcement Corrosion <b>Certainty</b> High
<b>Comment on Cause</b>

Rust staining to the south return wall on the east bankseat.JPG

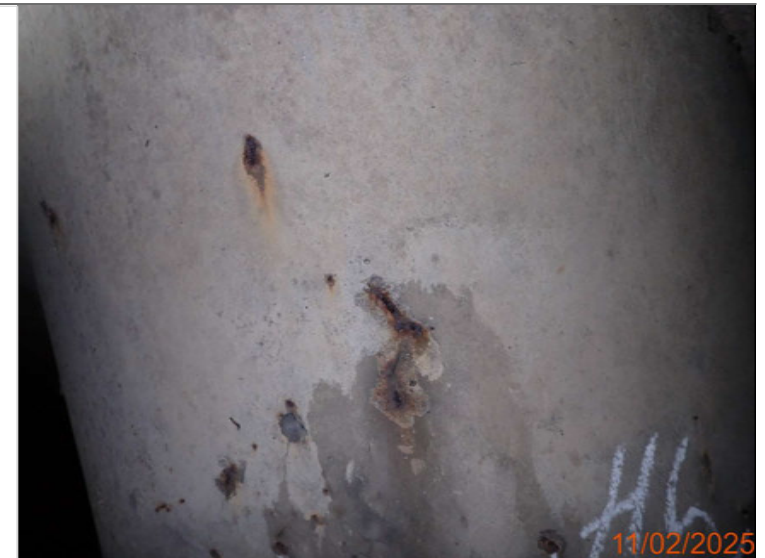
Rusty tie wire within the east span soffit.JPG

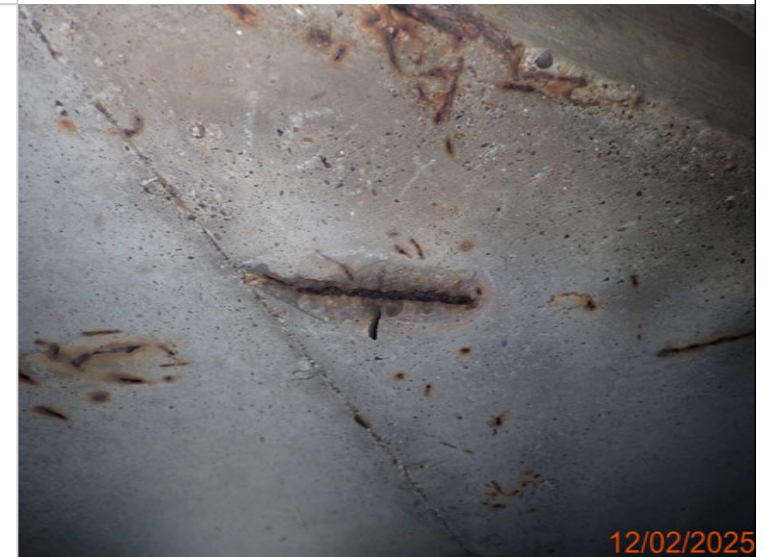
Rusty tie wire within the west span northbound soffit.JPG

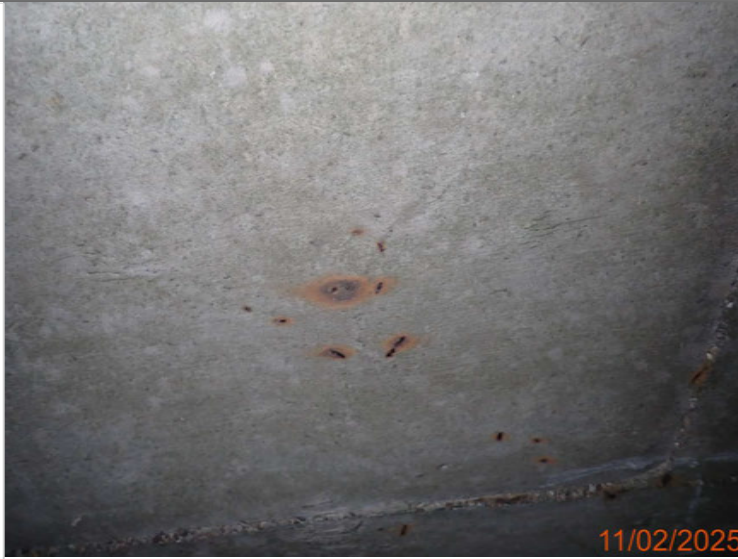
Rusty tie wire to the west span soffit.JPG

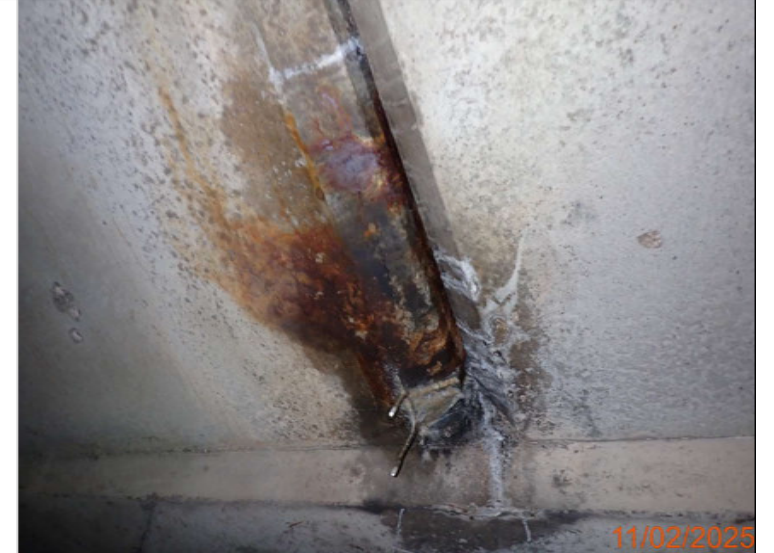
<b>Defect Code</b>	DEF_2130581-0005		
<b>Component</b>	SLB - Slab	Reinforced concrete deck slab	
<b>Defect Type</b>	RSt - Rust stain/streak/spot Leaching/Staining		
<b>Extent</b>	SB - Defect present in not more than 5% of area or length of element		
<b>Severity</b>	D2 - Minor: Defect is unlikely to be causing damage to the element or structure now or unlikely to do so in the near future		
<b>Priority</b>	Low		
<b>Comments</b>	Rust staining can be found on isolated service bays.		
<b>Cause</b>	Reinforcement Corrosion	<b>Certainty</b>	High
<b>Comment on Cause</b>

Rust staining to the south service bay over NB L1.JPG
