**Structure ESB10m4ch, Ridge Road Bridge,
Shepton Mallet**

Ecological Survey Report in Support of Planning Application for Infill

December 2017

Project No: B18280DW
Document Title: Ecological Survey Report in Support of Planning Application for Infill
Revision: 0
Date: December 2017
Client Name: Highways England Historic Railways Estate

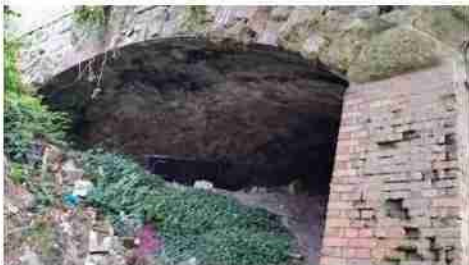
- the northern arch Arch 1' (Plate 1) was open on the south western side but infilled on the north eastern side with large slabs of concrete and masonry forming a slope which meets the soffit of the arch on the north eastern facing site and the southern arch;
- the middle arch 'Arch 2' (Plate 2) was open on both sides; and
- 'Arch 3' (Plate 3) was infilled on both sides, though a significant internal cavity was present with a small accessible gap allowing animals (but not humans) to enter.

Plate 1 Arch 1 infilled on northern eastern facing side only

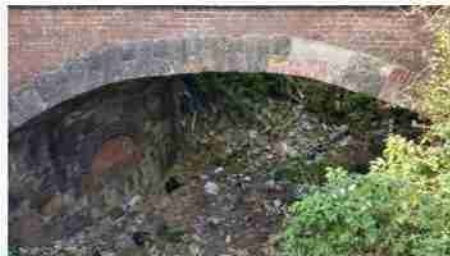
Plate 2 Arch 2 open on both sides

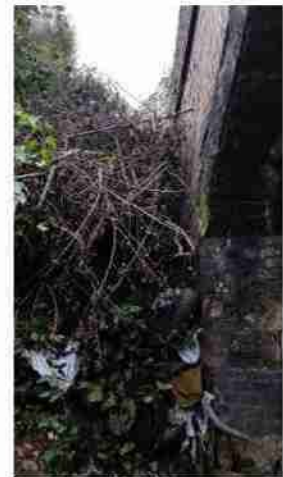
Plate 3 Arch 3 infilled on both sides but with a narrow bat accessible gap on the north west facing side leading into a large internal void (Not visible in photo)

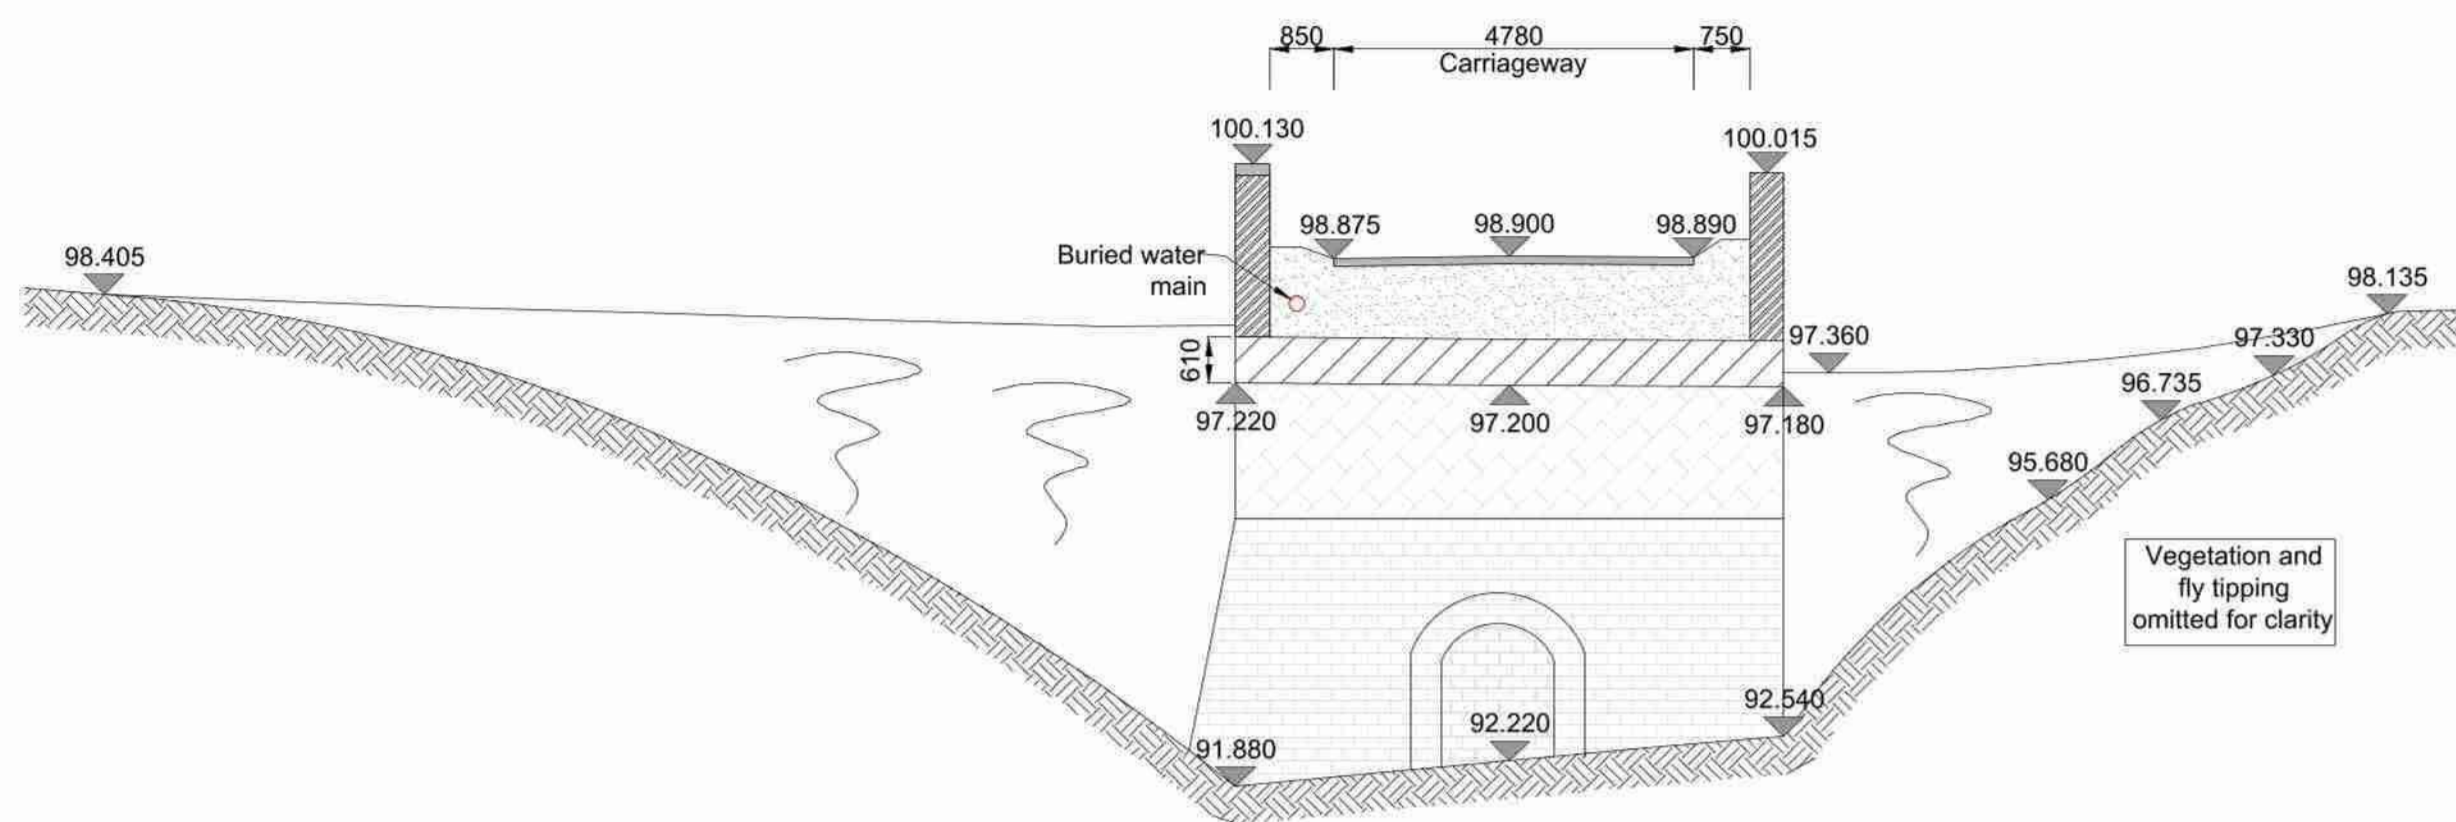
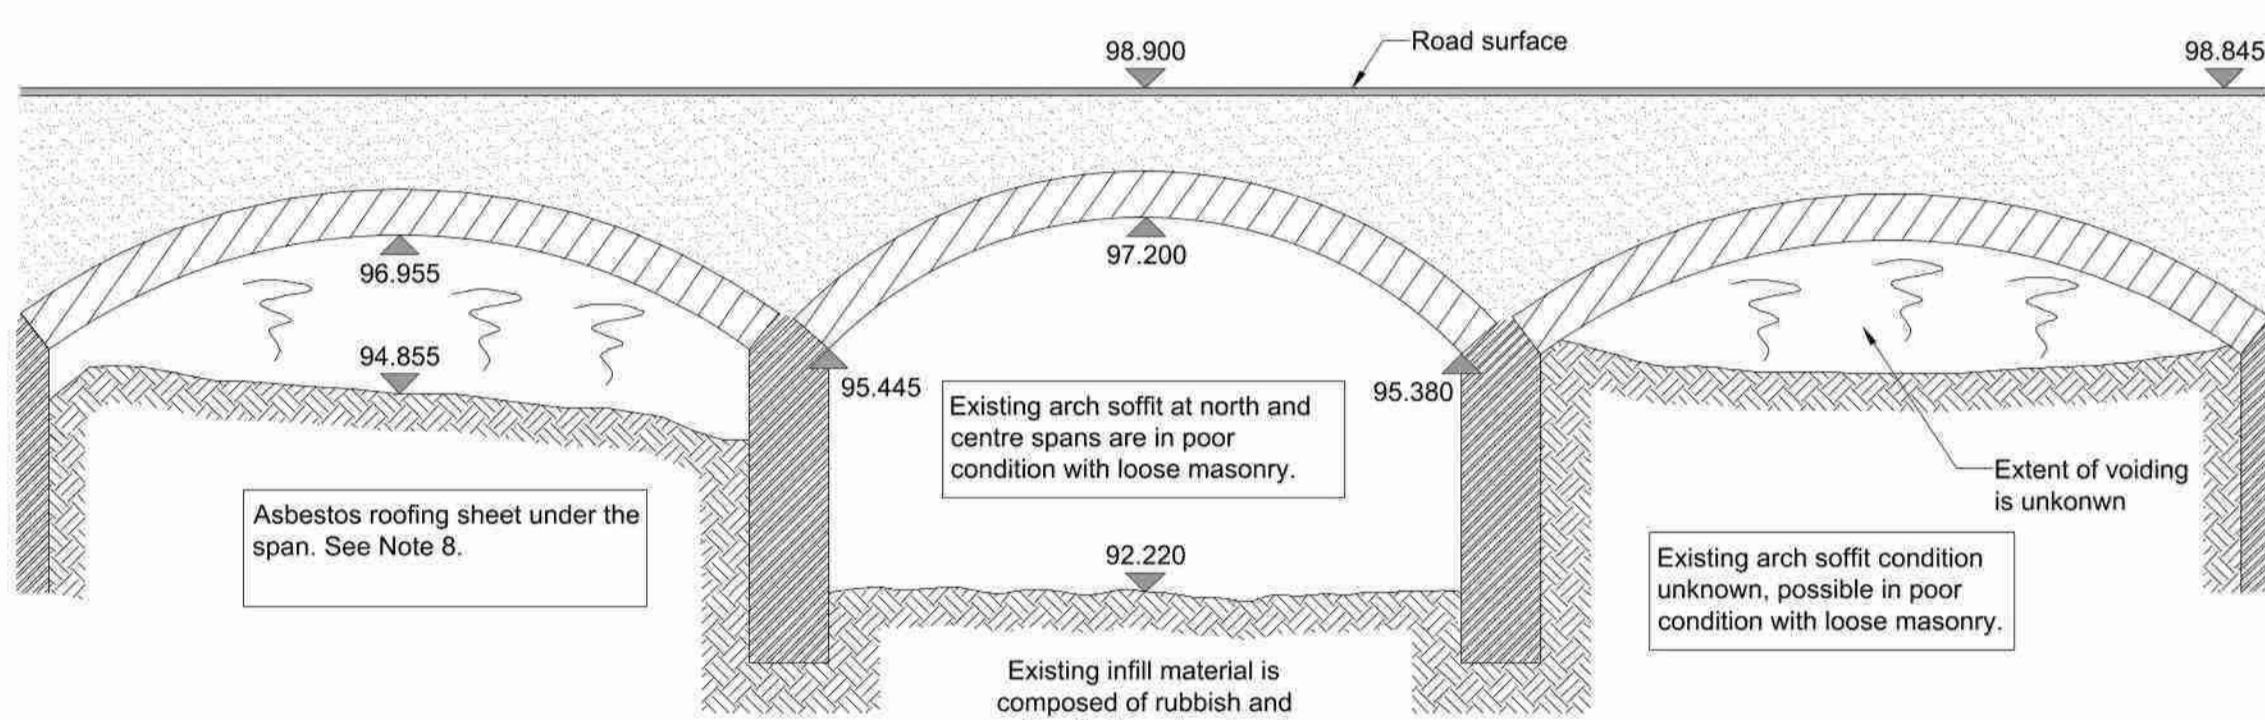
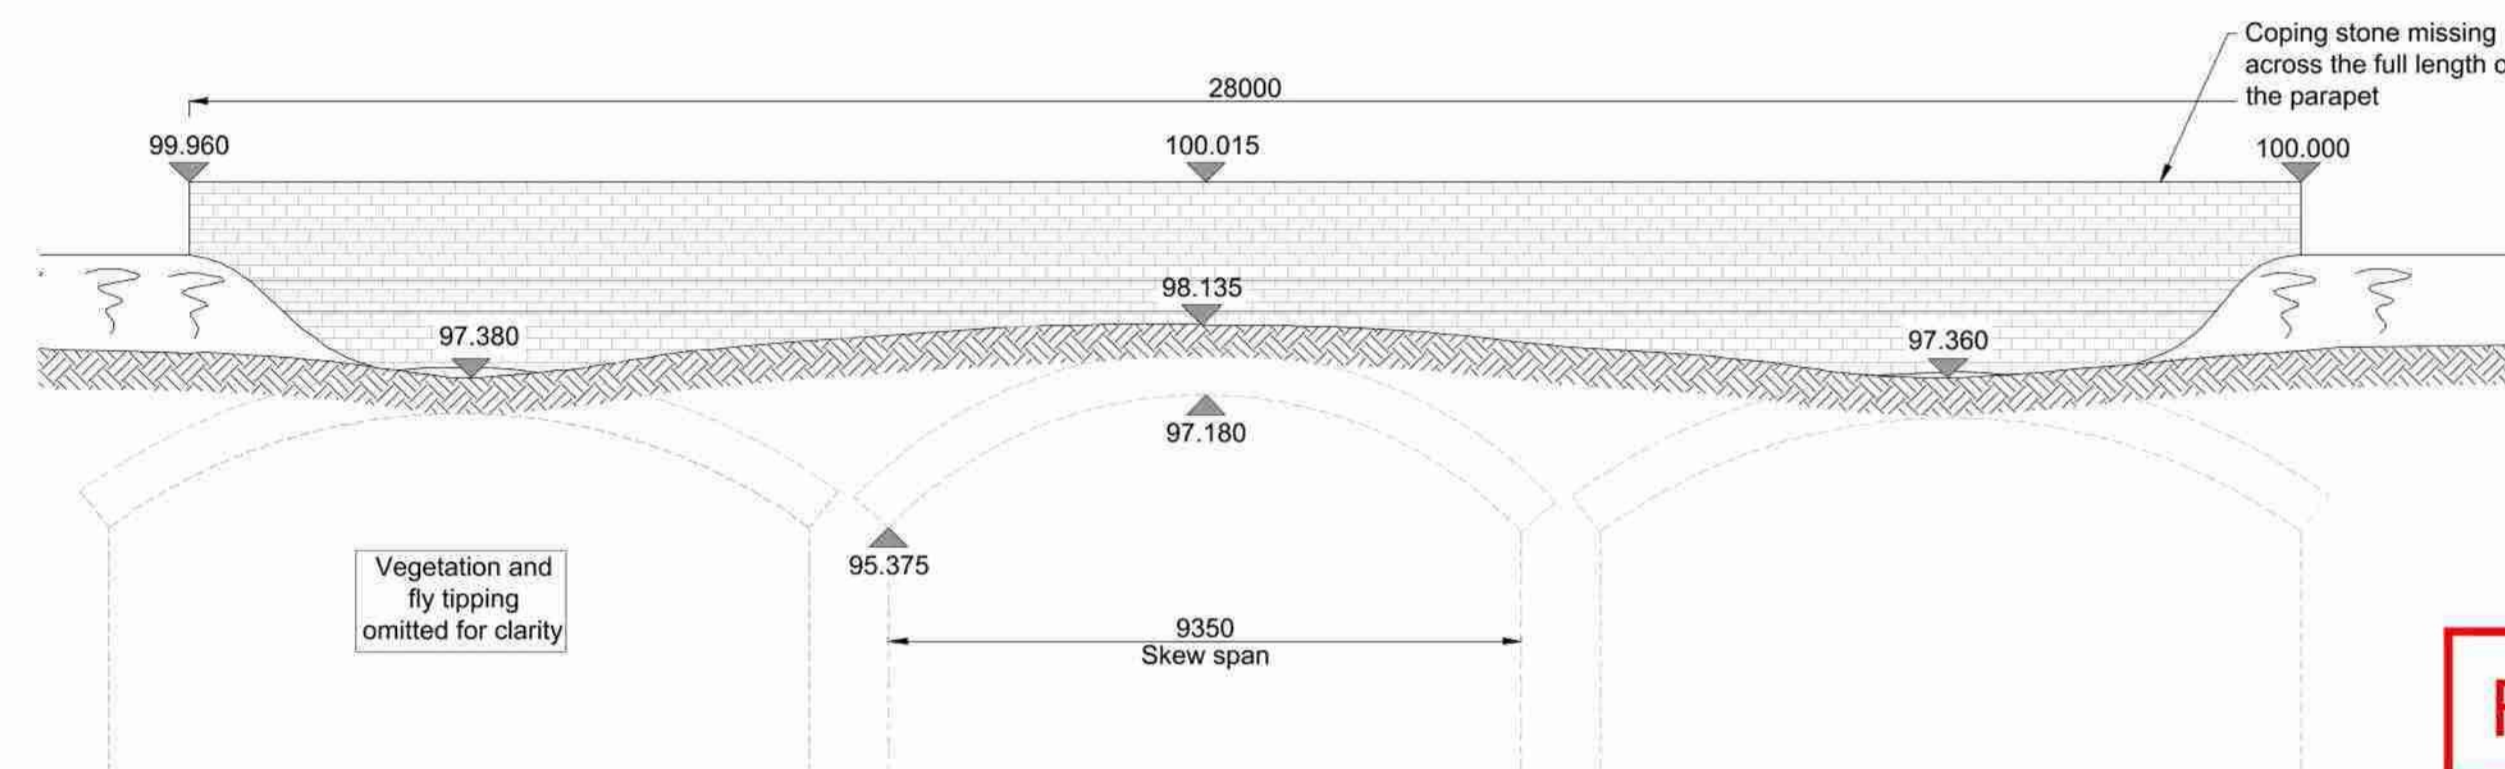
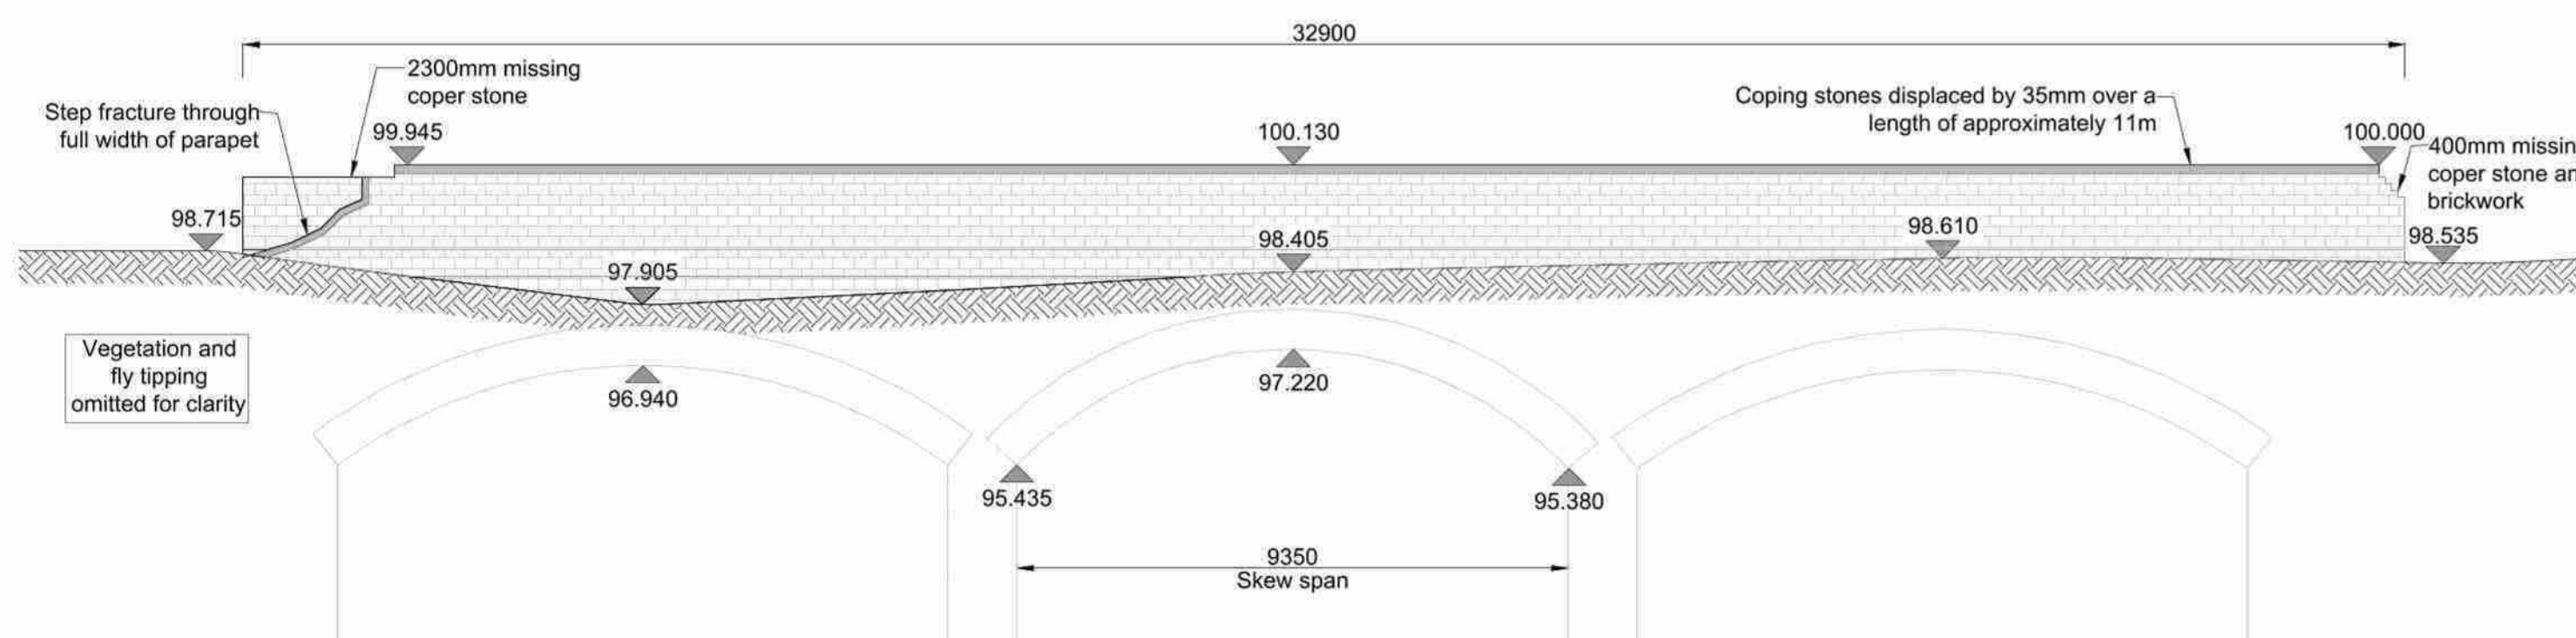
SCALE: AS NOTED @ A1 DO NOT SCALE
JACOBS No. B18280DW
CLIENT No. ESB 10m4ch
DRAWING NUMBER B18280-DW-0001

PLAN
SCALE 1:200

SECTION B-B
SCALE 1:100

SECTION A-A
SCALE 1:100

EAST ELEVATION
SCALE 1:100

SAFETY NOTES:
FLY TIPPED ASBESTOS SHEETING AND ROOFING PRESENT ON SITE

WEST ELEVATION
SCALE 1:100

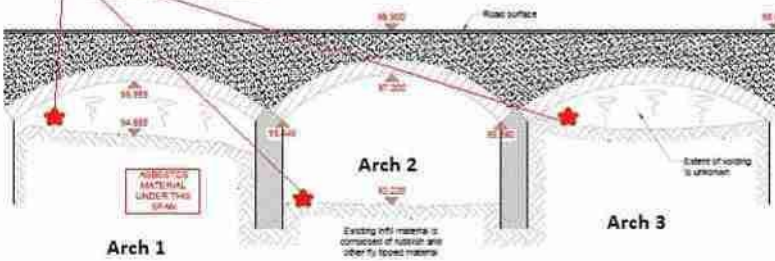
Position of Static bat detectors

PLAN (for illustration only)

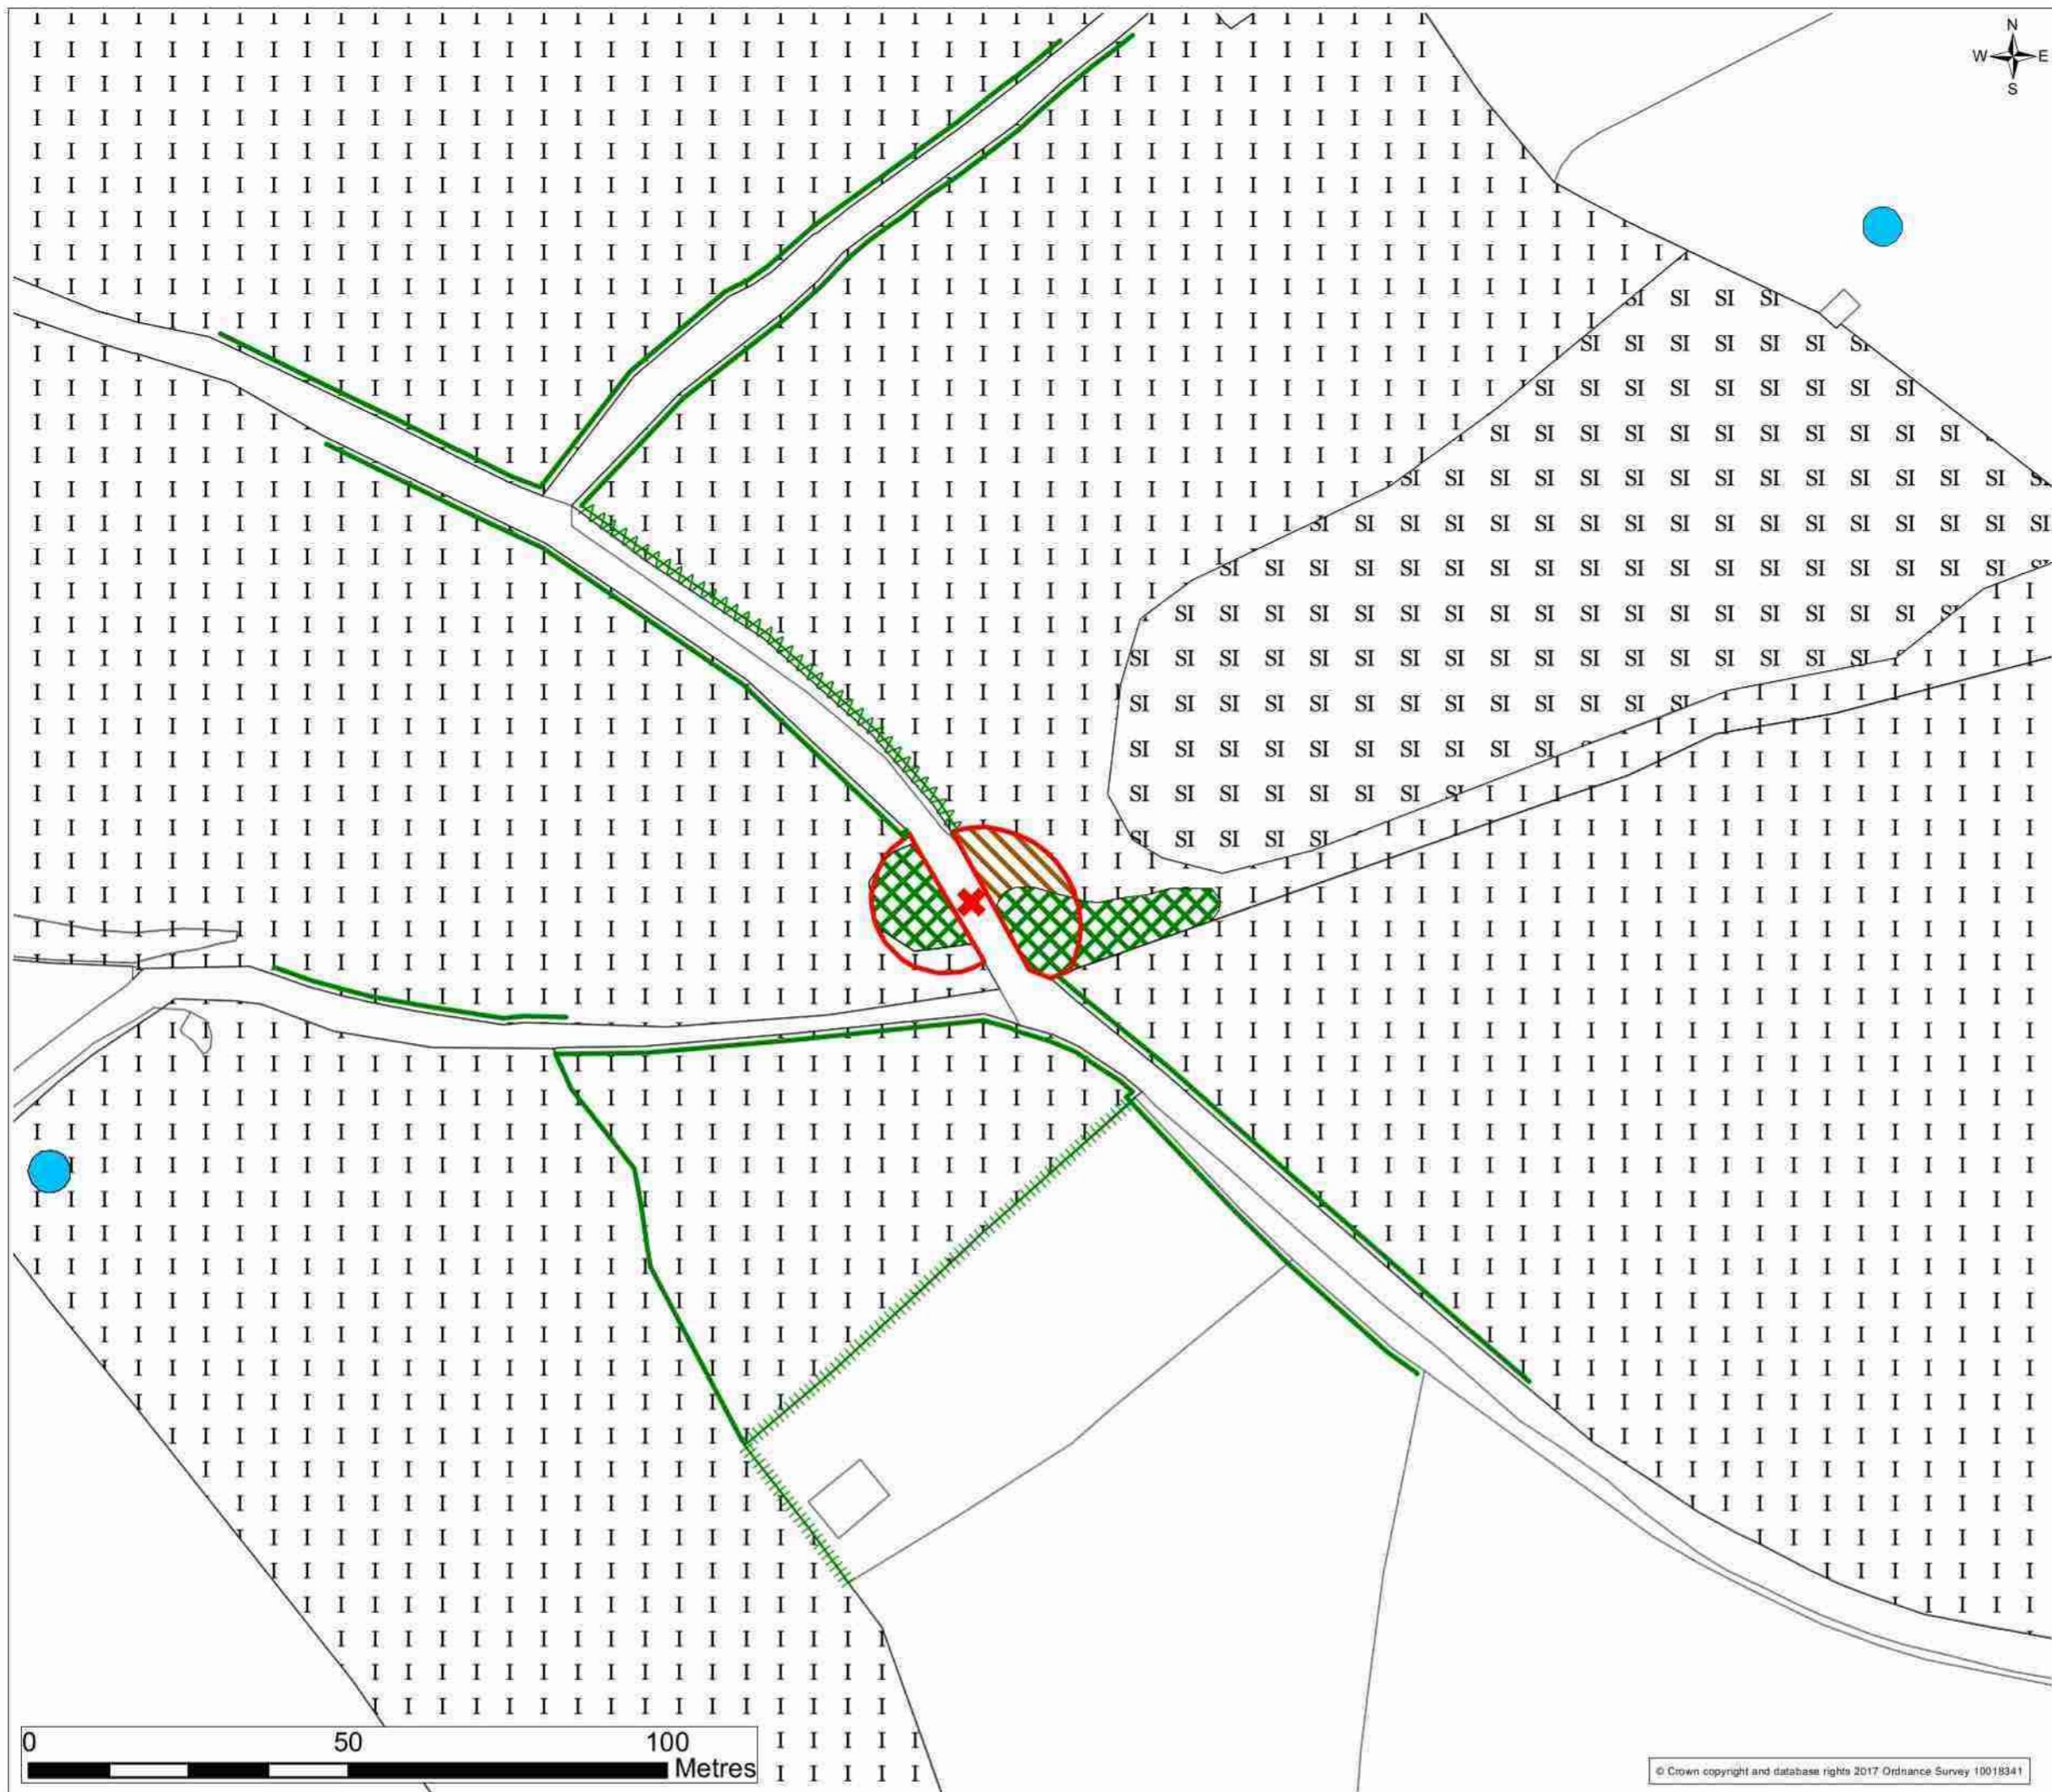
FIGURE 5

Drawing Title: Figure 5: Phase 1 habitat survey results

The Phase 1 Habitat survey results are set out in Figure 5. Habitats around the structure consisted of, scrub, tall ruderal, poor semi improved grassland, and improved grassland bordered by species rich intact hedgerow to the north and species poor intact hedgerow to the south. The fields to the north east were horse grazed, the fields to the south west were cattle grazed. Habitat connectivity was considered good with good bat foraging habitats; the cattle grazed fields with intact hedgerows were assessed as of potential value to [REDACTED] species, depending on animal husbandry (i.e. the use of antiparasitic drugs such as Ivermectin which may have adverse effects on the abundance of the invertebrate prey of bats).

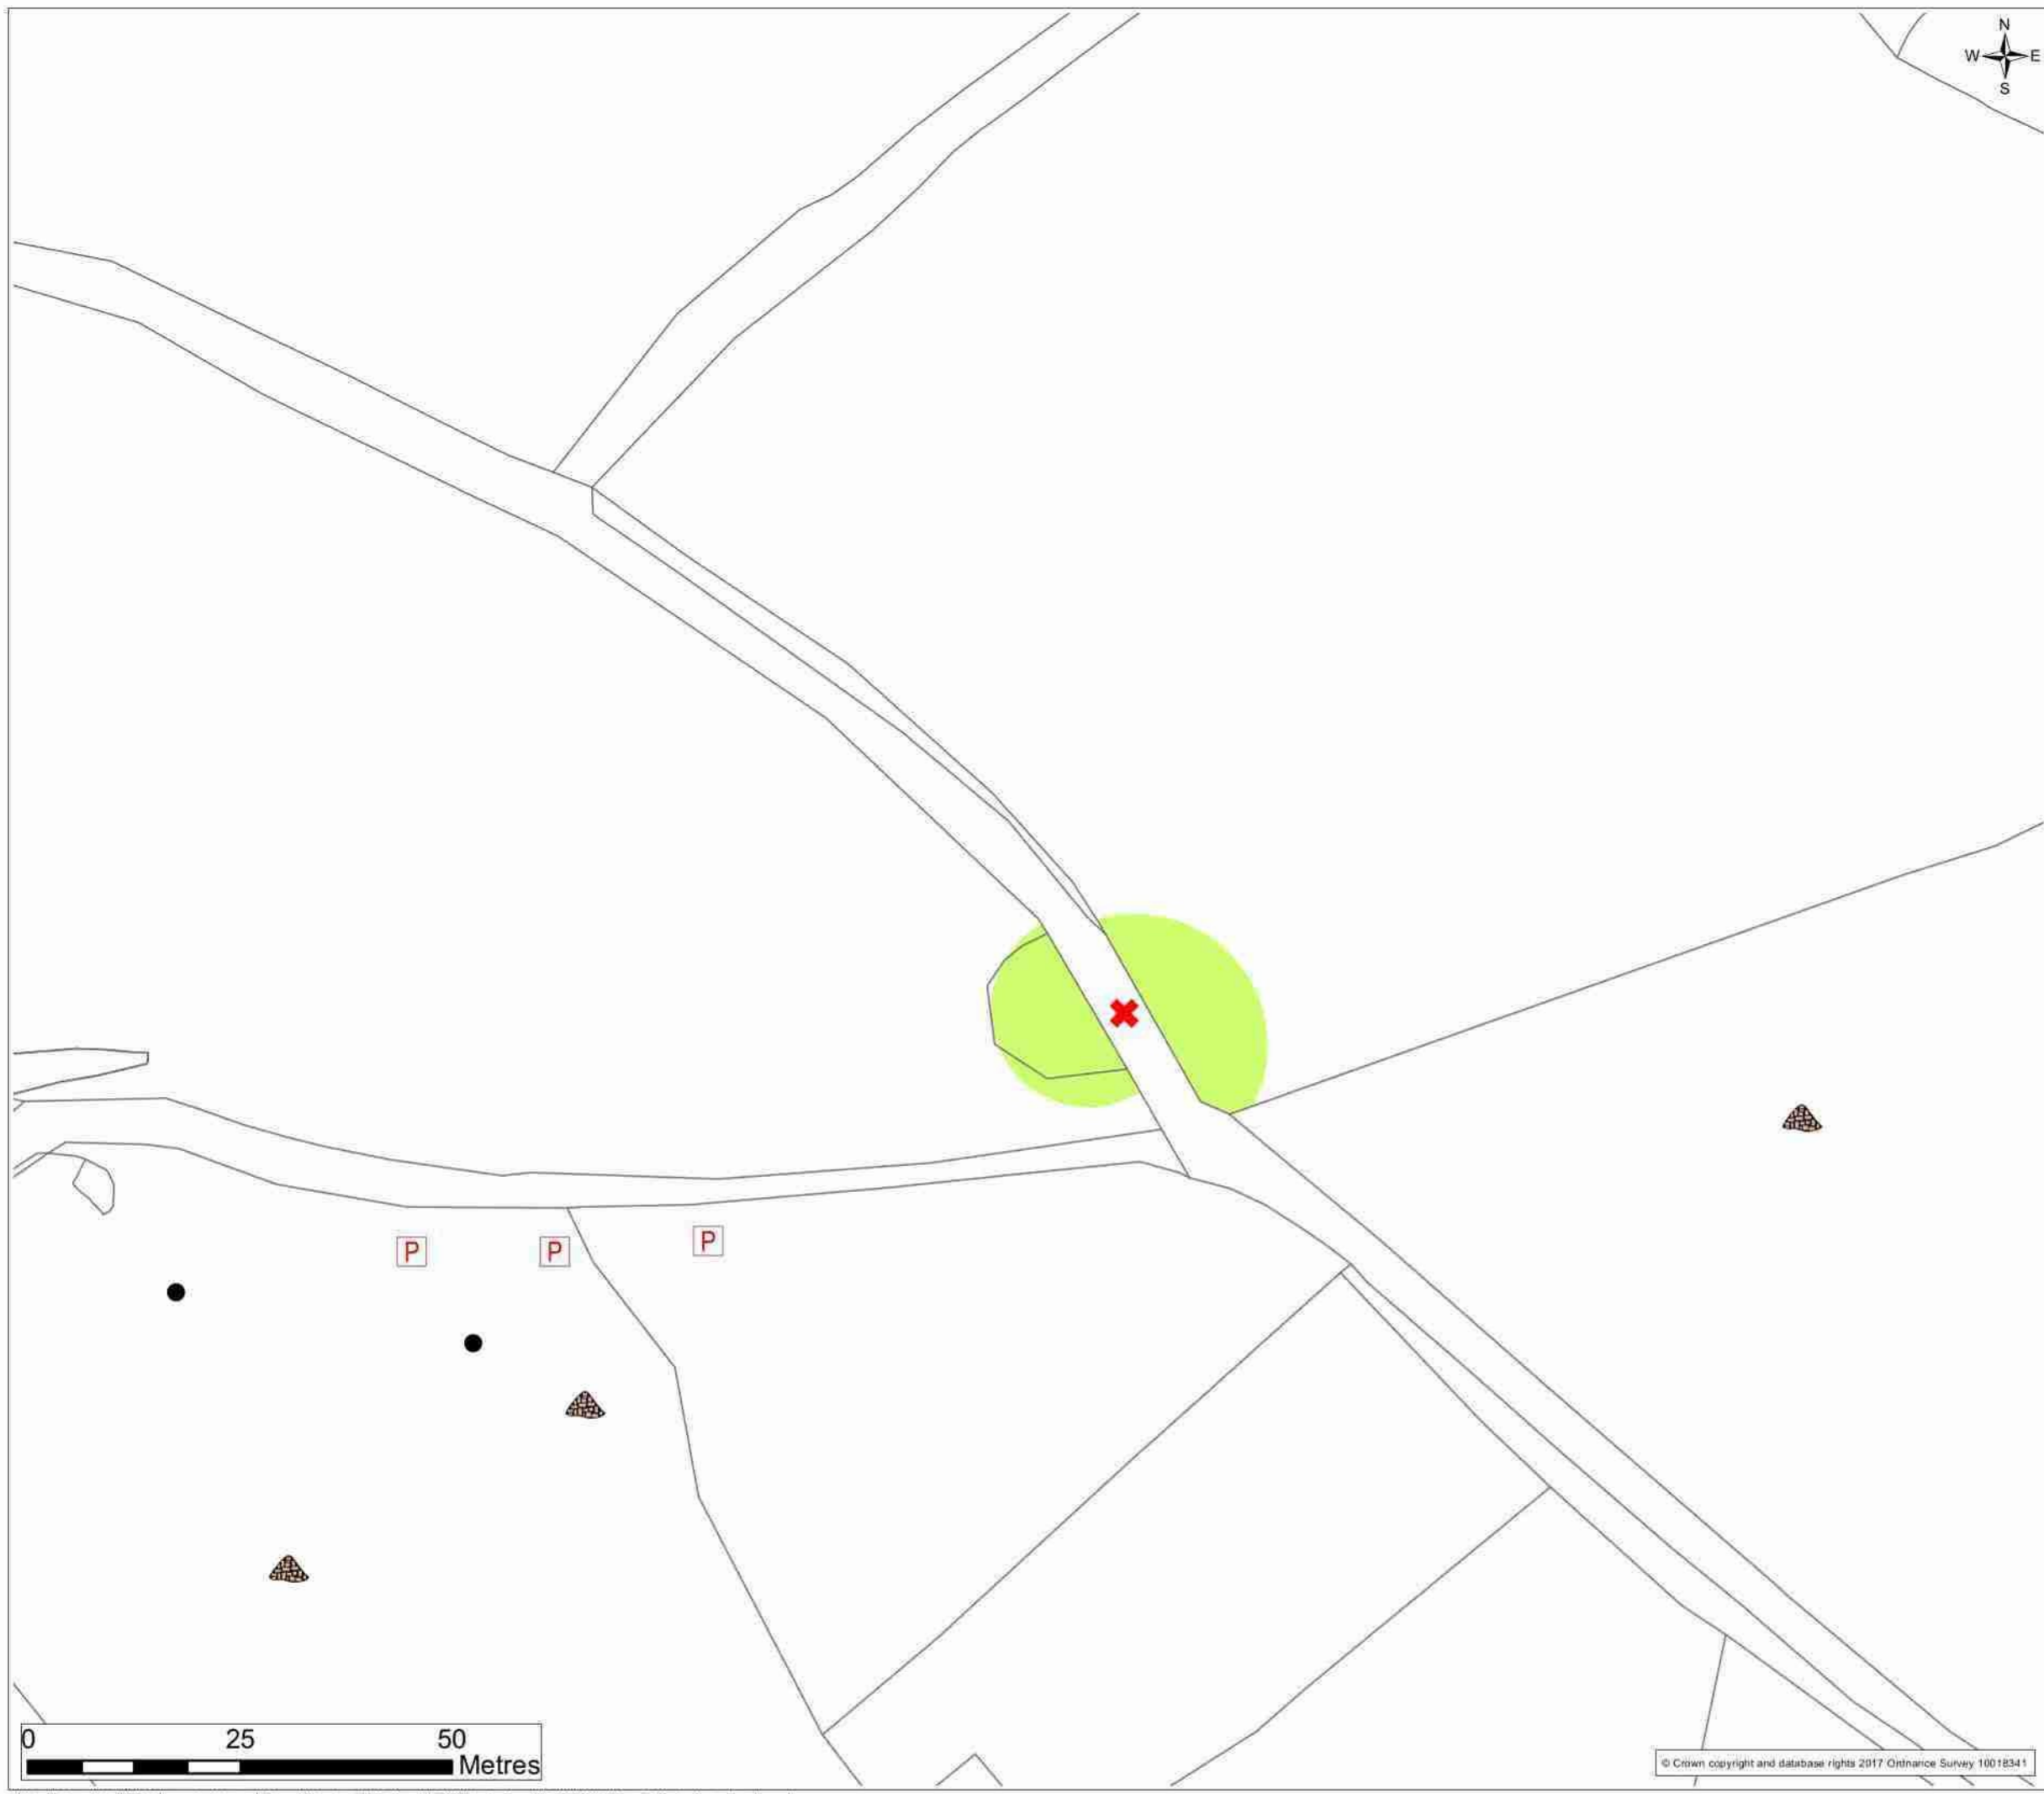
FIGURE 8

Drawing Title: Figure 8: Locations of dormouse tubes

The field surveys revealed no evidence of hazel dormouse in the nest tubes shown in Figure 8.
