Drawing title	STRUCTURE AGB/3 STRUCTURAL REPAIRS PROPOSED GENERAL ARRANGEMENT
Drawing status	FOR CONSTRUCTION Suitability
Scale	AS NOTED @ A1 DO NOT SCALE
Jacobs No.	B38380DE Rev
Client No.	AGB/3 04

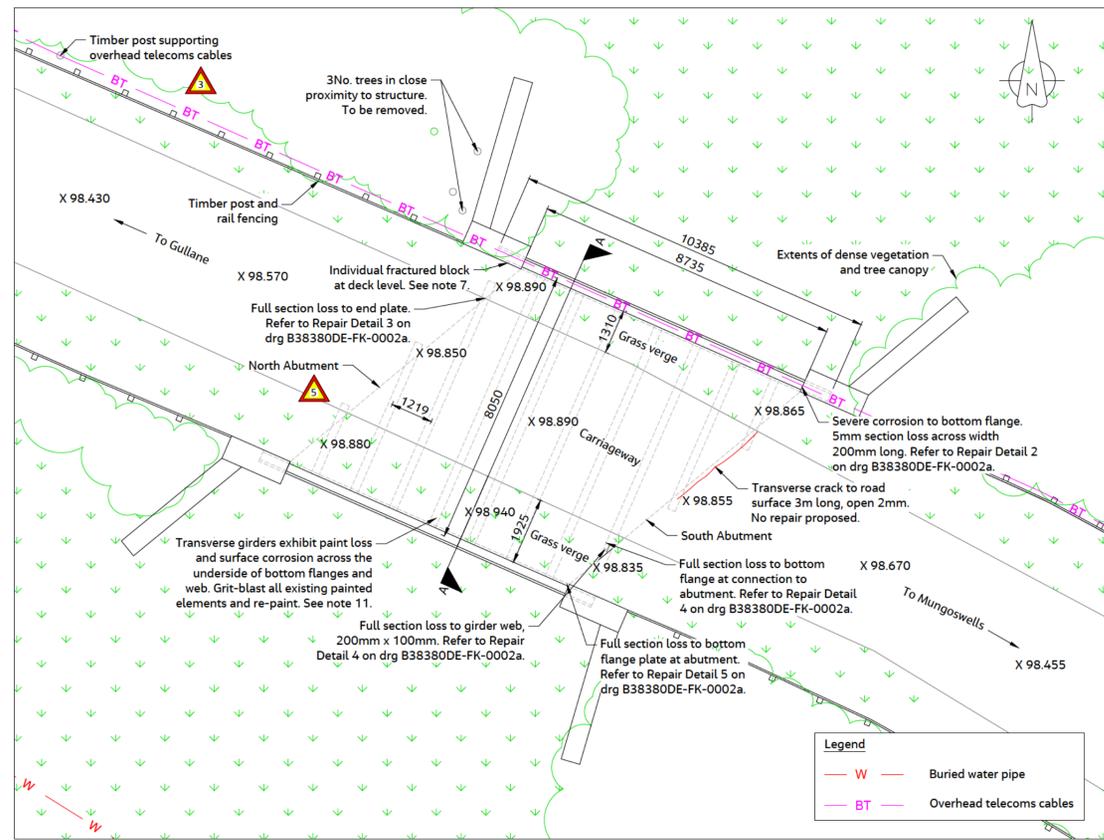
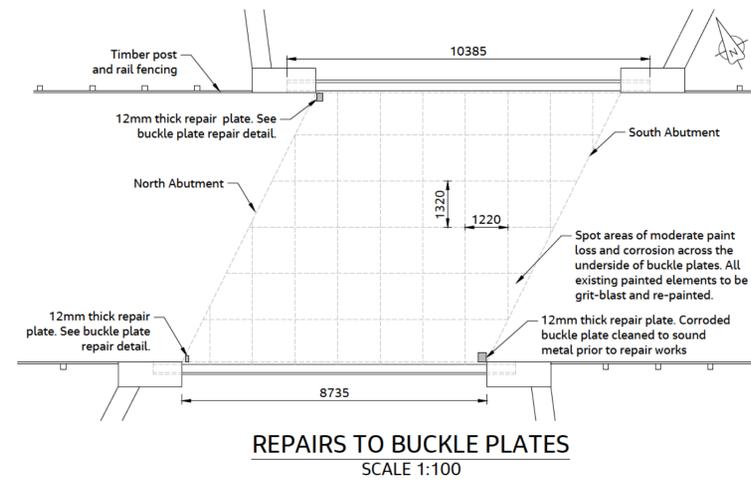
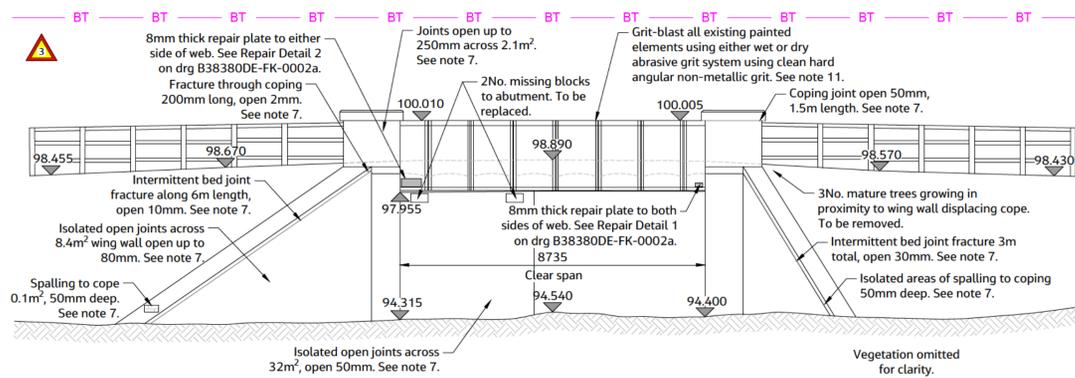
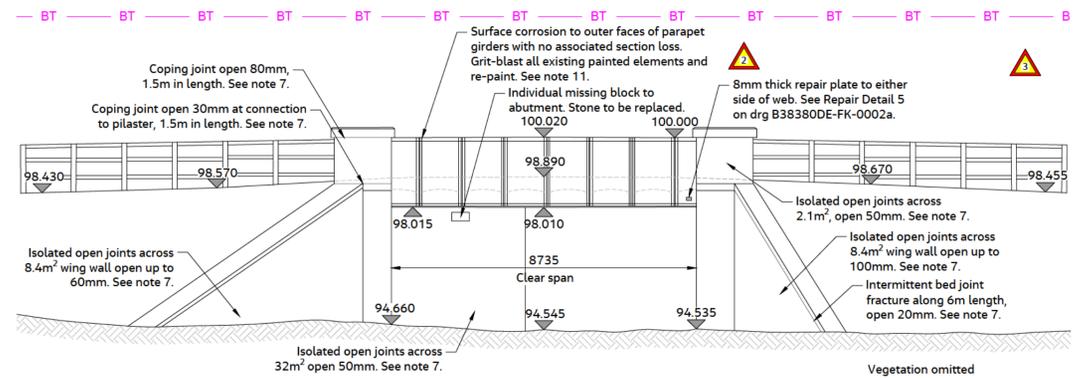
- Excavate verge and fill from above the defective area. Remove a sample of existing waterproofing and test for asbestos. If waterproofing is an ACM, arrange for removal in area of defective buckle plate. Once safely removed or confirmed not to be an ACM, move onto item 2
- Remove corroded section and clean back repair area to sound metal
- Cut to shape and fix 12mm thick plate to defective buckle plate repair area using Loctite epoxy adhesive
- Fill any voids with Loctite metal-filled compound paste. The compound should be skimmed to be flush with the existing plate.
- Once sealed, coat in a zinc rich paint.

No plant or equipment exceeding the assessed 3 tonne GVW capacity of the structure is to traverse the bridge deck.

- Heavily corroded steel to be cut out and replaced with new S355 steel. Replacement steel to be welded to the existing elements by a 6mm thick butt or fillet weld connection.

- Holed metallic elements are to be over-plated with new S355 steel. Corroded material surrounding the hole should be cut out prior to repairing.
 - Heavily corroded rivets to be removed and replaced with dome headed HSFG bolts with the same diameter and similar appearance to the original.
